Geotechnical Investigation

Faringdon South Subdivision 23 Dynes Road Rolleston

22.12.2016 12903.000.000_07

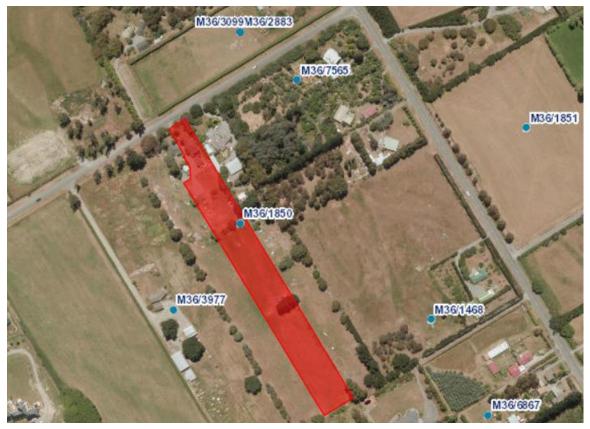
Figure 2: Nearby ECan Borehole Locations

A review of a deep ECan borehole log approximately 150 m northeast of the site has been conducted. The log from this hole is presented in Appendix 3 and indicates the site is underlain by a mixture sandy gravels to depths of at least 35 m below ground level.

Groundwater is recorded in the surrounding boreholes between approximately 10 and 12 m depth.

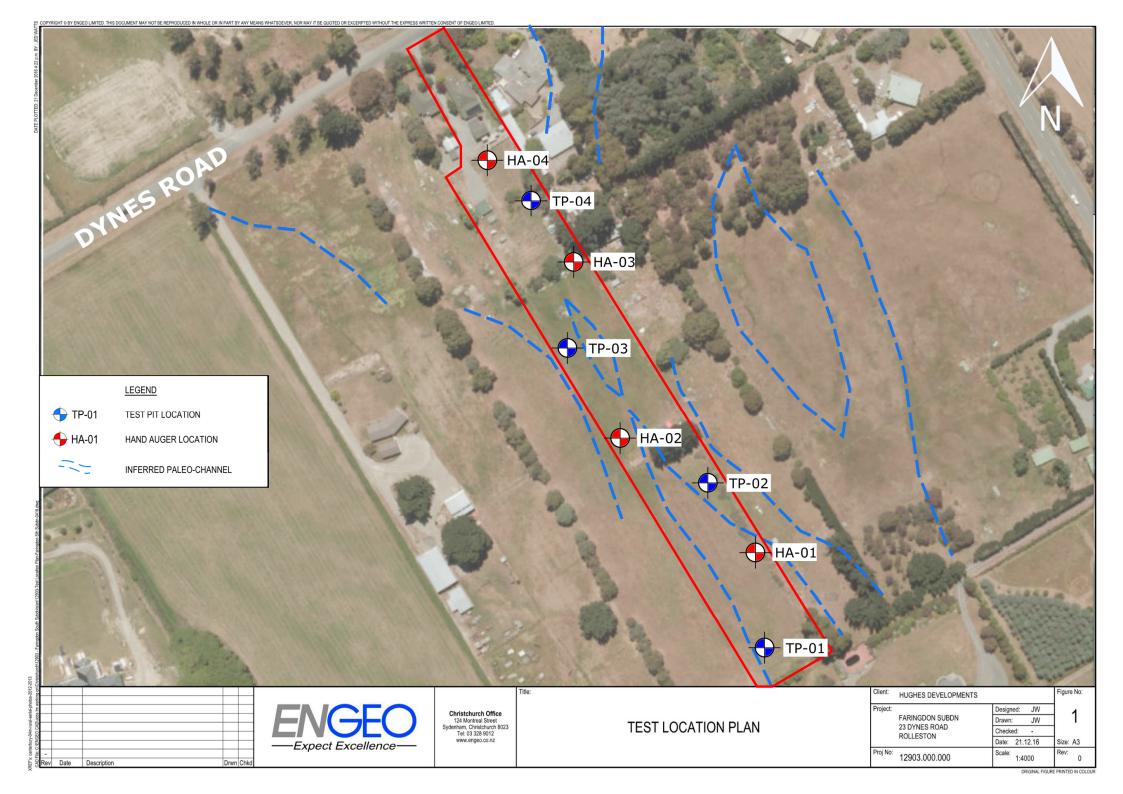
APPENDIX 1: Test Location Plan

The site comprises relatively flat ground, with gentle undulations and depressions in some areas. As evident on aerial imagery (Canterbury Maps, 2016) and observed during our site walkover conducted on 21 December 2016, undulating and depressed ground can be attributed to paleo-channels, which traverse the site in a general northwest to southeast trend. Based on observations, silt deposits with variable thickness (up to 0.7 m) are expected to have in-filled the paleo-channels. Inferred paleo-channels have been mapped to give an indication of areas with potential channel in-fill (Appendix 1).

Investigations undertaken within or adjacent to inferred paleo-channels revealed deeper silt deposits to depths up to 0.7 m.

Test Locations are shown on Figure 1, Appendix 1. Test pit and hand auger hole logs, showing detailed soil descriptions are presented in Appendix 2.
