DETAILED SITE INVESTIGATION

Faringdon Development, Rolleston, Christchurch

Report Number. 1278203872_007_R_Rev0

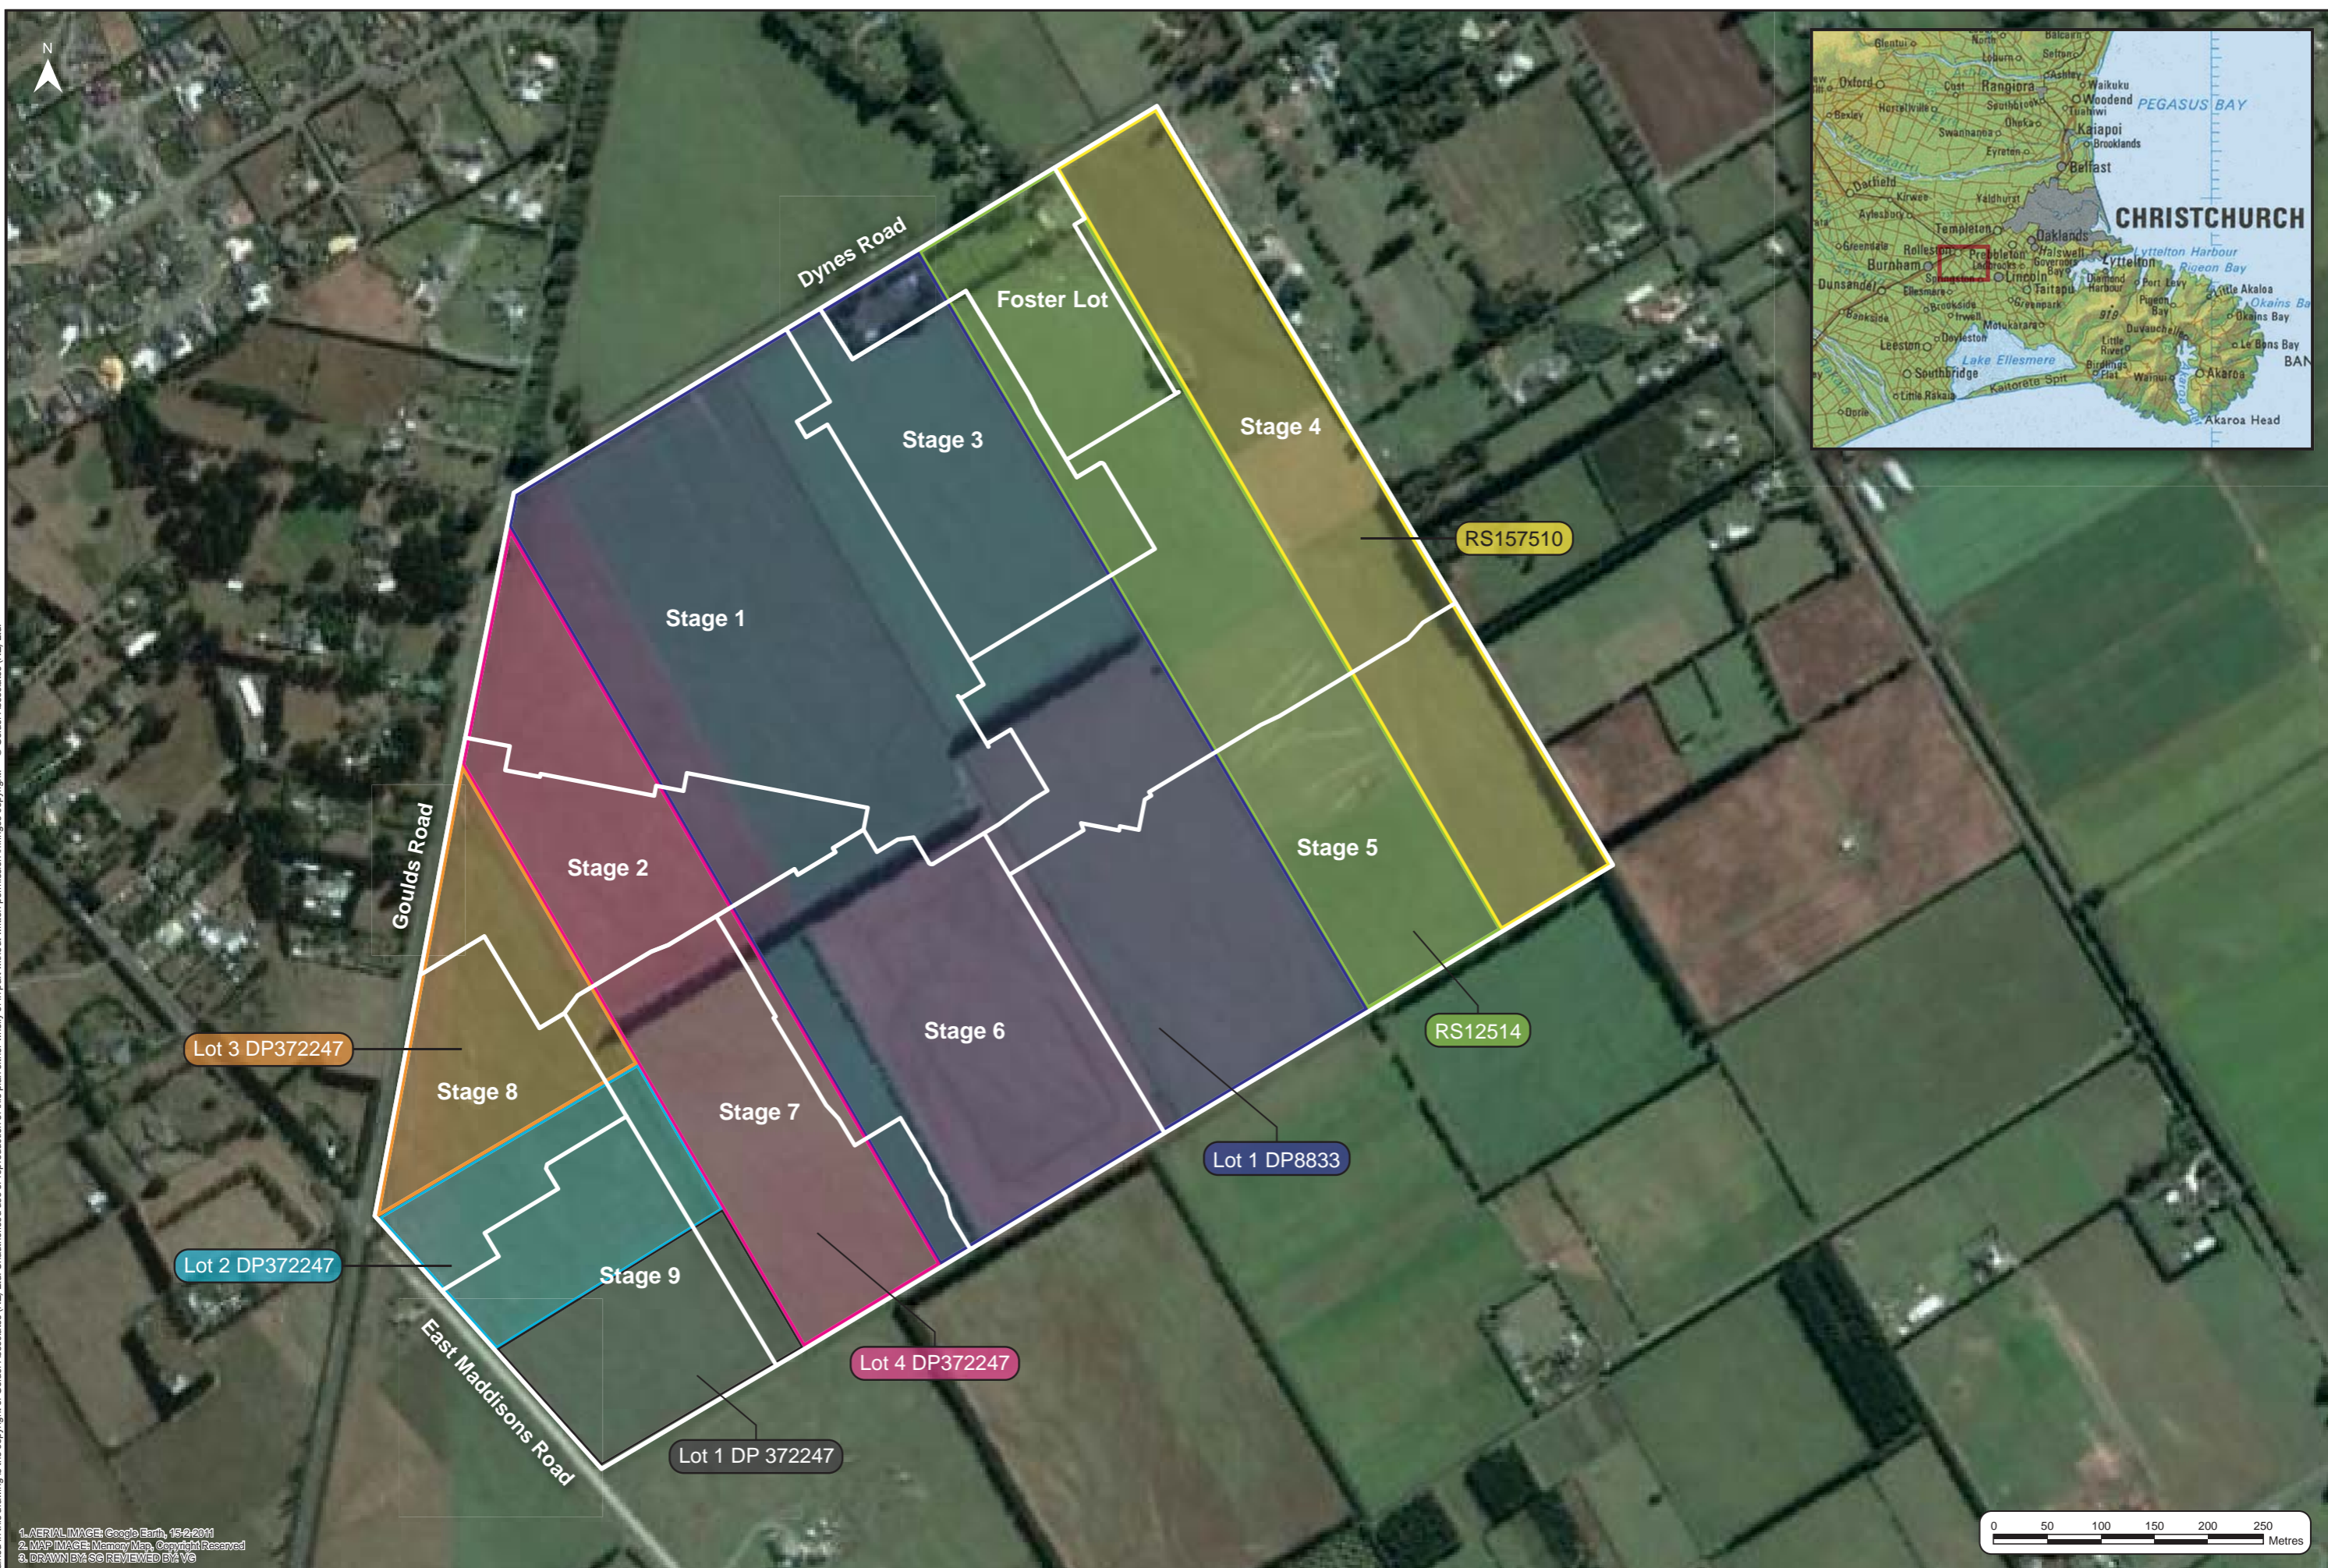
The layout and the historical activities undertaken on each stage of the development are described in the PSI (Appendix B). A site layout plan is presented in Figure 2.

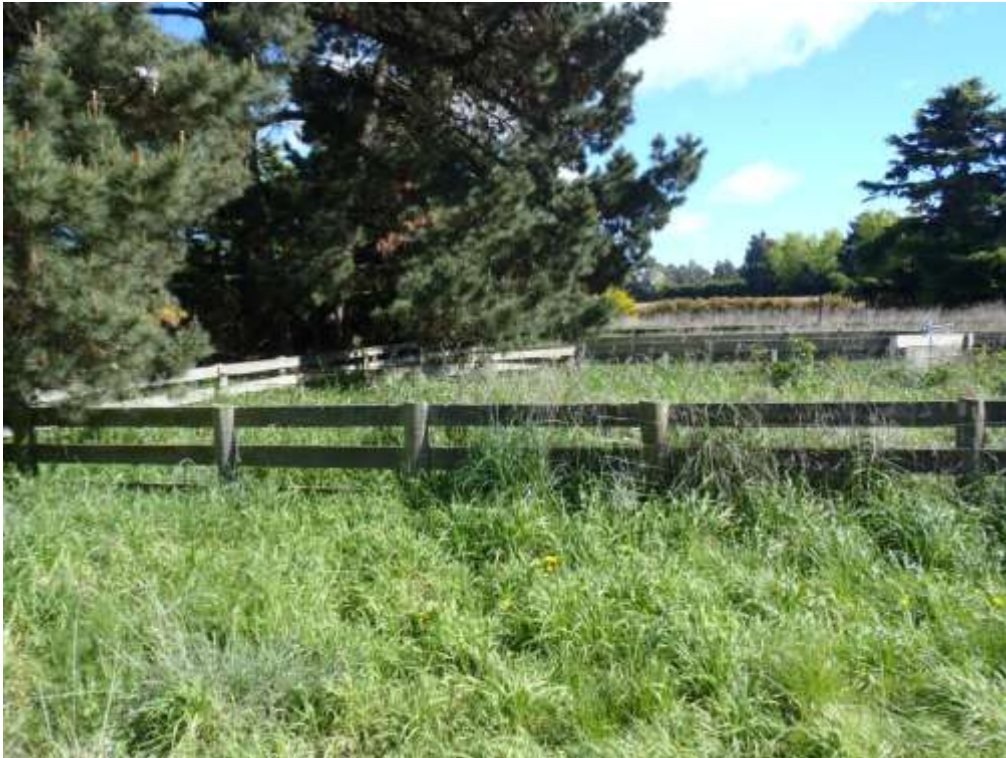
- There is considered to be a **low** level of risk associated with potential hydrocarbon and mineral oil contamination associated with the maintenance and storage of the vintage cars.
 - Although there were no signs of petroleum hydrocarbon staining on the soils beneath any of the vintage vehicles, the soil maybe impacted with hydrocarbon or mineral oils from leaking parts of the vintage vehicles.
- There is considered to be a **medium** level residual contaminants associated with sheep dipping in the sheep pens in the north-east of Stage 3.
 - Small sheep pens are located to the north-east of Stage 3 adjacent to where historically the mobile sheep dipping occurred, on the Foster Lot. The soil within the pens maybe impacted by residual contaminants associated with sheep dipping.

Photograph 1 – Sheep pens in the north of Stage 3.

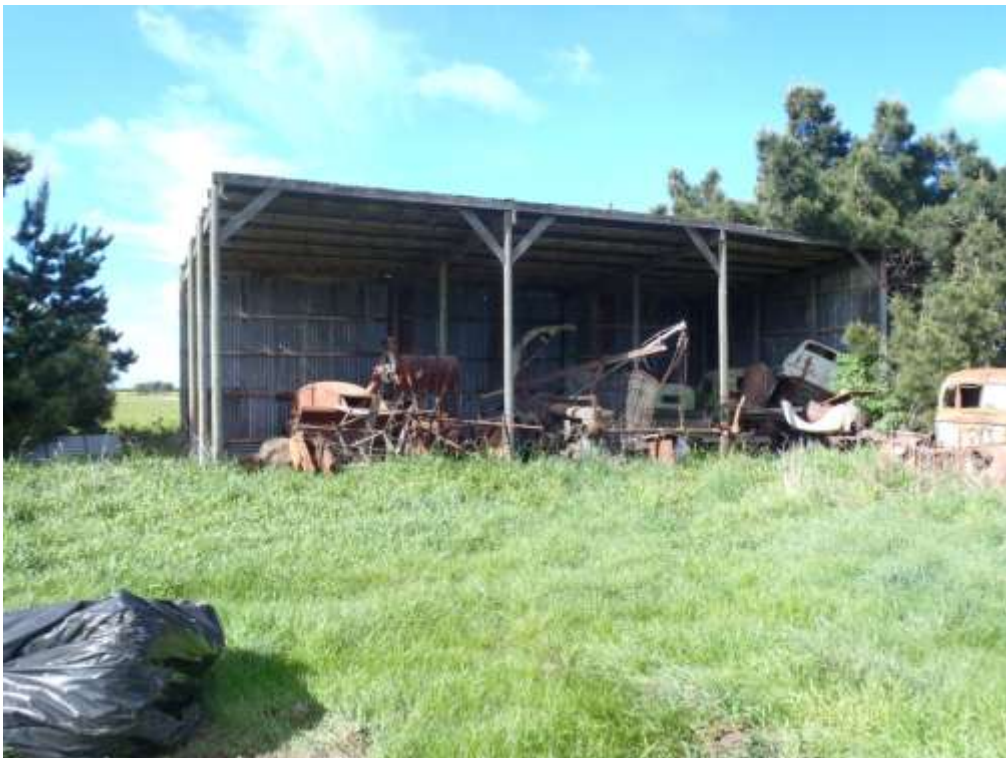
- The storage of vintage vehicles: Due to the age and condition of the vehicles stored on the site a number of contaminants associated with vehicle maintenance are considered to be of potential concern (including hydrocarbons, and metals which may be contained in waste oils).

Photograph 2 – Vintage vehicles stored in the hay barn in the north of Stage 3.

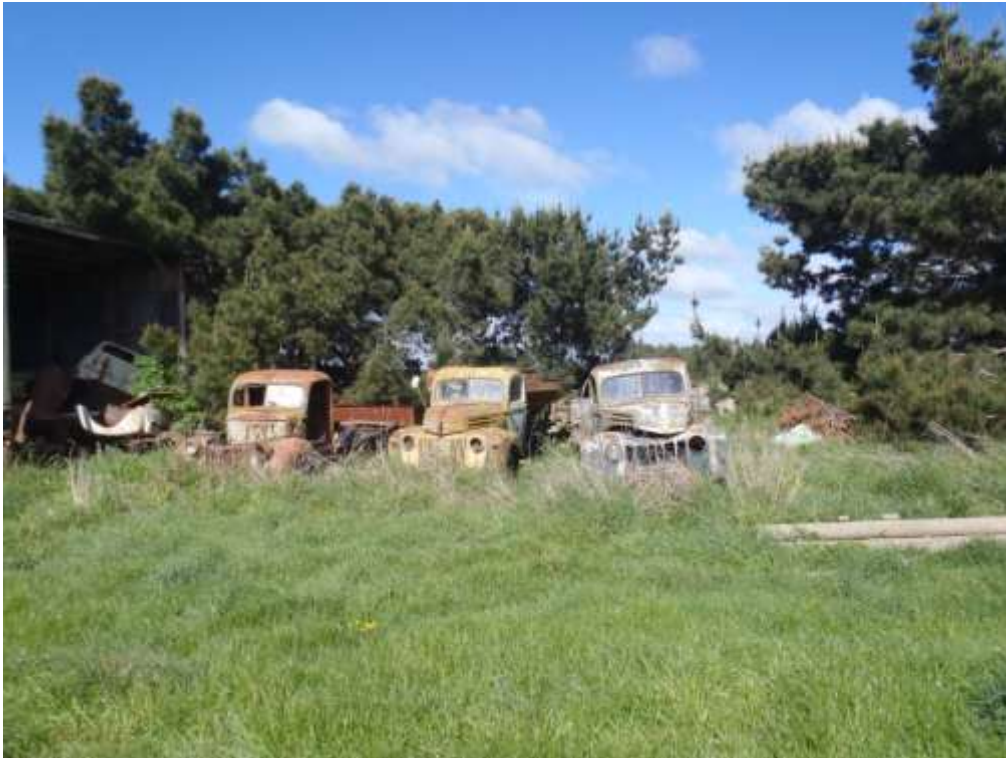
Photograph 3 – Vintage vehicles store in the north of Stage 3

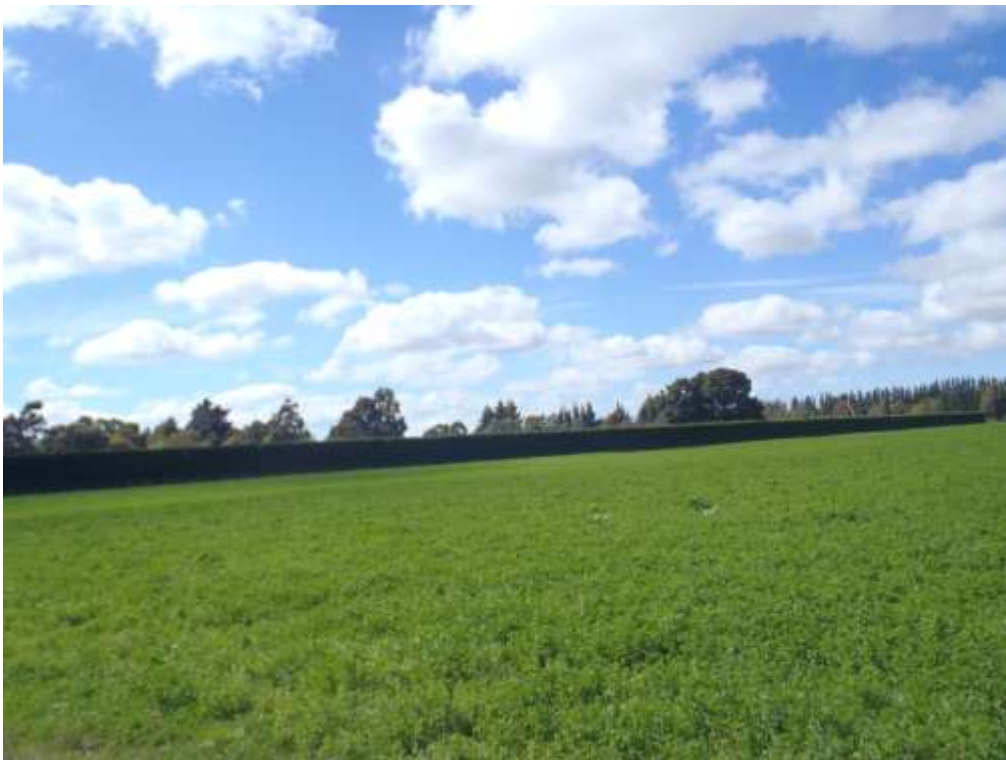
One shallow sample (0.1m) and one deeper (0.2m) soil sample were collected from six locations from the lucerne field. The soil samples were analysed for potential contaminants of concern including arsenic, copper, lead, organonitrogen (ONP), organophosphate (OPP) and organochlorine (OCP).

Photograph 4 – Lucerne field in the north of Stage 4.

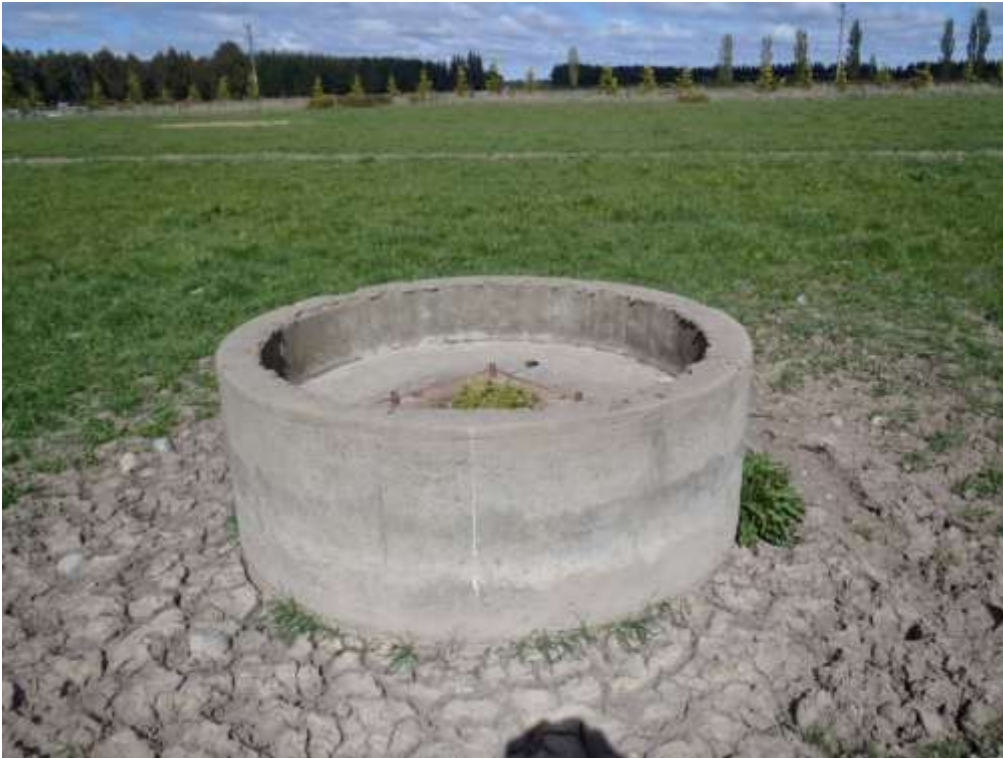
- There is considered to be a **low** level of risk associated with a former observatory tower.
 - Lead-based paint residues may be present around the location of the observatory tower in Stage 9. The observatory tower was present between at least 1955 until the late 1960's when the observatory was removed off-site. Until 1965, many paints on the New Zealand market had high lead levels. (Resene, 2012)
 - Potential ACM may be present in the surface soils surrounding the building footprint as a result of damage to the structure during tower relocation.
- There is considered to be a **low** risk associated with the presence of an offal pit.
 - Anecdotal information indicates a small offal pit lies along the southern boundary of Stage 9.

Photograph 5 – Footings from observatory in Stage 9.

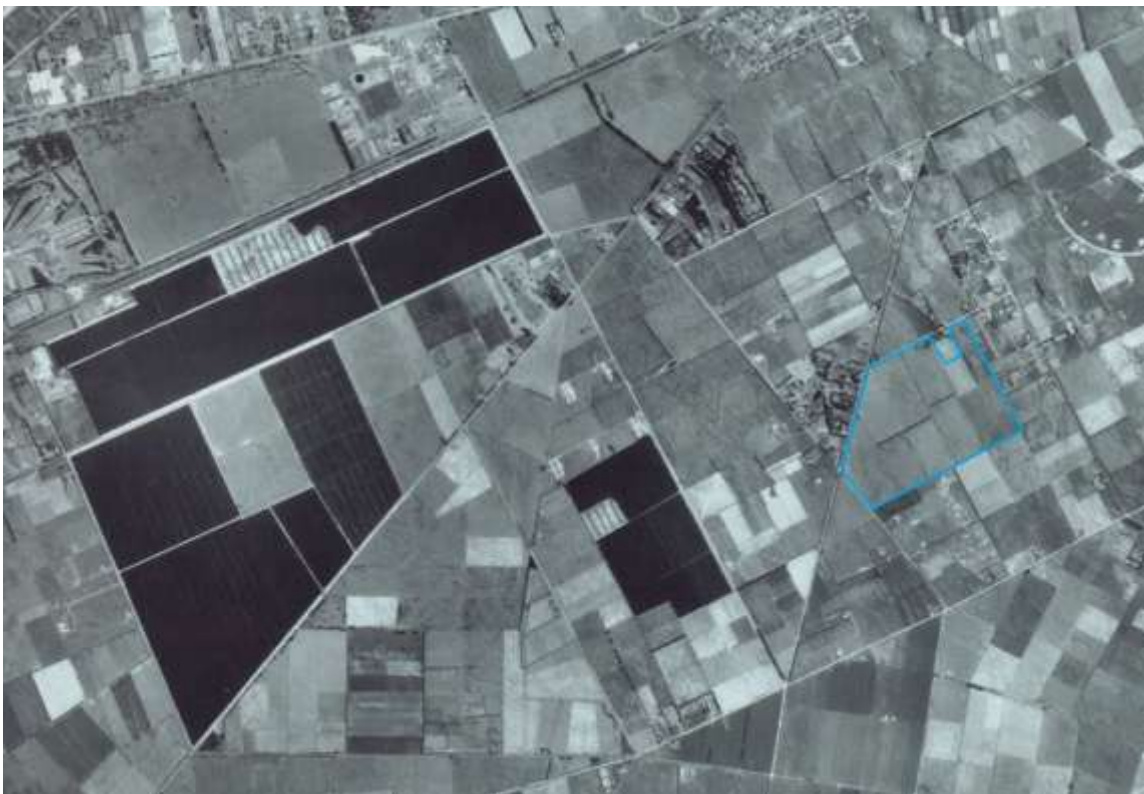
Photograph 4: NZAM 26/11/1994 blue outline depicts approximate site area.

26 November 1994 Black and white	The site and surrounds are similar to 1984 (i.e. only minor changes) (Refer to photograph 4, Appendix D).
13 July 2009 Google Earth, colour	The site is similar to 1984 (i.e. only minor changes). Increased residential properties are evident to the north-west of the site (Refer to photograph 5, Appendix D).
3 August 2010 Google Earth, colour	The site and surrounds are similar (i.e., minor changes only) to 2009 (Refer to photograph 6, Appendix D).
28 March 2011 Google Earth, colour	The site and surrounds are similar (i.e., minor changes only) to 2010 (Refer to photograph 7, Appendix D).

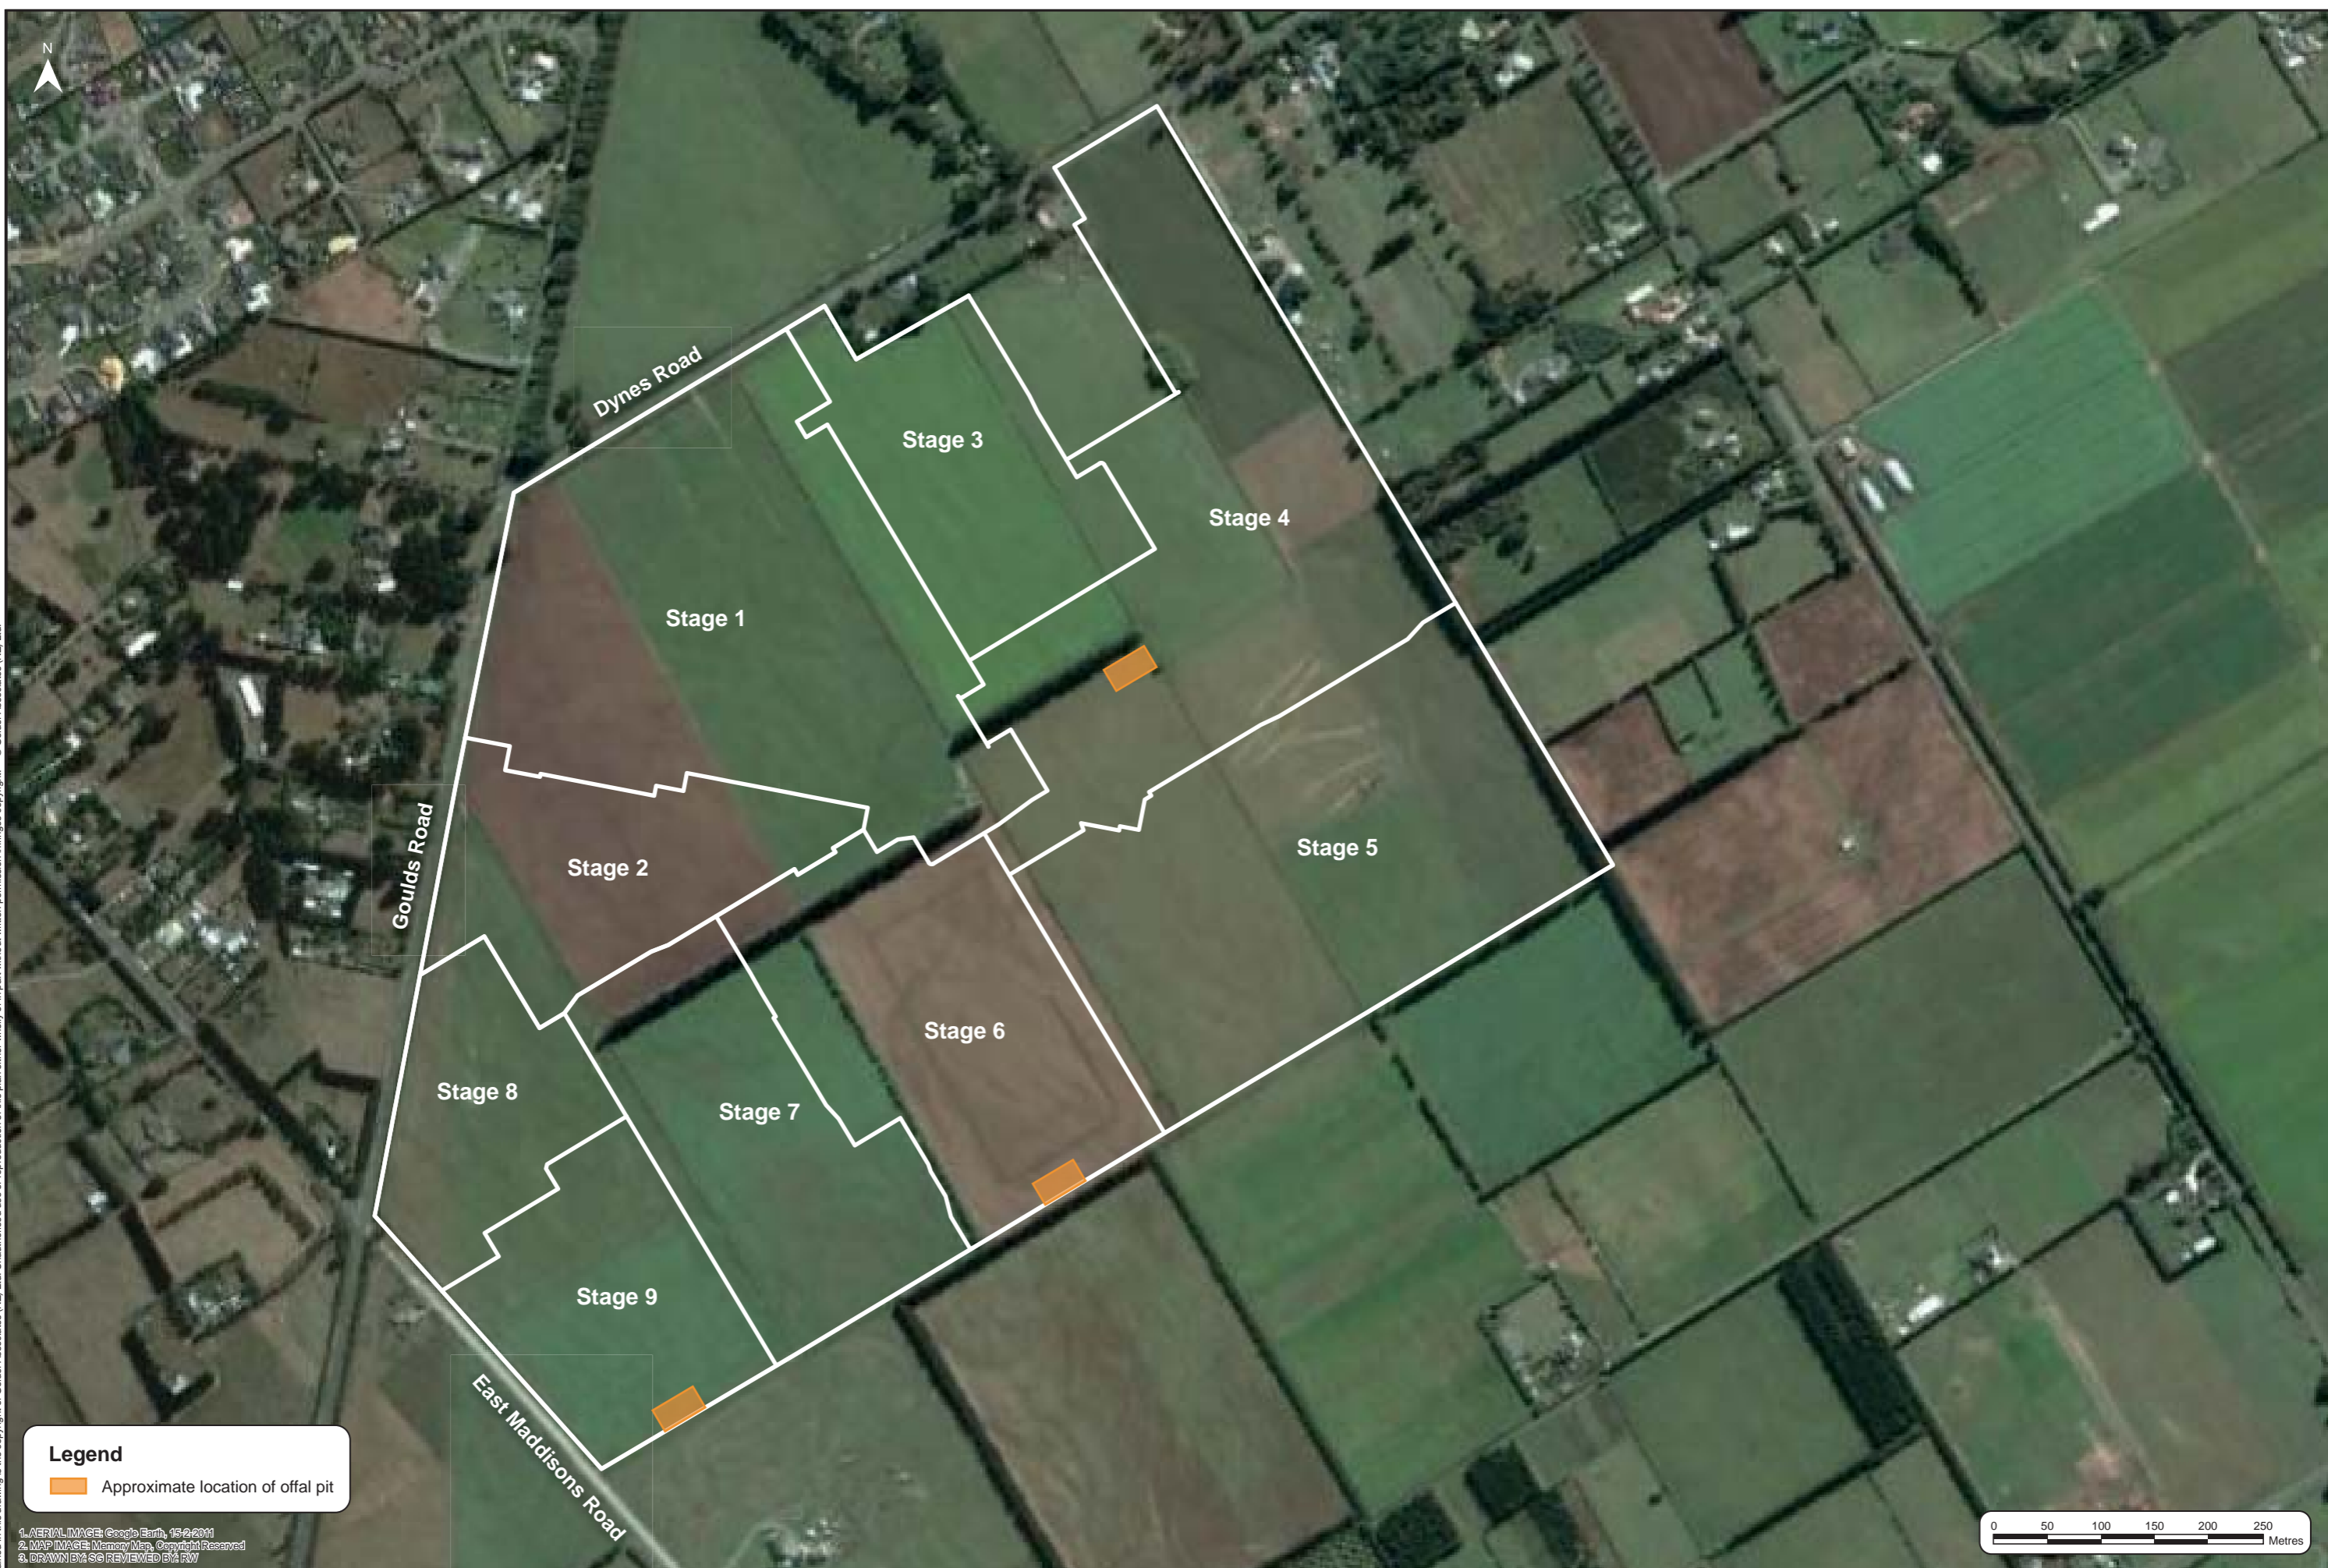
Legend
 [Orange Rectangle] Approximate location of offal pit

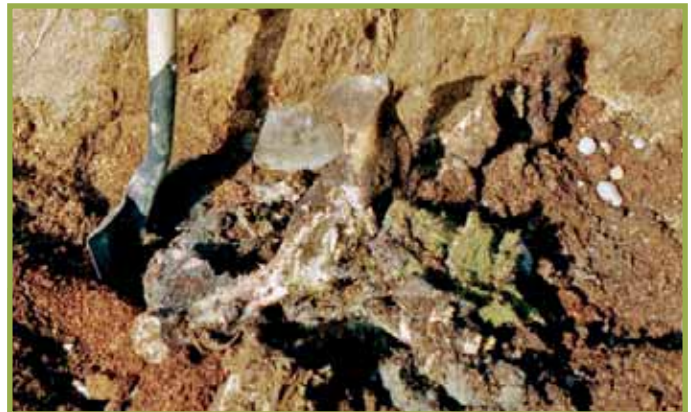
All that was left of a cow after 6 months composting in saw dust

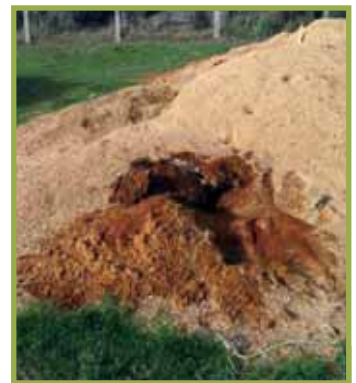
- a. Windrows are generally built up to be 1.5m high and 3m wide.
- b. Windrows need to be fenced to keep stock and scavengers out.

Sheep composting windrow

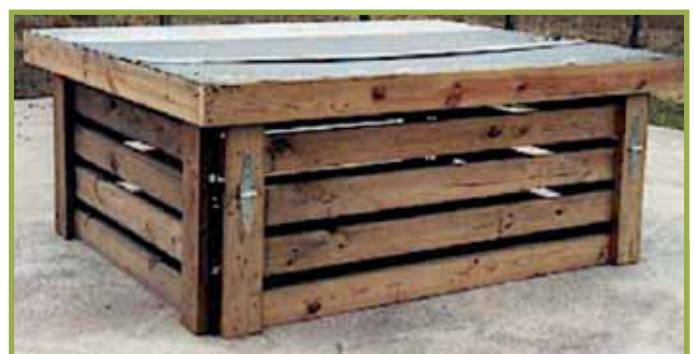
A sheep composting bin made of 50x150mm treated timber

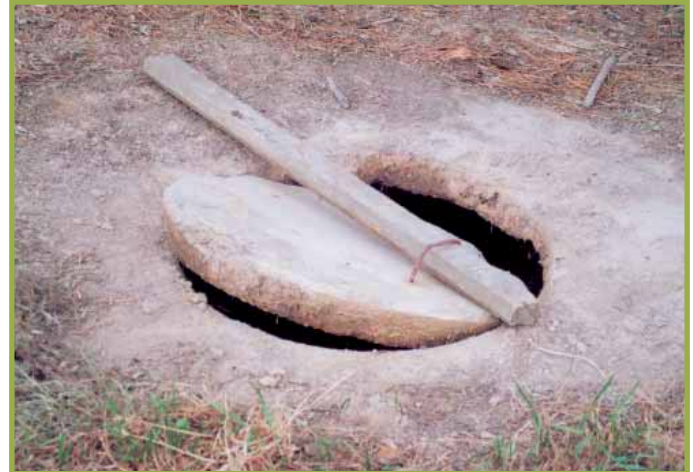
- Offal pits may be narrow trenches dug by an excavator, or vertical shafts usually about 1m in diameter and a few meters deep constructed by a large diameter auger.
- The volume of the pit should be no more than 30 cubic metres.
- The top of the pit should be covered with a heavy-duty concrete slab at least 125mm thick with access from at least one airtight cover-plate.

Example of a well constructed offal pit
