GEOTECHNICAL INVESTIGATION

FOSTER BLOCK, GOULDS ROAD

ROLLESTON

21 December 2011

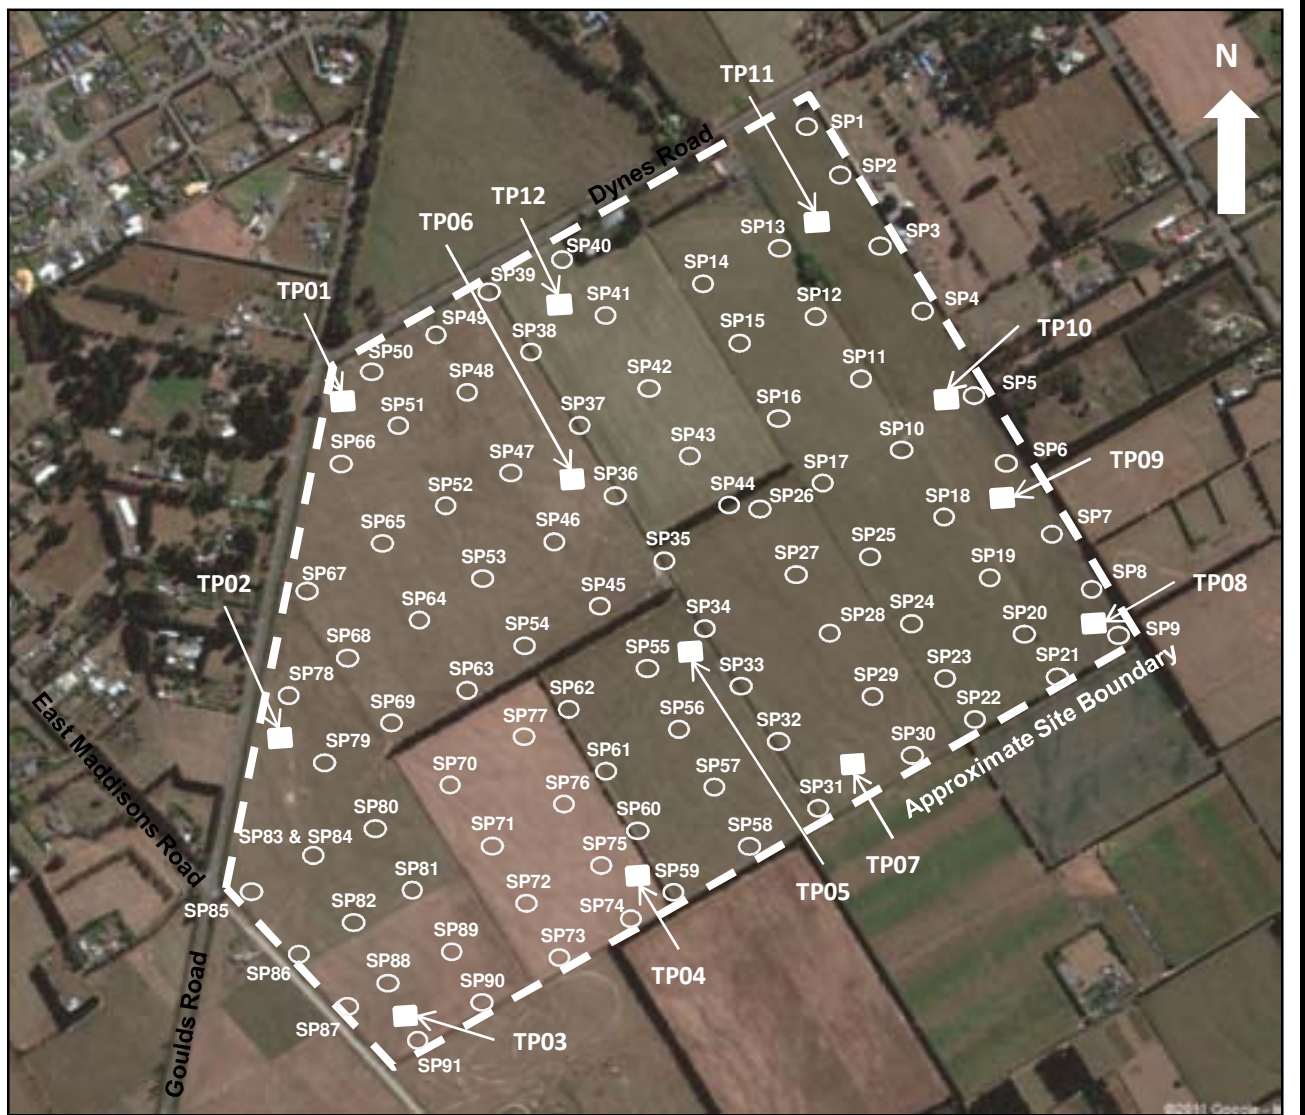
Date	Nov-11	Client	Hughes Construction Ltd		
Drawn by	CM	Project	Foster Block, Goulds Road, Rolleston		
Approved by	MW	Description	Site Location Plan		
Scale	NTS	Figure Number	1	Project Number	11283_1

- AutoScala Test Location
- = Test Pit Location

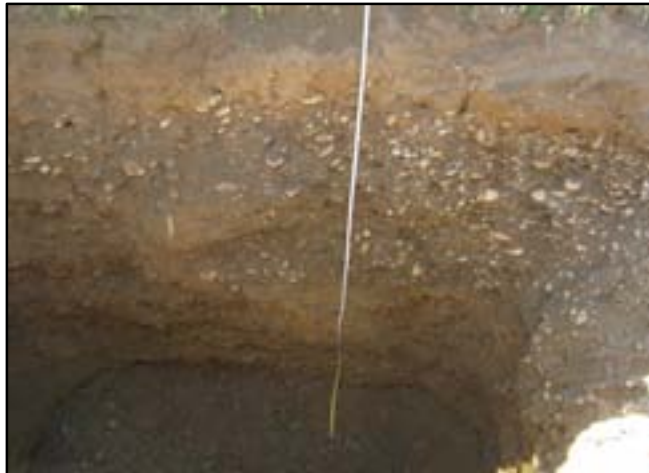
Photo 5: View of sub surface material in Test Pit 1.

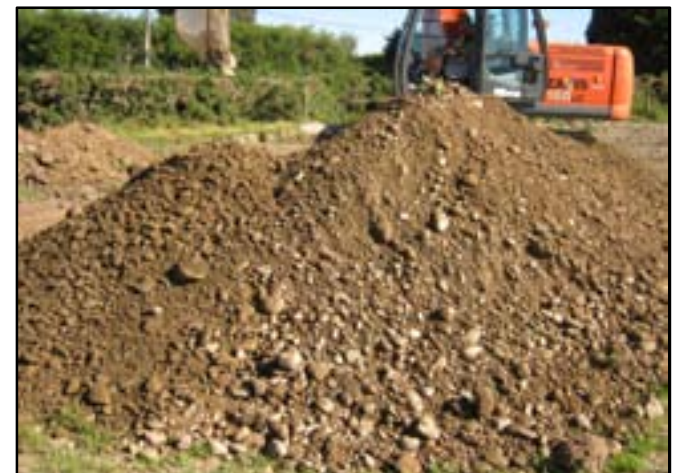
Photo 6: Gravel removed from Test Pit.

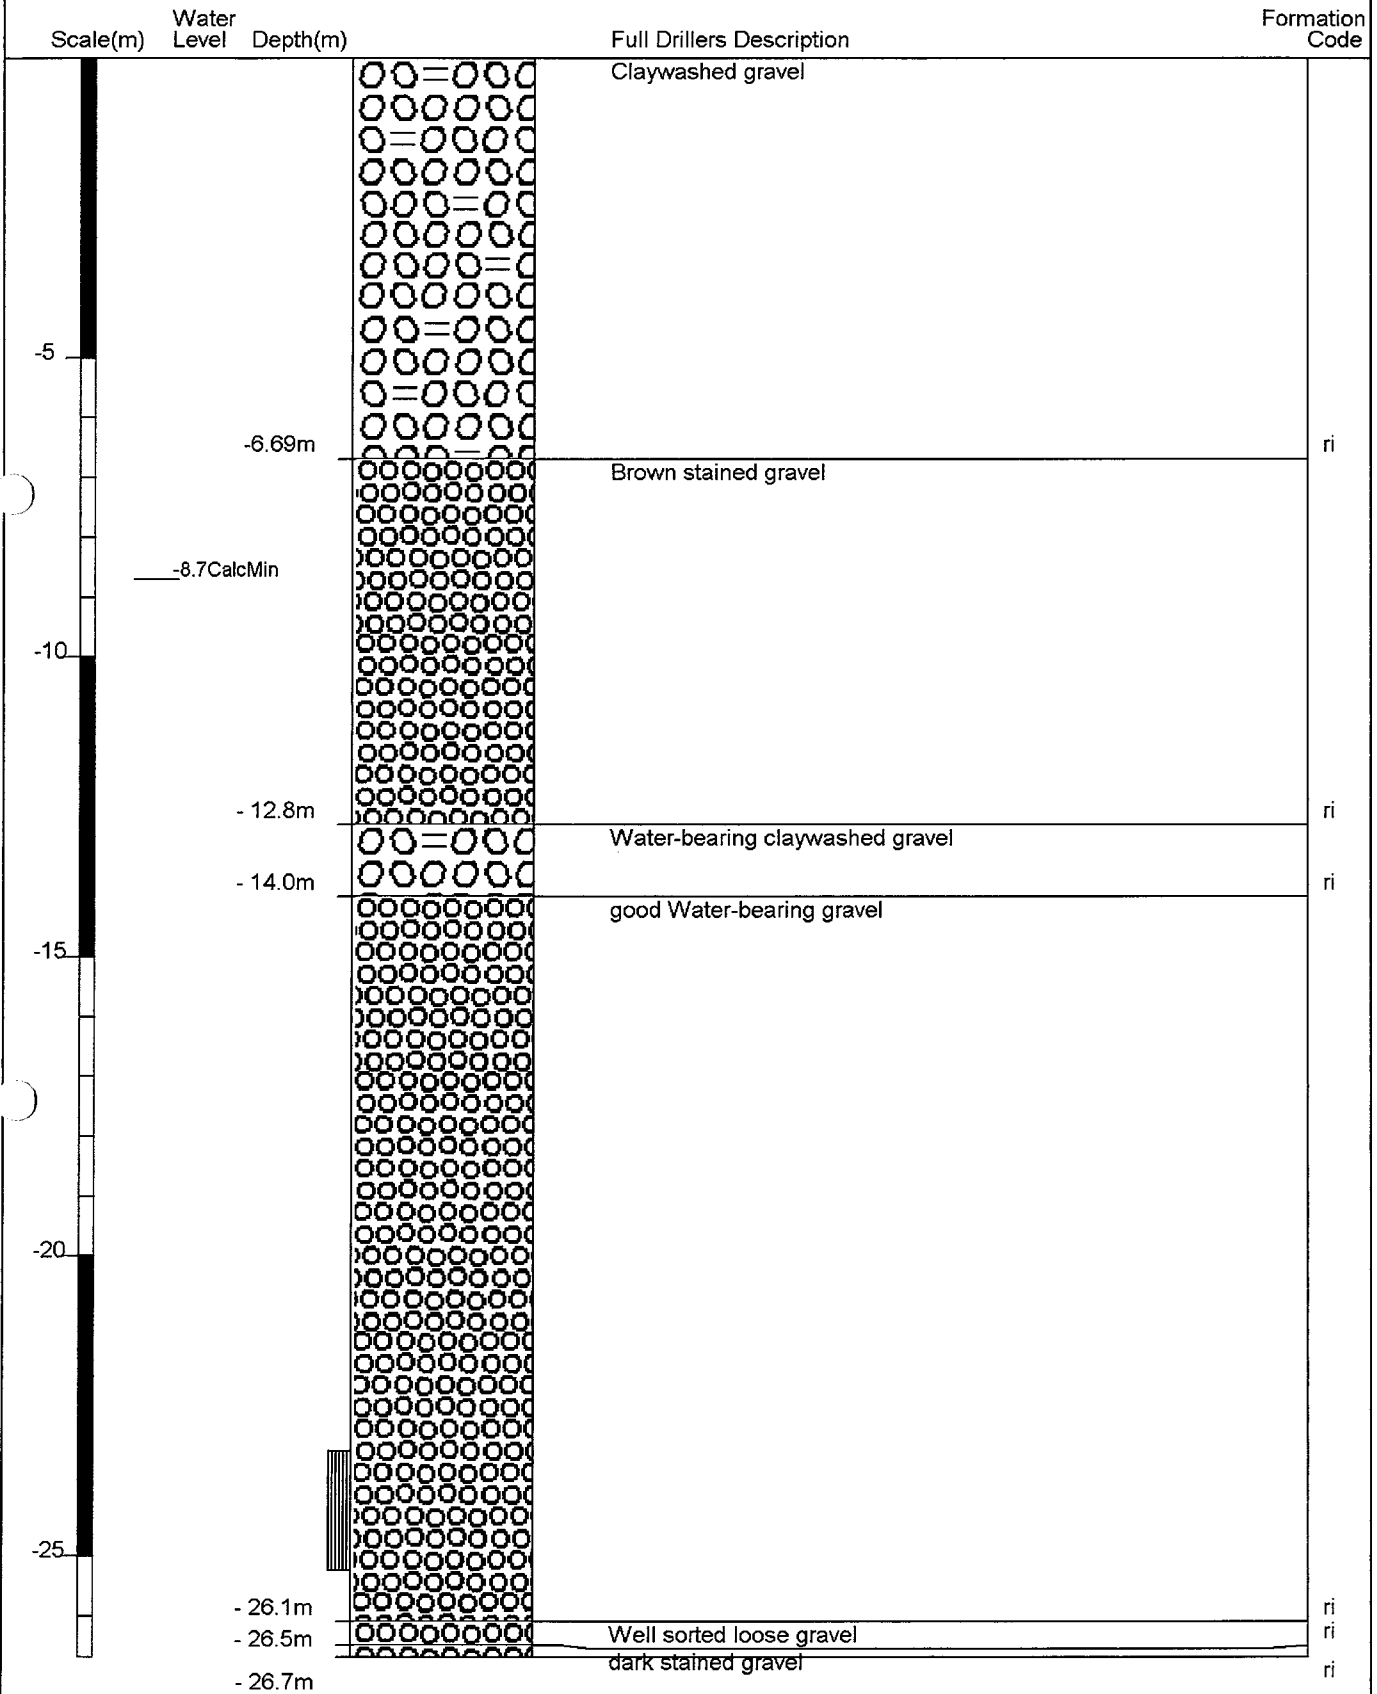
Borelog for well M36/4891

Gridref: M36:6011-3161 Accuracy : 4 (1=best, 4=worst)
 Ground Level Altitude : 39.15 +MSD
 Driller : Clemence Drilling Contractors
 Drill Method : Unknown
 Drill Depth : -26.7m Drill Date : 5/05/1995
