Geotechnical Investigation Faringdon South Subdivision Rolleston

Submitted to:
Hughes Developments Ltd
Canterbury

22.04.2016
12903.000_02/1

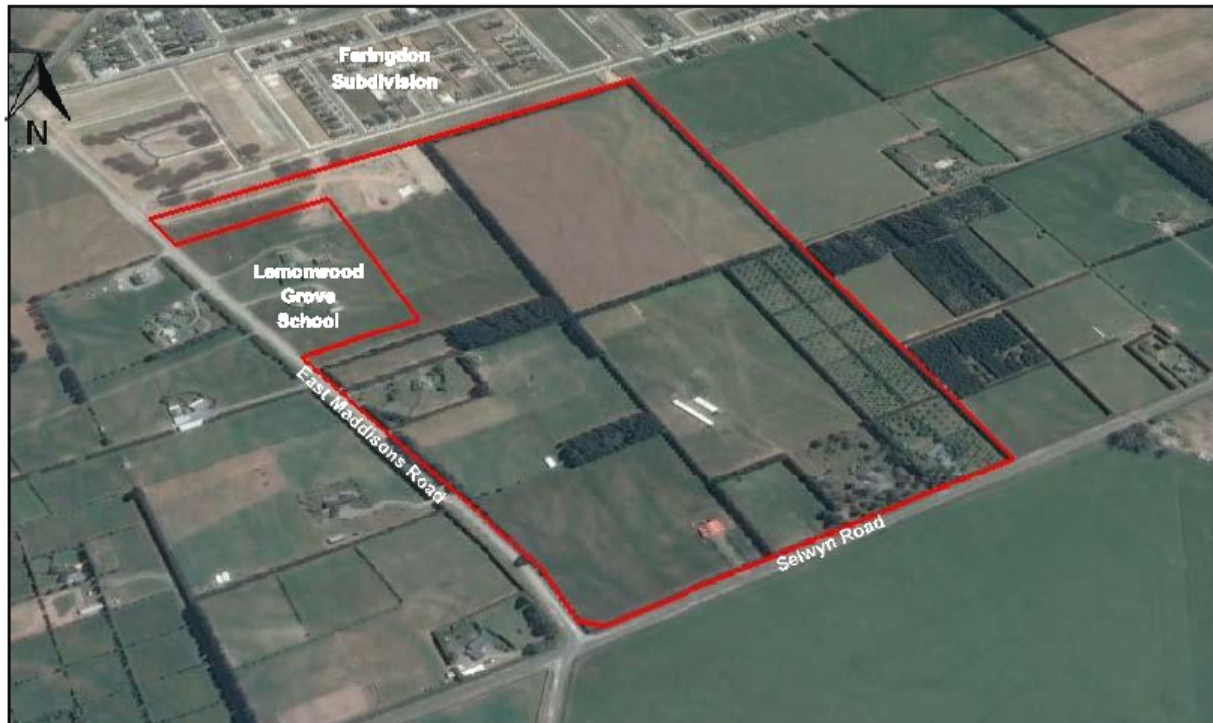
Figure 1: Site Location

Image obtained from Google Earth

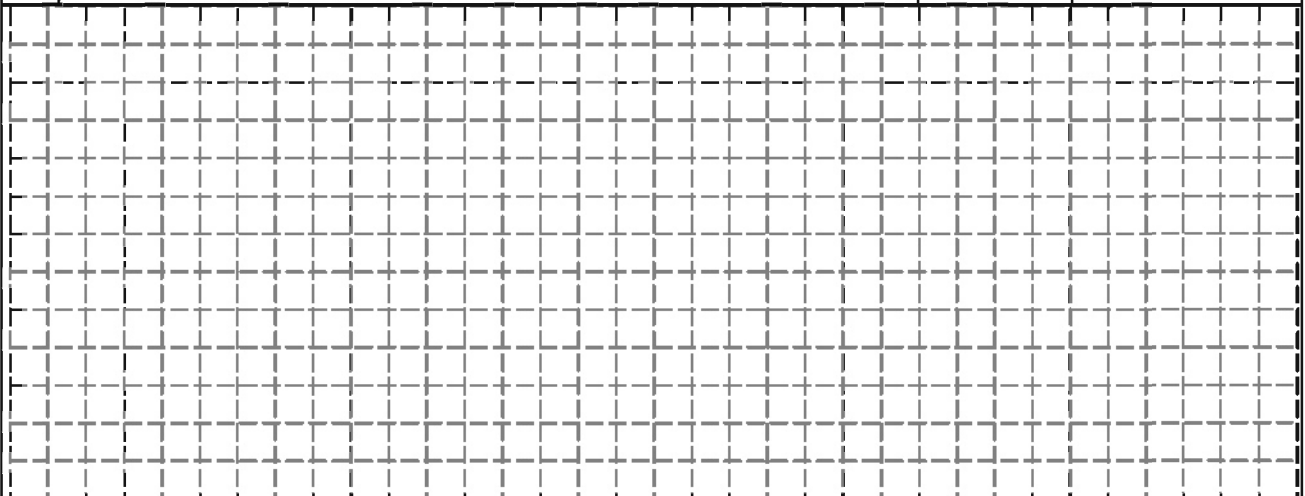
LOG OF TEST PIT TP14

Test pit met target depth at 3.0 m.
 Standing groundwater was not encountered

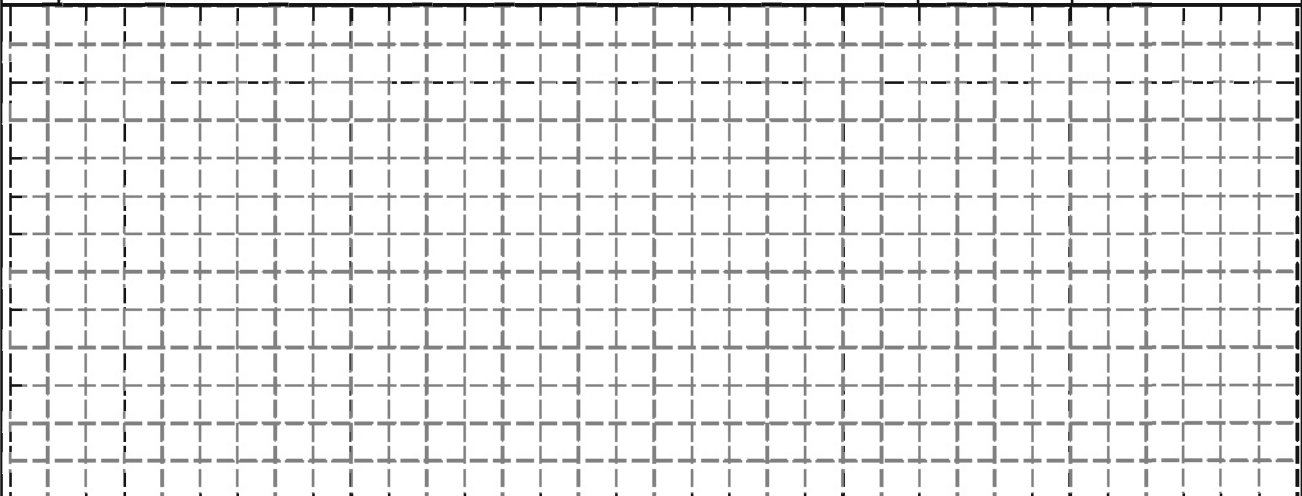
LOG OF TEST PIT TP16

Test pit met target depth at 3.0 m.
 Standing groundwater was not encountered

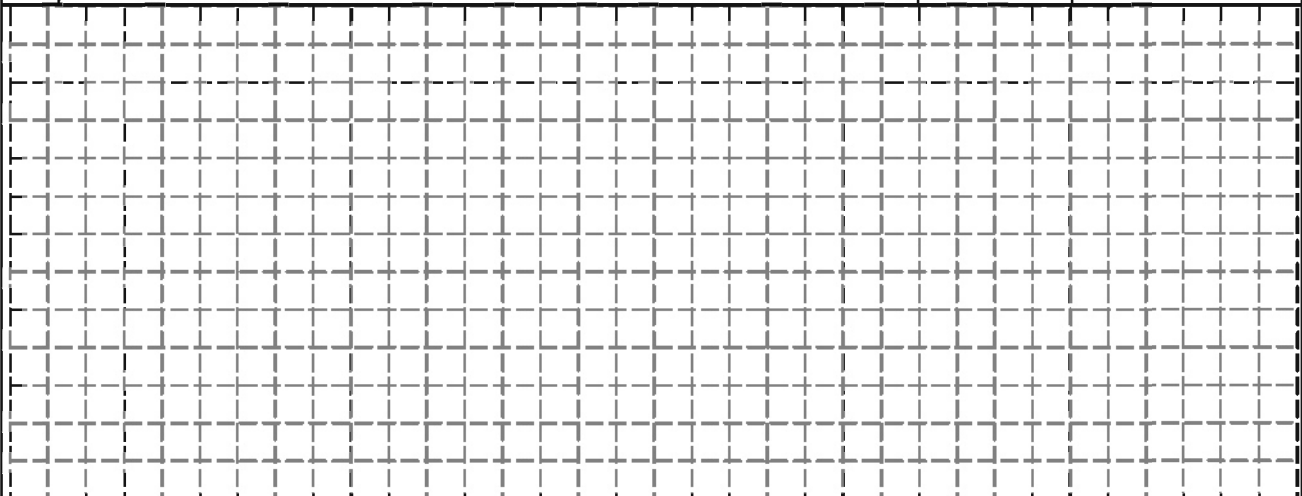
LOG OF TEST PIT TP17

Test pit met target depth at 3.0 m.
 TS = TOPSOIL
 Standing groundwater was not encountered

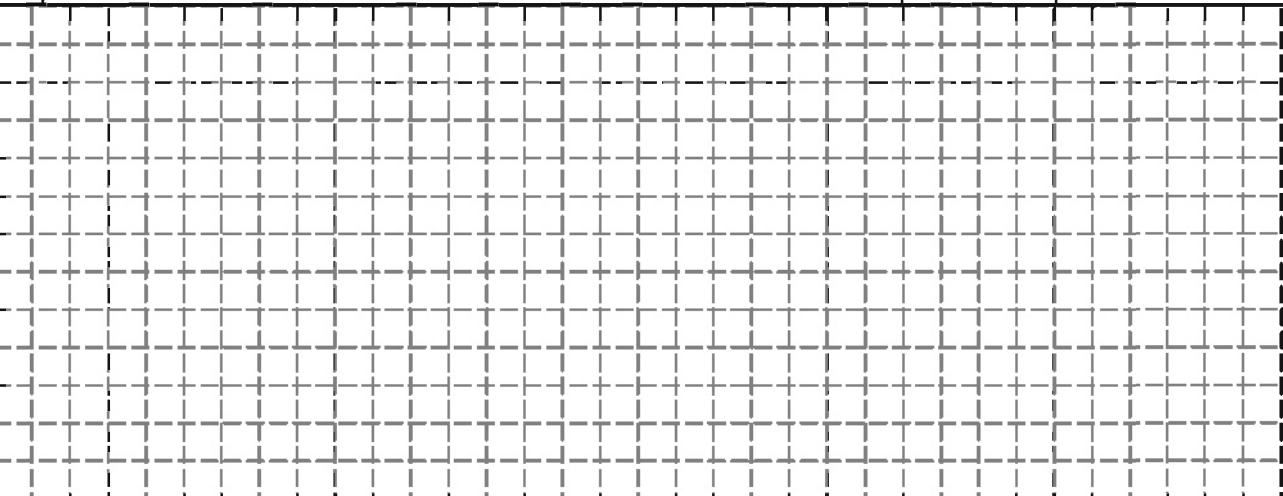
LOG OF TEST PIT TP18

Test pit met target depth at 3.0 m.
 TS = TOPSOIL
 Standing groundwater was not encountered

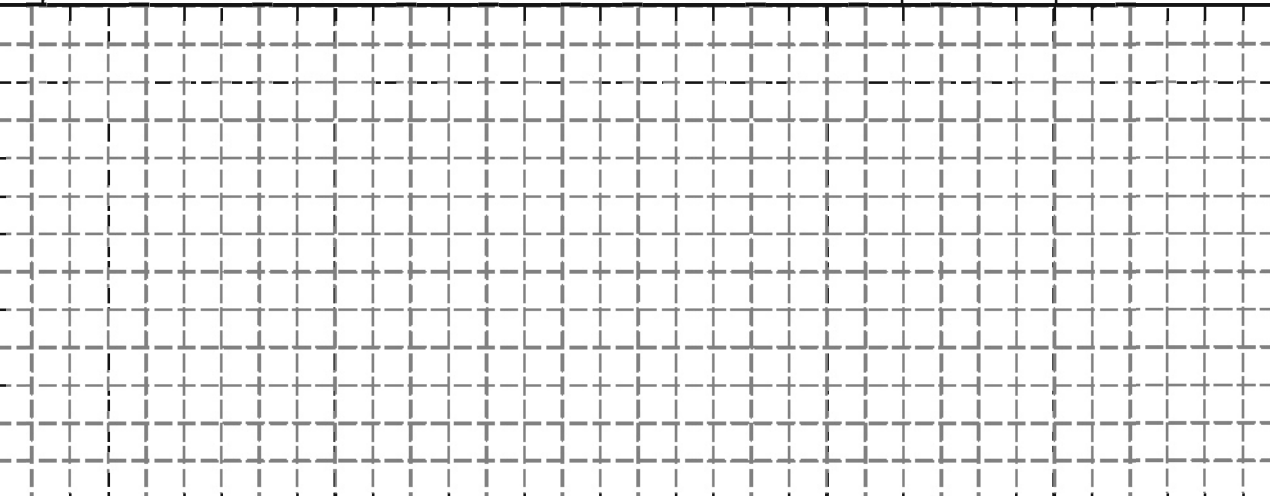
LOG OF TEST PIT TP19

Test pit met target depth at 3.0 m.
 TS = TOPSOIL
 Standing groundwater was not encountered

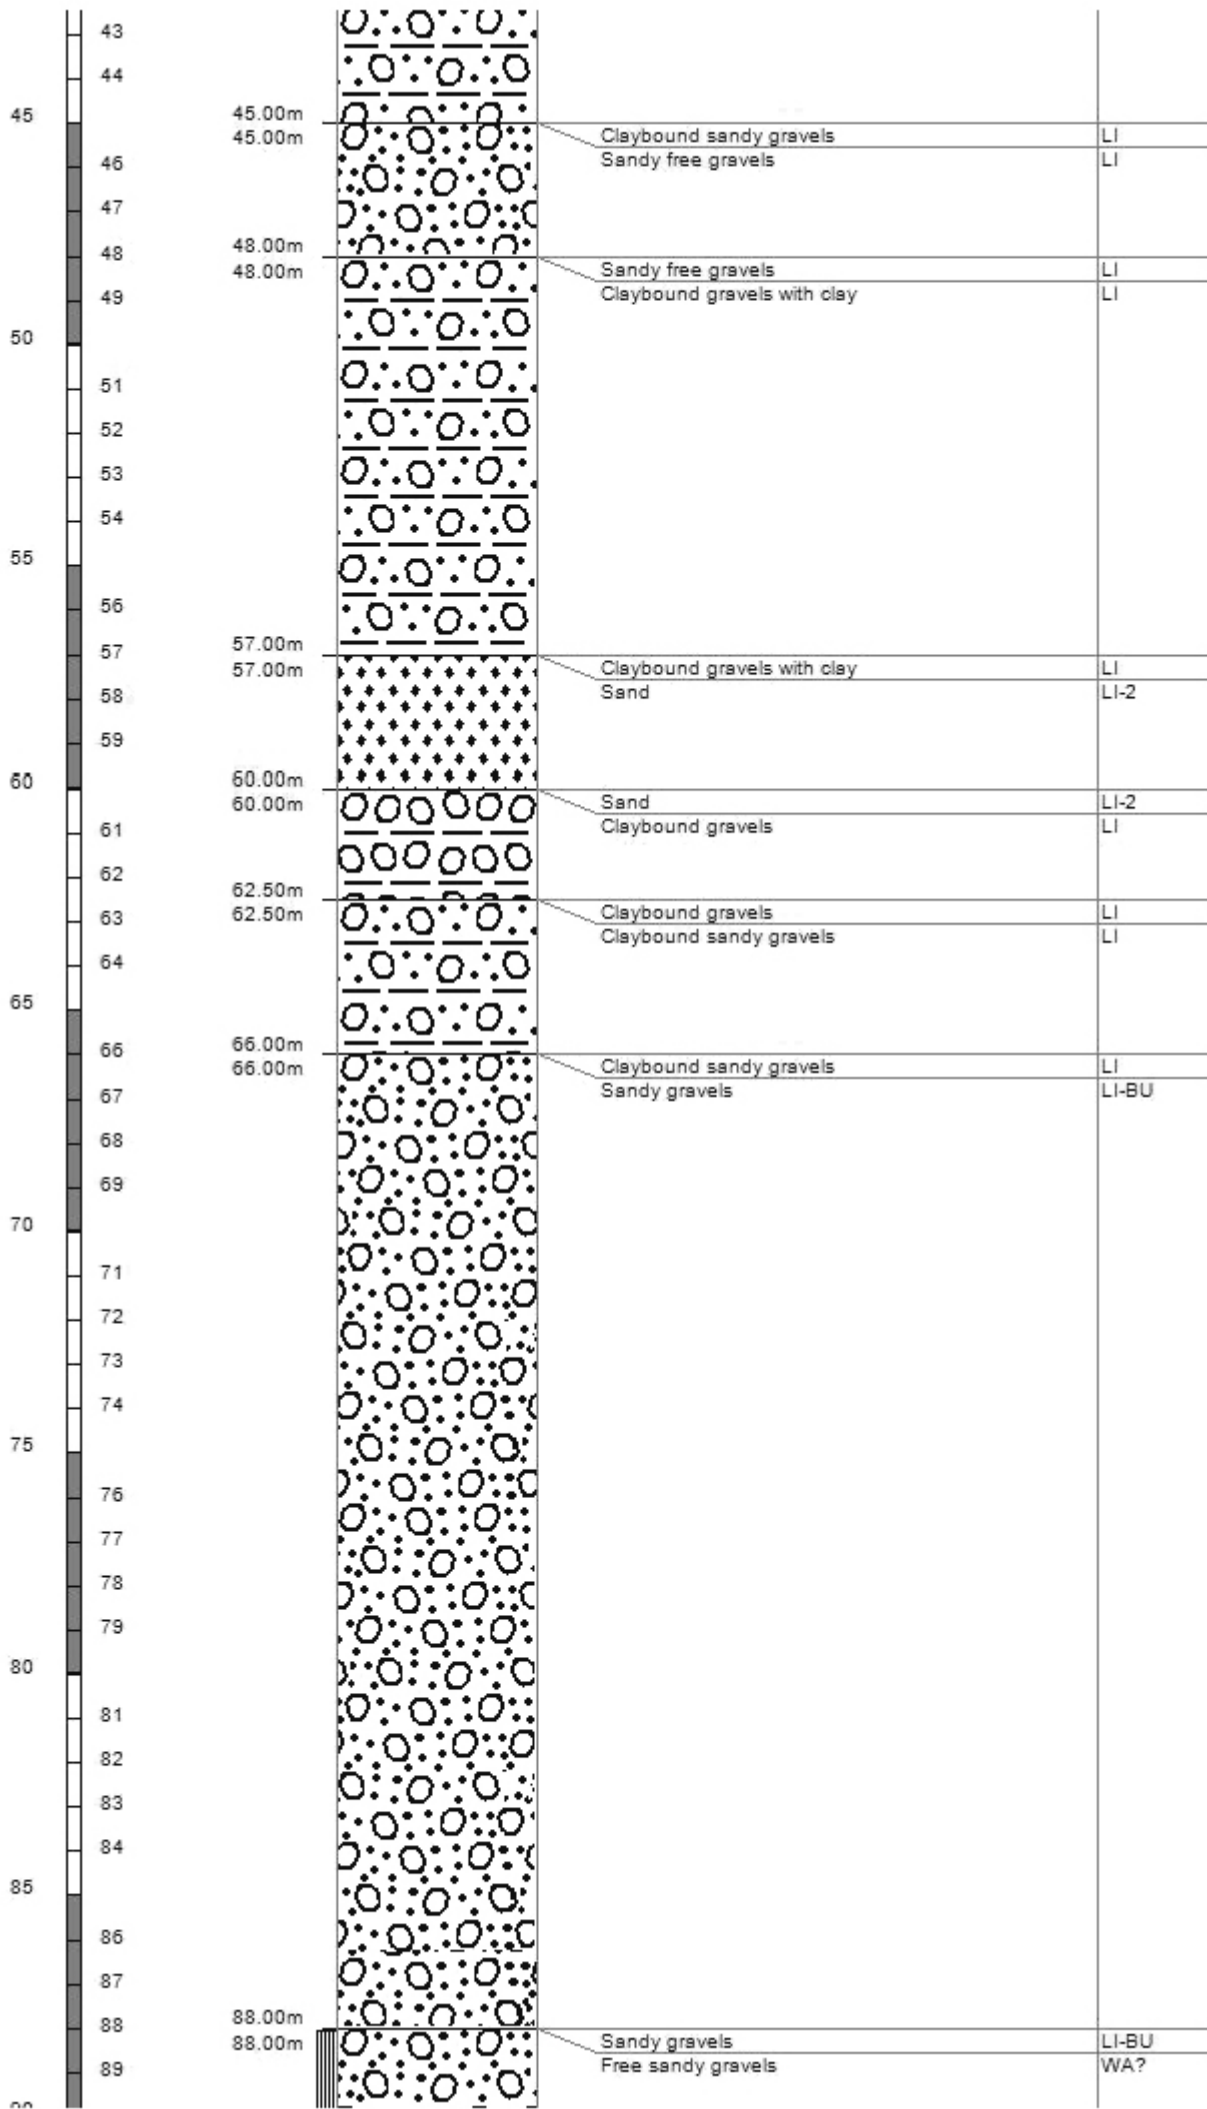
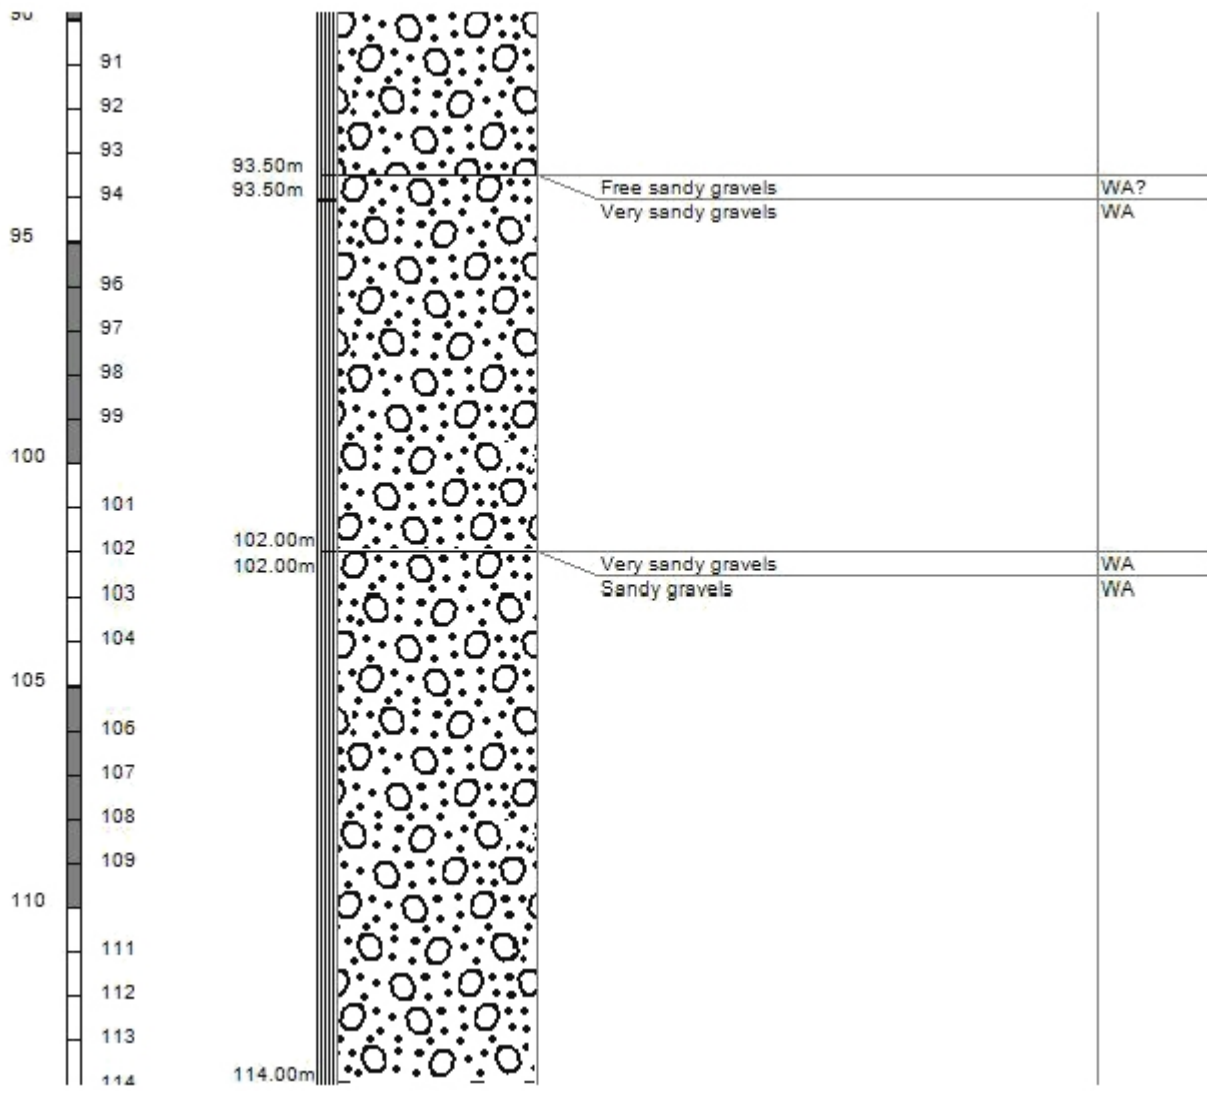
Drill Method: Rotary Rig

Borelog Depth: 114.0 m Drill Date: 23-Aug-2000
