Geotechnical Investigation

19 & 35 Dynes Road

Rolleston

Hughes Developments Ltd

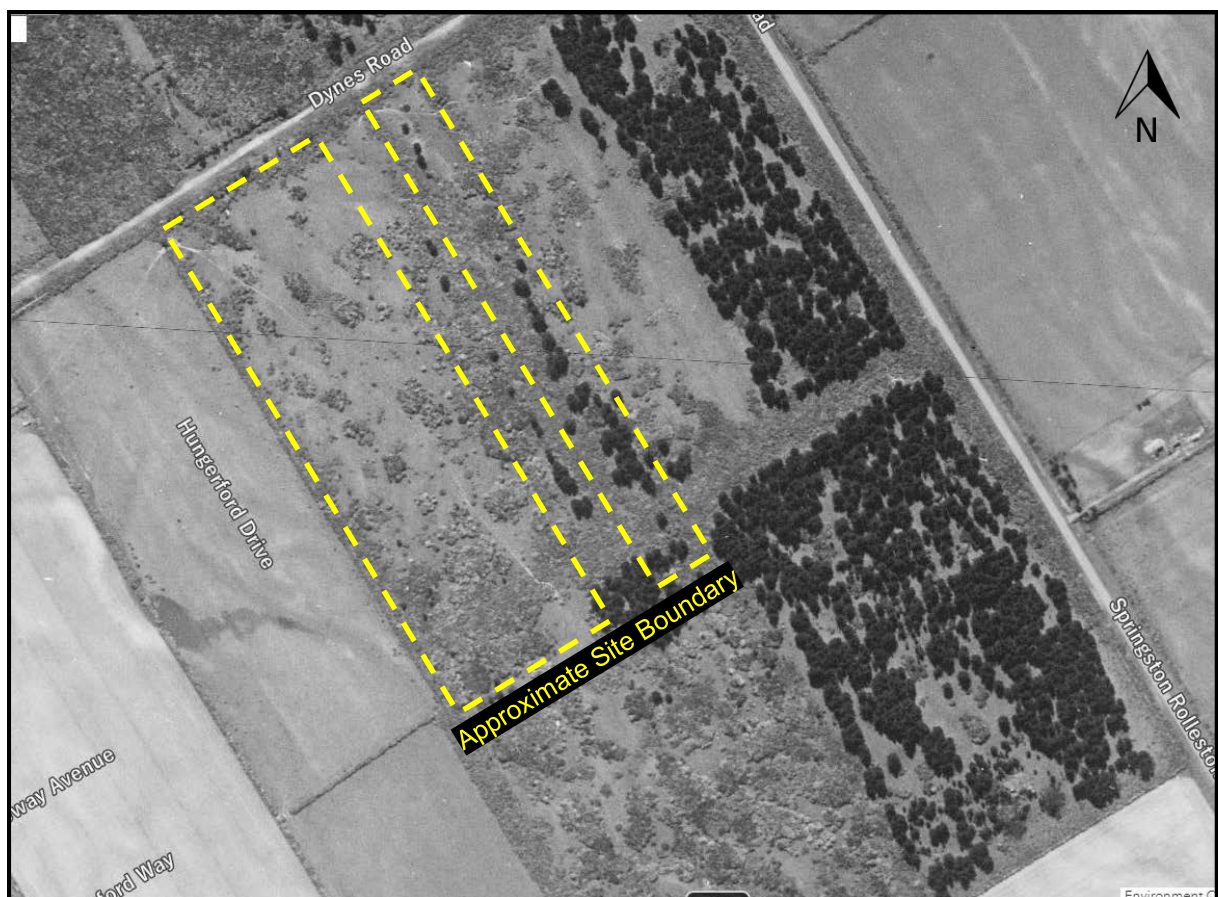
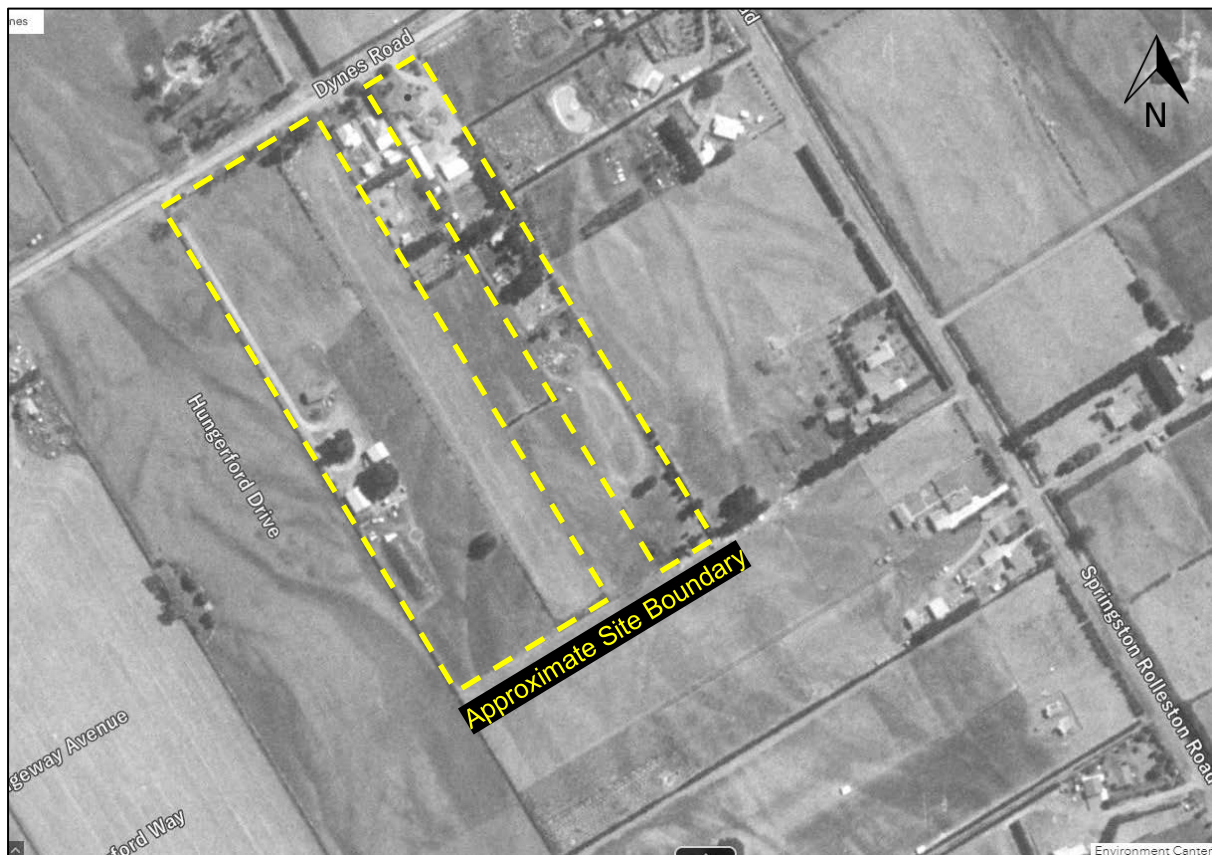
Figure 2: Historical Aerial Photography

The site comprises relatively flat ground, with gentle undulations and depressions in some areas. As evident on aerial imagery (Canterbury Maps, 2019) and observed during our site walkover conducted on 2 August 2019, undulating and depressed ground can be attributed to paleo-channels, which traverse the site in a general northwest to southeast trend. Based on observations, silt and sand deposits with variable thickness (up to 1.0 m) are expected to have in-filled the paleo-channels where they have not remained as channel features. Inferred paleo-channels have been mapped to give an indication of areas with potential channel in-fill (Appendix 1).

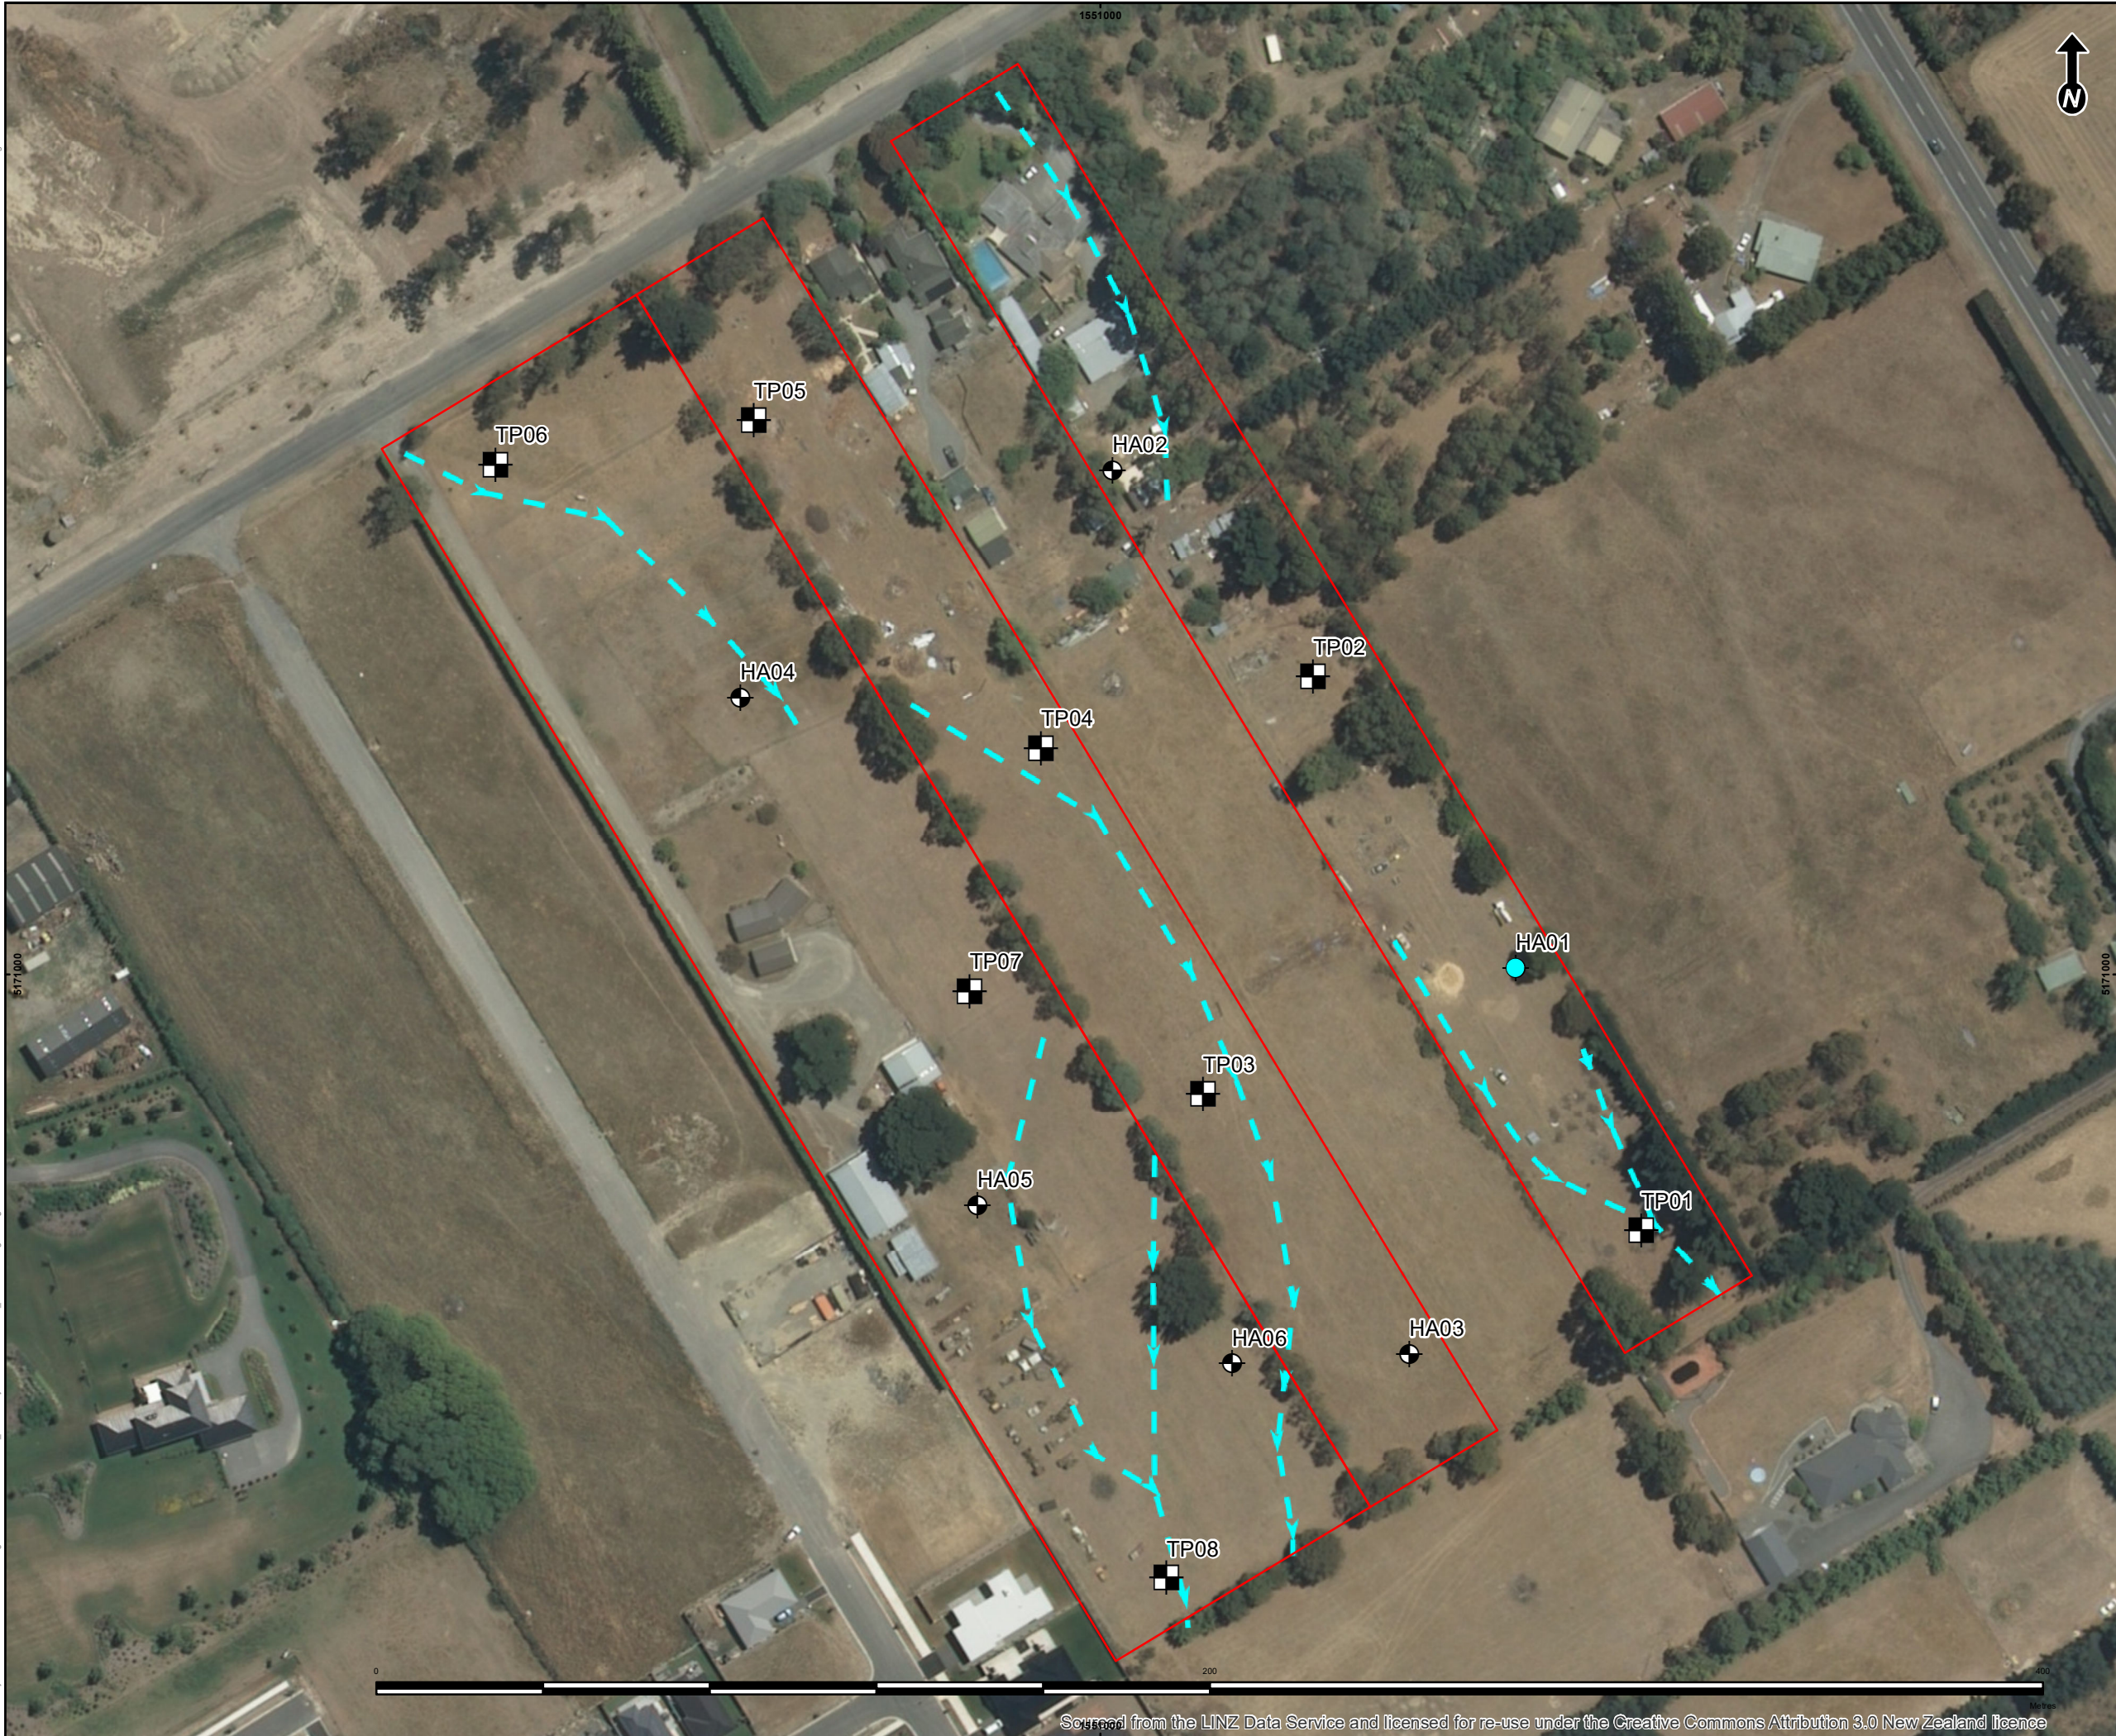
Site Plan and Inferred Paleo Channels

The investigations revealed subsurface conditions across the site are consistent with the published geological mapping, as summarised in Table 1. Hand auger and test pit logs are included in Appendix 2 of this report.

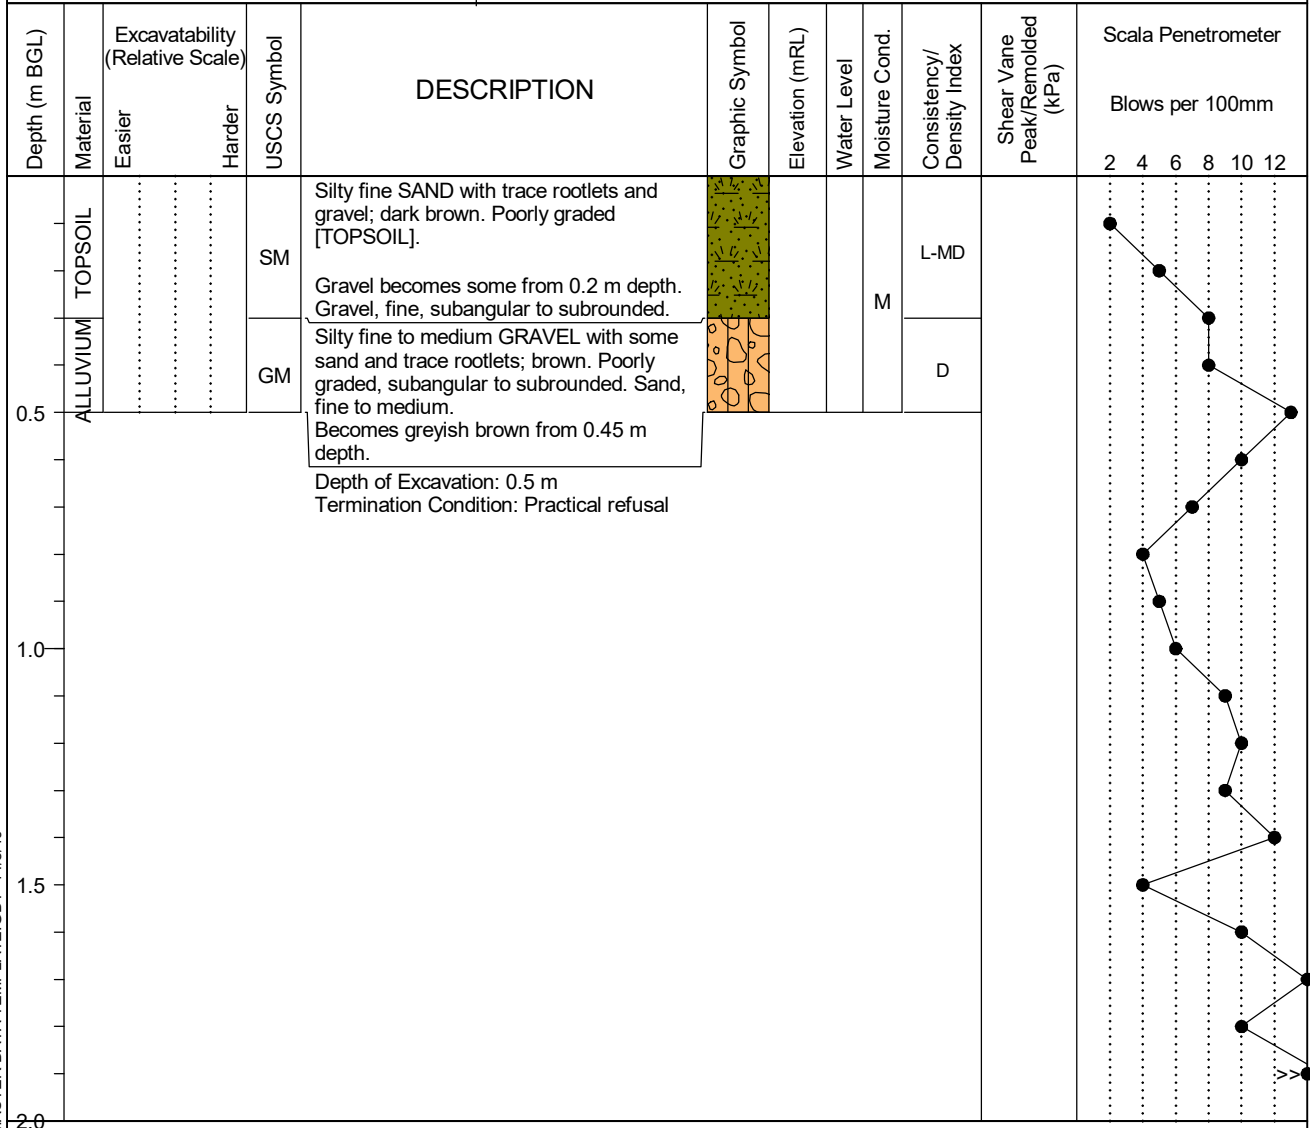
Hand auger met practical refusal
Scala Penetrometer met practical refusal
Standing groundwater was not encountered.
