Geotechnical Investigation

527 Springston Rolleston Road

Faringdon East Extended Block

Rolleston

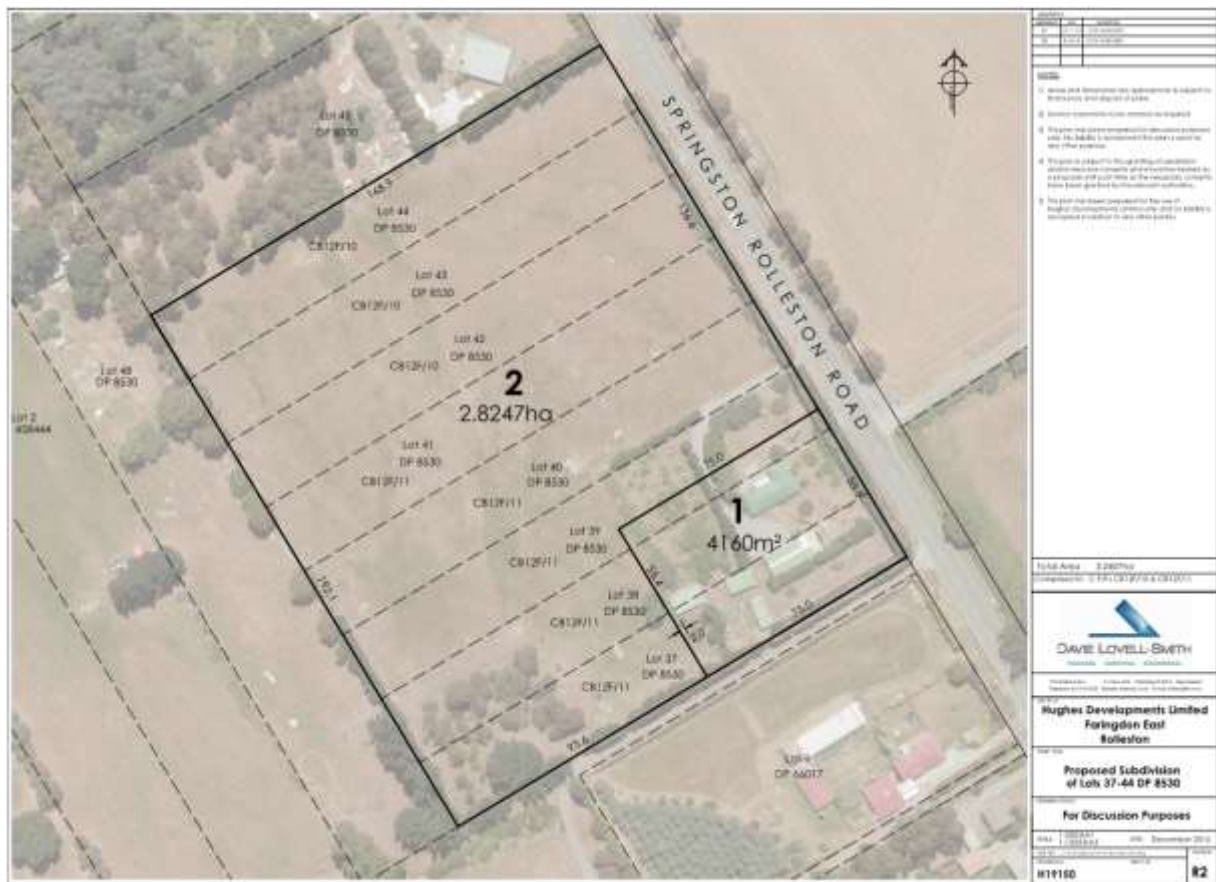
Figure 1: Site Location

The site covers a total area of 2.8 ha (Figure 1), and has the legal description of Lots 37 to 44 DP 8530 (Selwyn District Council). We understand the proposed development is to exclude the block labelled 1 on Figure 1, therefore this report pertains to Block 2. It is located approximately 3 km southeast of Rolleston town centre and is bound by Springston-Rolleston Road to the northeast and farmland on the remaining sides.

Image obtained from Davie Lovell-Smith proposed plans. Not to scale.

The predominantly flat site is currently agricultural land and is part of the properties within Block 1 and 2 (Figure 1).

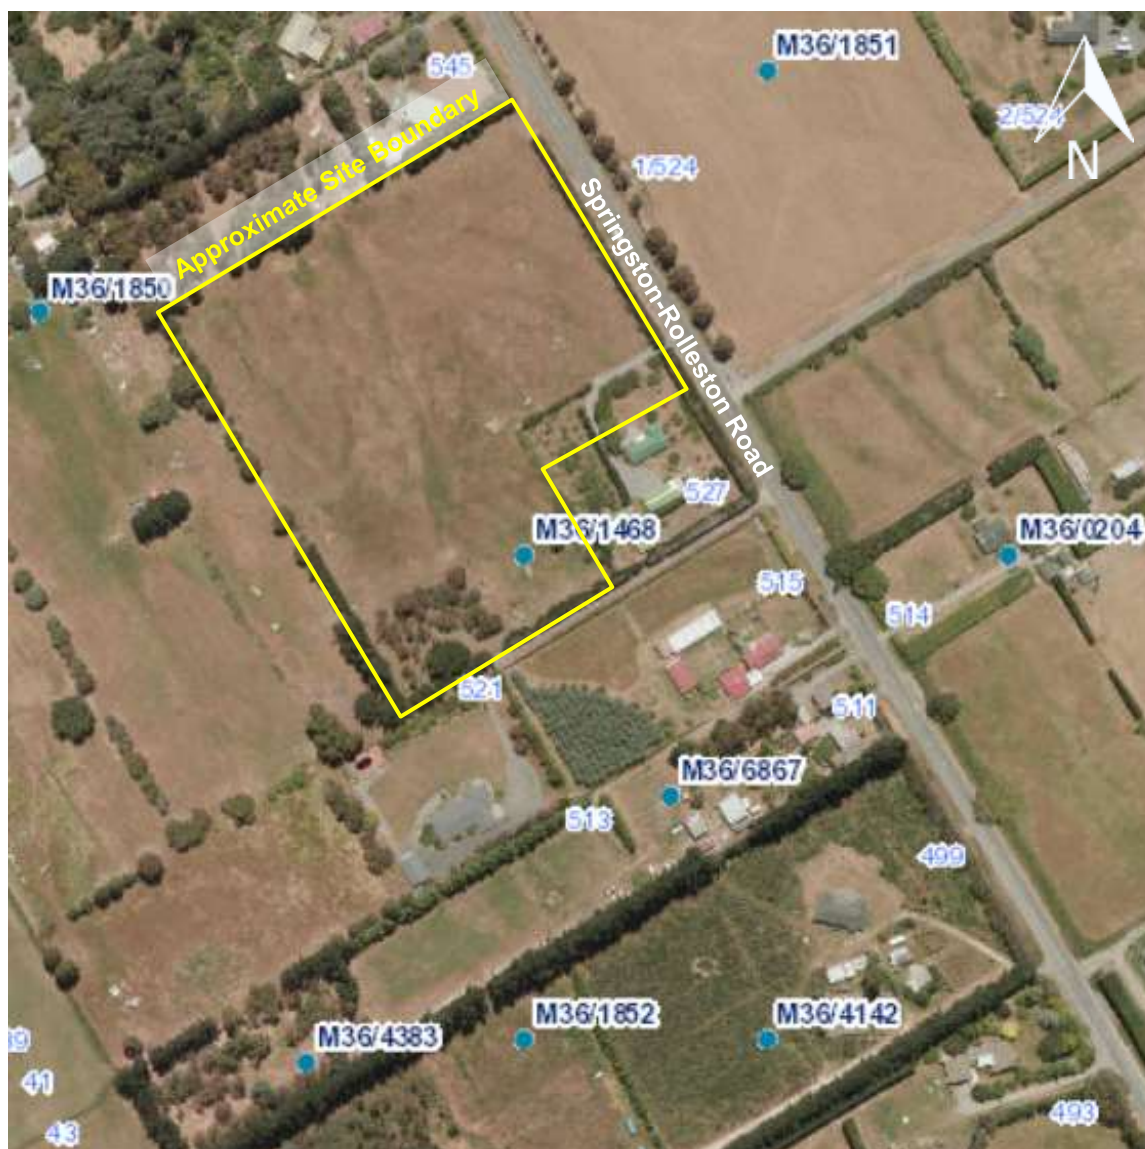
Figure 2: Nearby ECan Borehole Locations

A review of two deep ECan borehole logs located 200 m south (M36/1852) and 200 m east of the site (M36/0204) was conducted (Canterbury Maps). The location of these boreholes is presented in Figure 2 and includes the well points that have no log data available. The logs from the two holes of interest are presented in Appendix 3 and indicate the site is underlain by a mixture of gravel and sand to depths of at least 27.4 m below ground level.

Image sourced from Canterbury Maps (February 2017). Not to scale.

Groundwater is recorded in the surrounding boreholes between approximately 10.8 and 11.2 m depth.

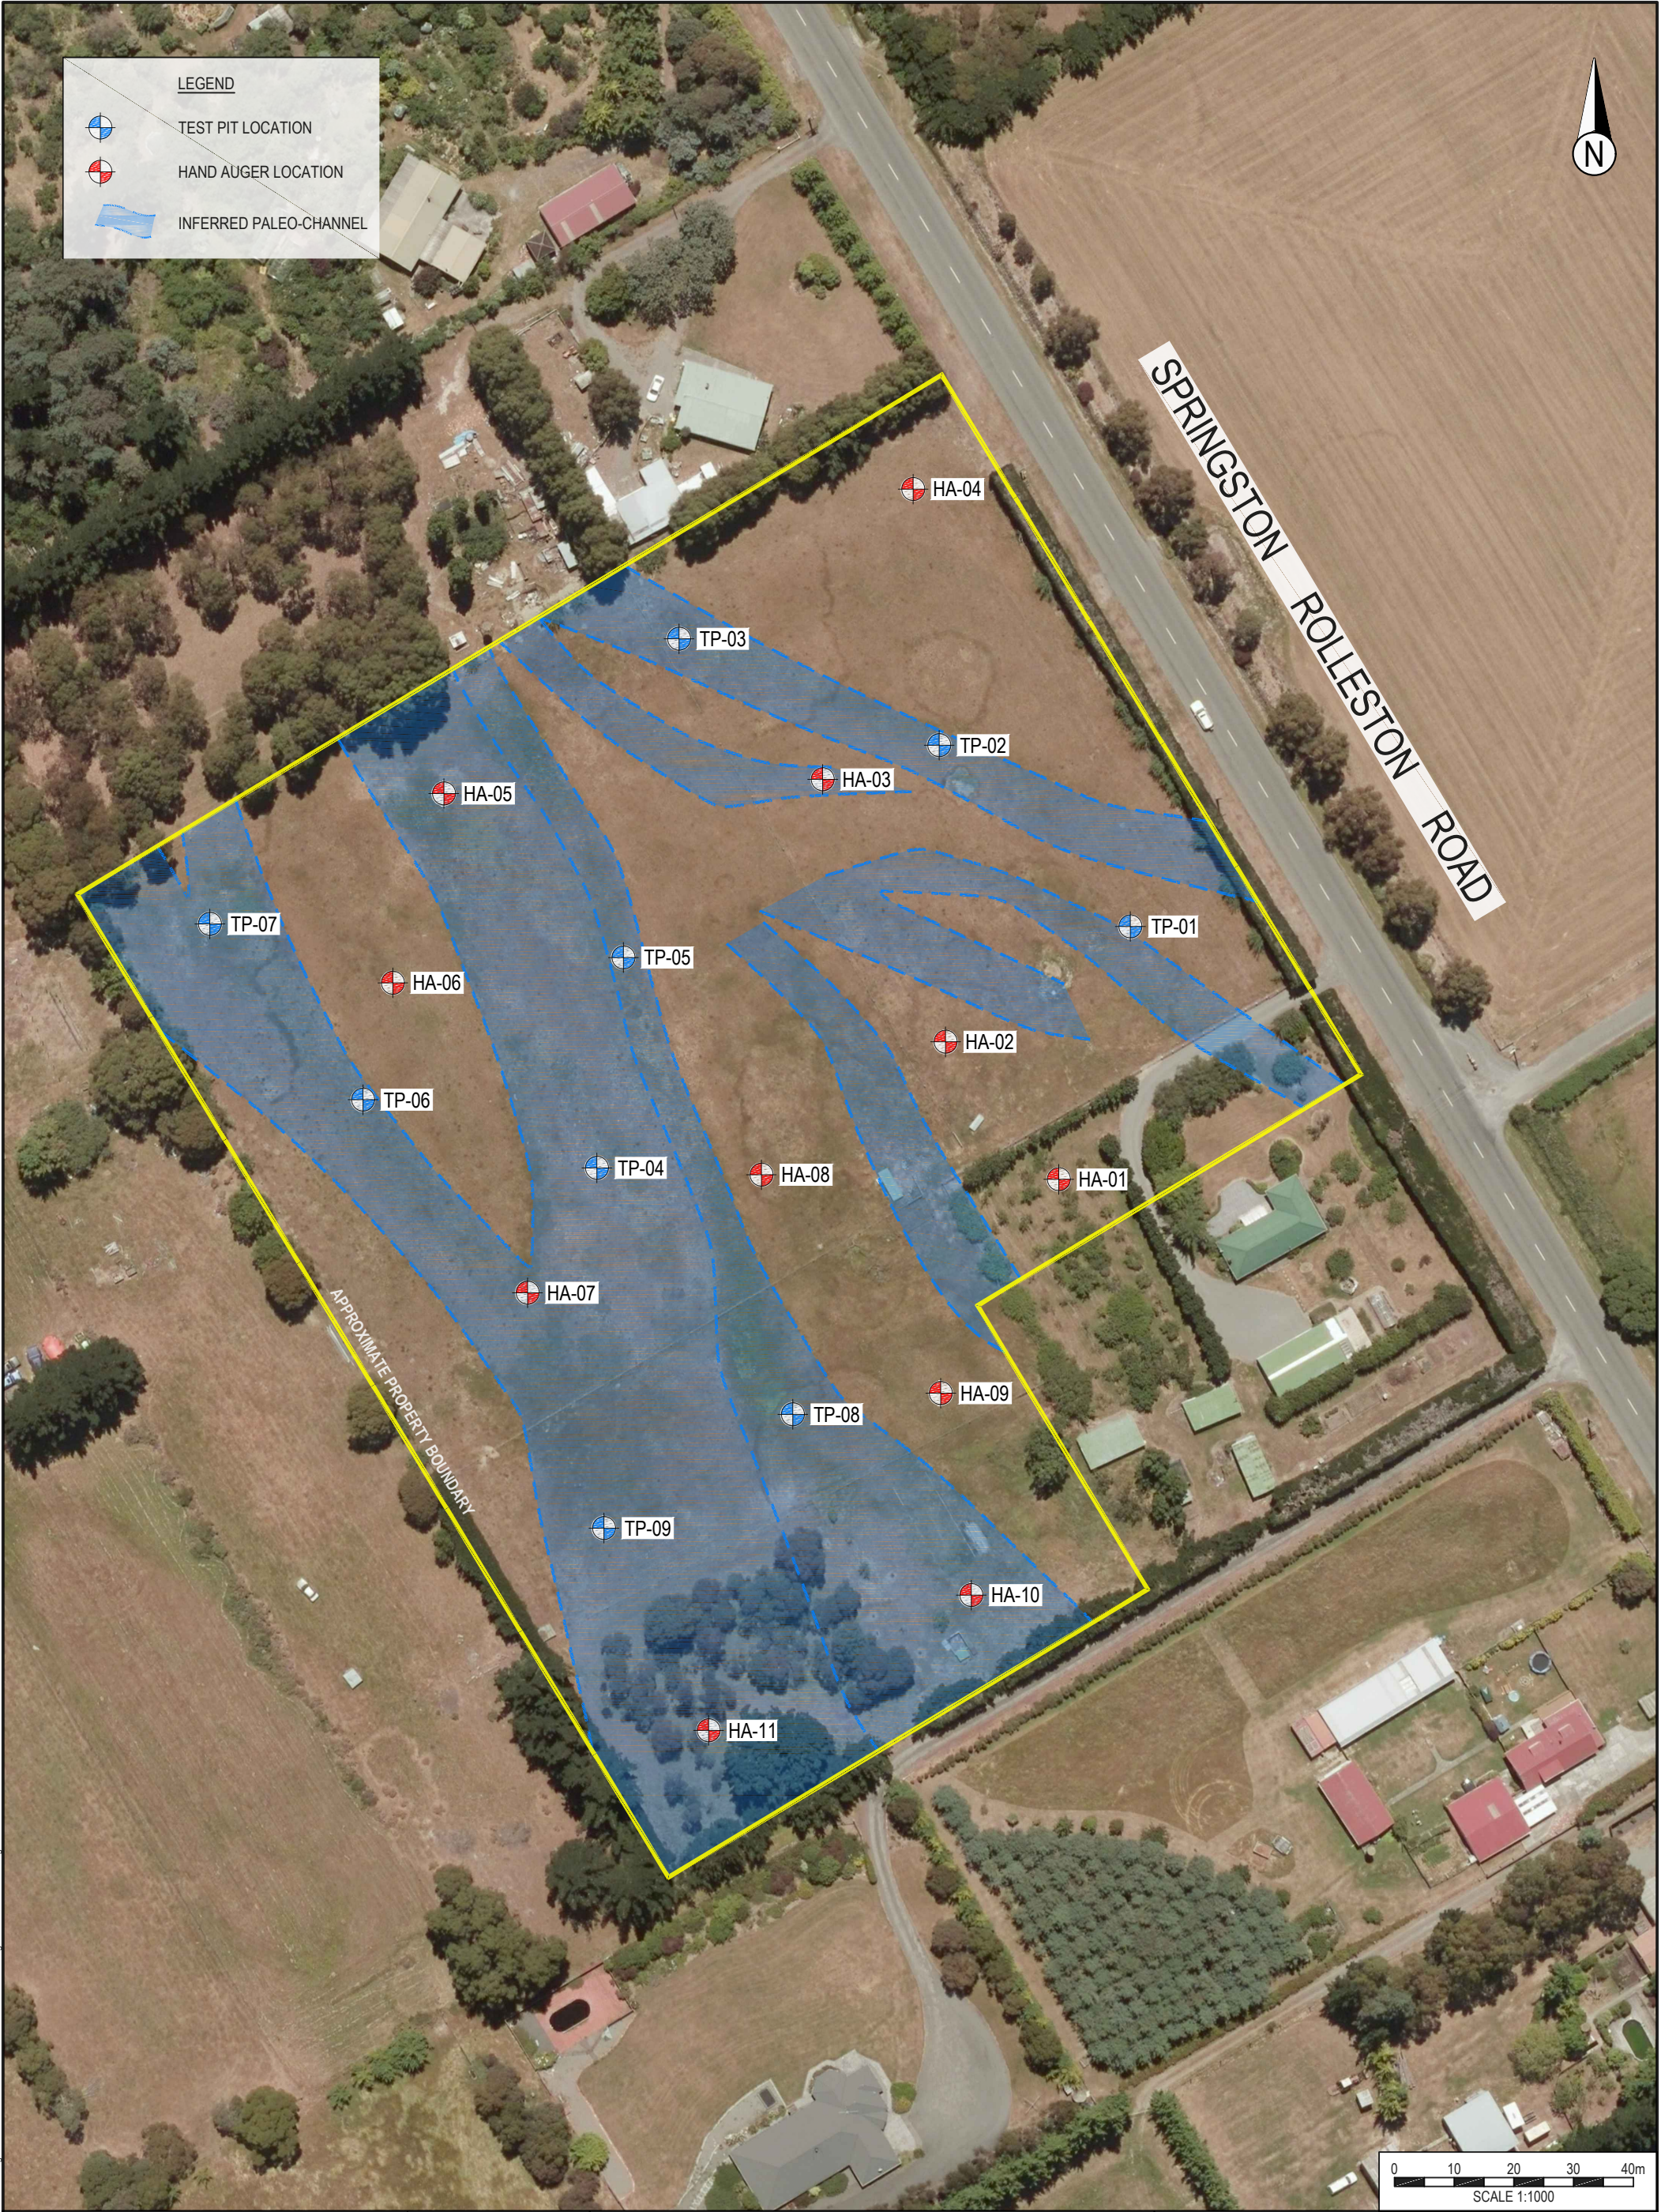
TEST LOCATION PLAN

The site comprises relatively flat ground, with gentle undulations and depressions in some areas. As evident on aerial imagery (Canterbury Maps, 2016) and observed during our site walkover conducted on 24 February 2017, undulating and depressed ground can be attributed to paleo-channels, which traverse the site in a general northwest to southeast trend. Based on observations, silt deposits with variable thickness (up to 1.0 m) are expected to have in-filled the paleo-channels where they have not remained as channel features. Inferred paleo-channels have been mapped to give an indication of areas with potential channel in-fill (Appendix 1).

Test Locations are shown on the site plan presented in Appendix 1. Test pit and hand auger hole logs, showing detailed soil descriptions are presented in Appendix 2.
