Reference No. 1278103872_005_P_Rev0

ADDENDUM – PRELIMINARY SITE INVESTIGATION, FARINGDON DEVELOPMENT, ROLLESTON, CANTERBURY.

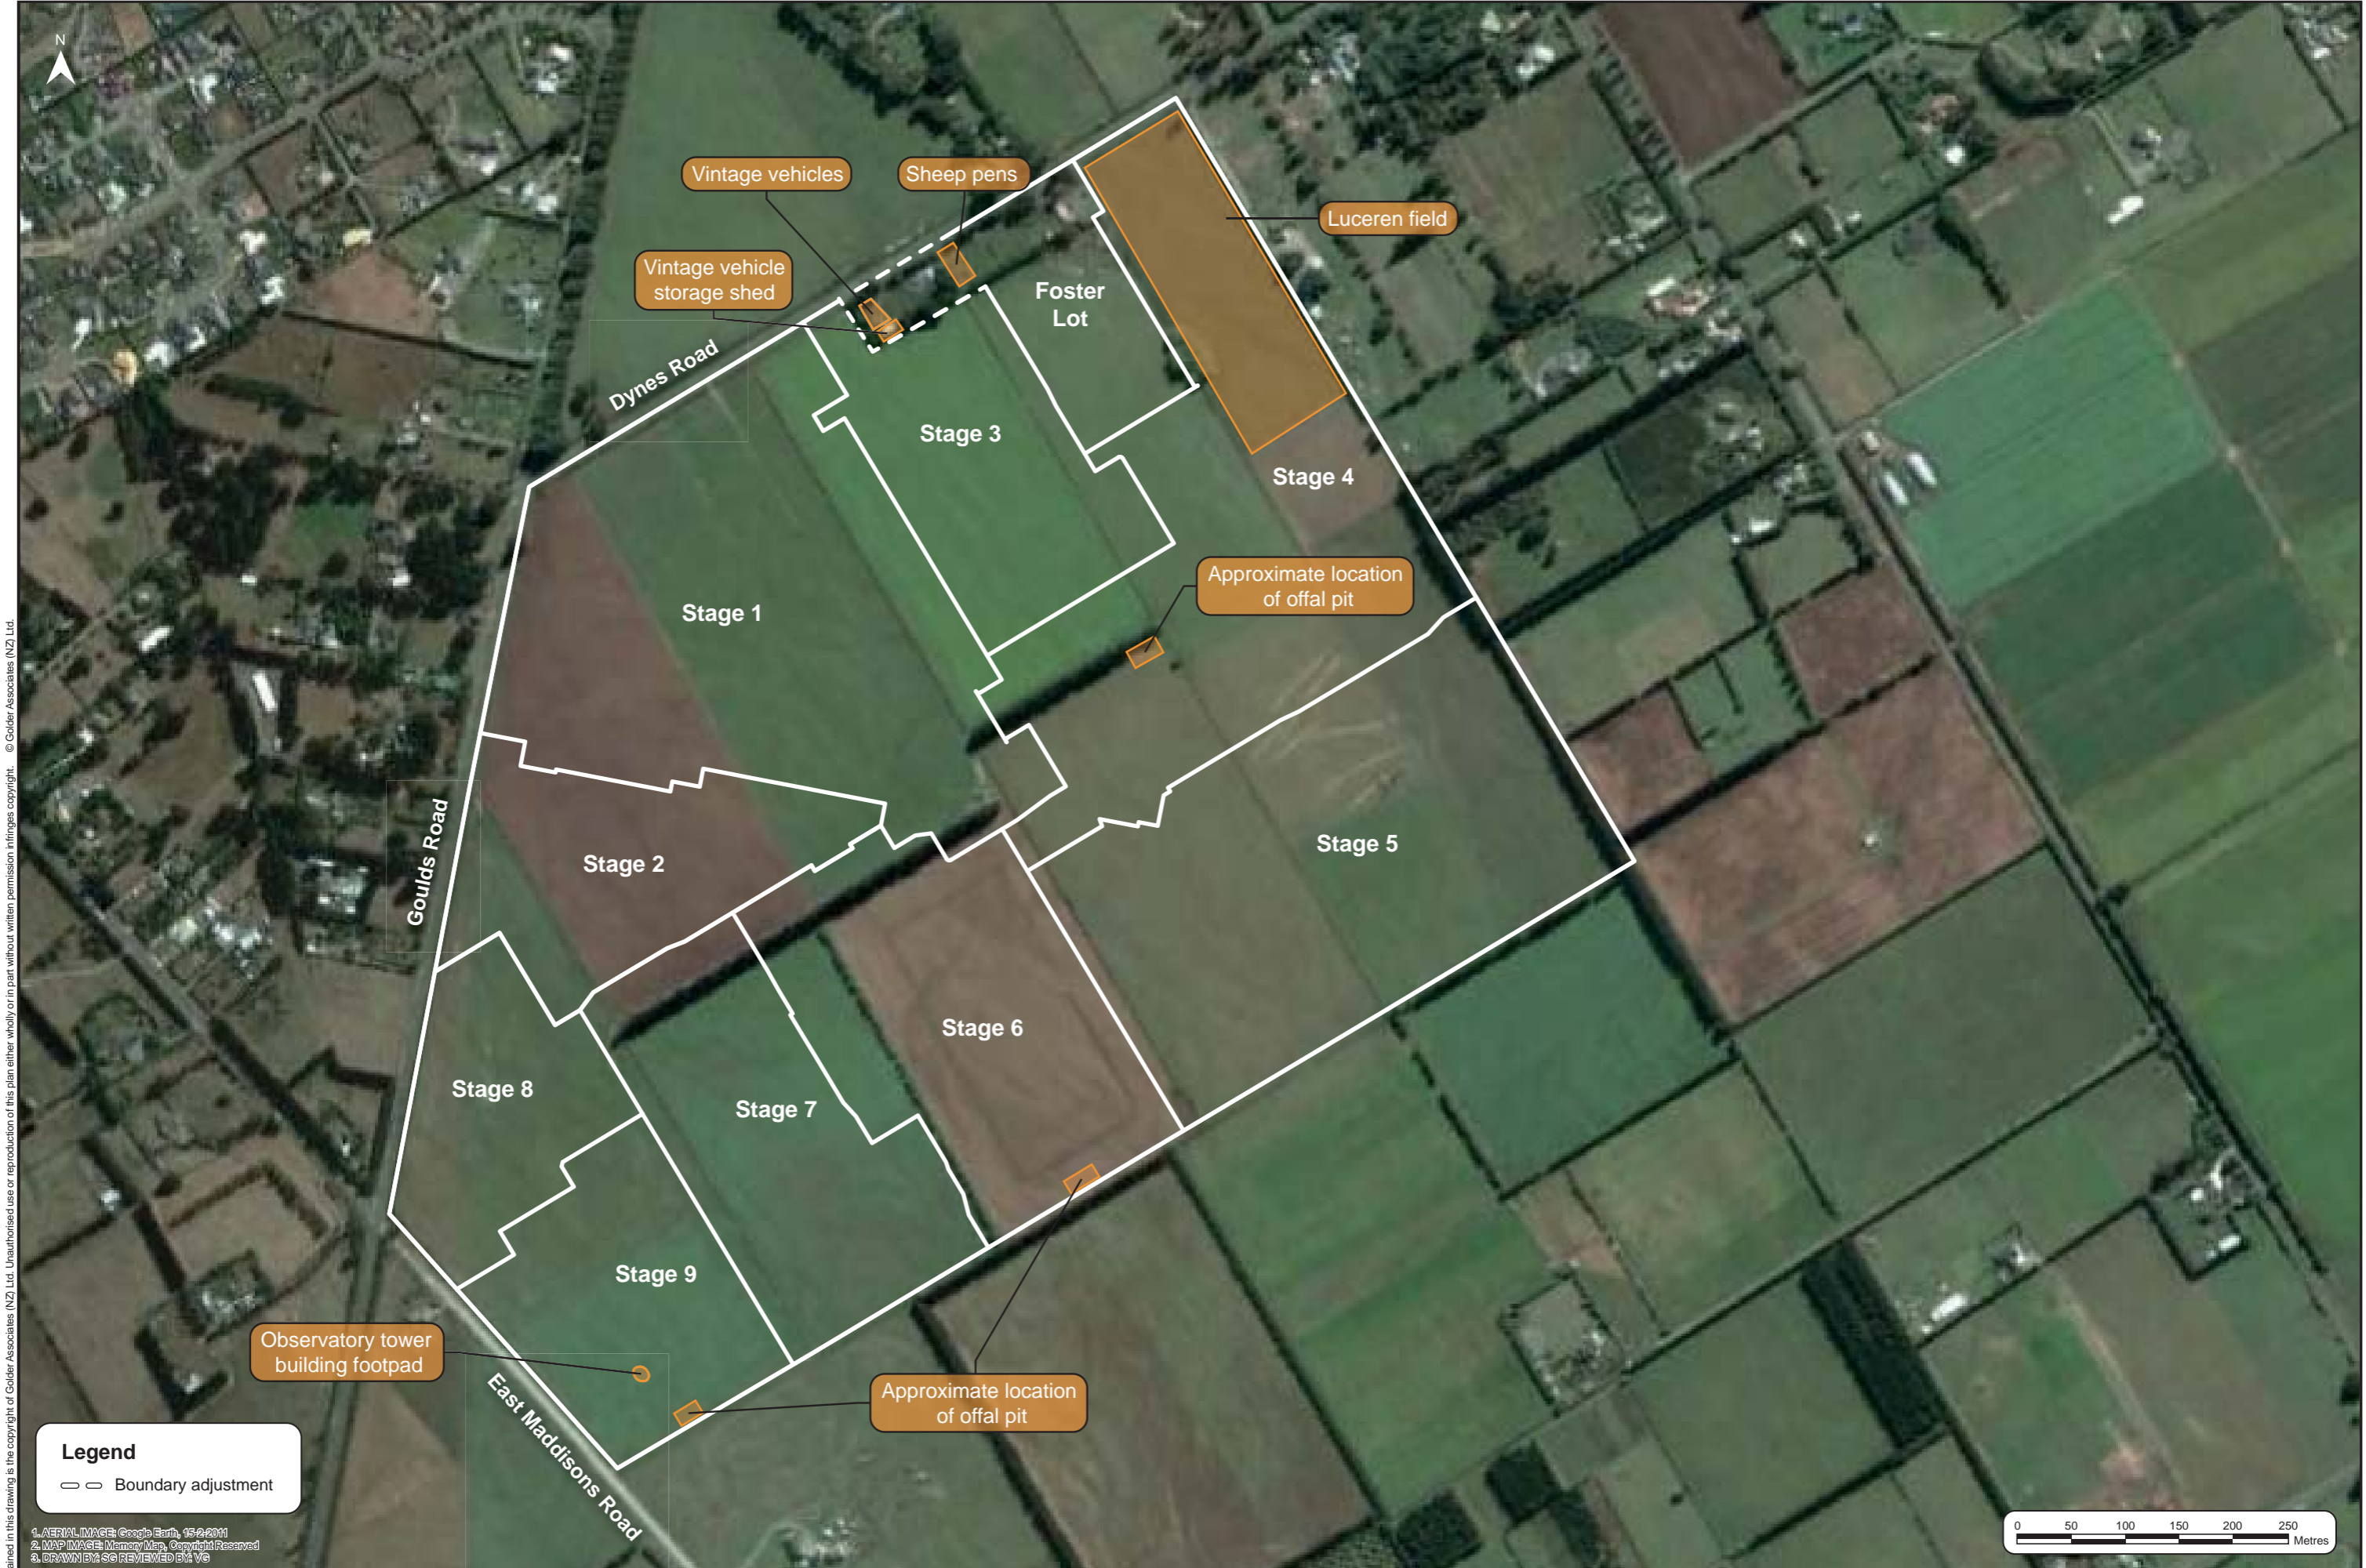
The information review indicated that, historically, the area of the proposed subdivision was predominantly used for sheep grazing. A summary of the main findings of the PSI (Golder 2012) are shown in Figure 1 and summarised below:

- Stages 1, 2, 5, 7 and 8 – no areas of potential contamination were identified within these stages of the proposed subdivision.
- Stage 3 – there was a **low** level of risk associated with the storage of vintage vehicles towards the centre of the stage's northern boundary. There was a **medium** level of risk associated with the use of a mobile sheep dip in the vicinity of the sheep pens located in the north-eastern corner of the stage.

- Stage 4 – there was a **low** risk of residual agricultural chemicals being present in surface soils in the north of the stage associated with the intermittent use of pesticides on lucerne and barley. There was a **low** risk of biological contaminants associated with an offal pit situated in the centre of the stage.

- Stage 6 – there was a **low** risk of biological contaminants associated with offal pits situated in the south of the stage.
- Stage 9 – there was a **low** risk of biological contaminants associated with offal pits situated in the south of the stage. There was a **low** risk of lead contamination in soils surrounding the observatory in the south west of the stage.

- On the basis of the PSI (Golder 2012) a detailed site investigation (DSI) for Stages 3, 4, and 9 is required to determine whether site soils are suitable for the proposed end use or whether remediation or management is required. The status of the consent application (i.e., whether controlled, restricted discretionary or discretionary) will be dependent upon the findings of the DSI.

- An Offal Pit Management Plan was recommended to ensure discharges to the environment are minimised and human health is protected if an offal pit was encountered during the redevelopment of the site.
