Geotechnical Investigation

Farringdon East Subdivision 514, 1/524, 2/524 and 550 Springston Rolleston Road Springston Christchurch

> Submitted to: Hughes Development Ltd Canterbury

ENGEO Limited

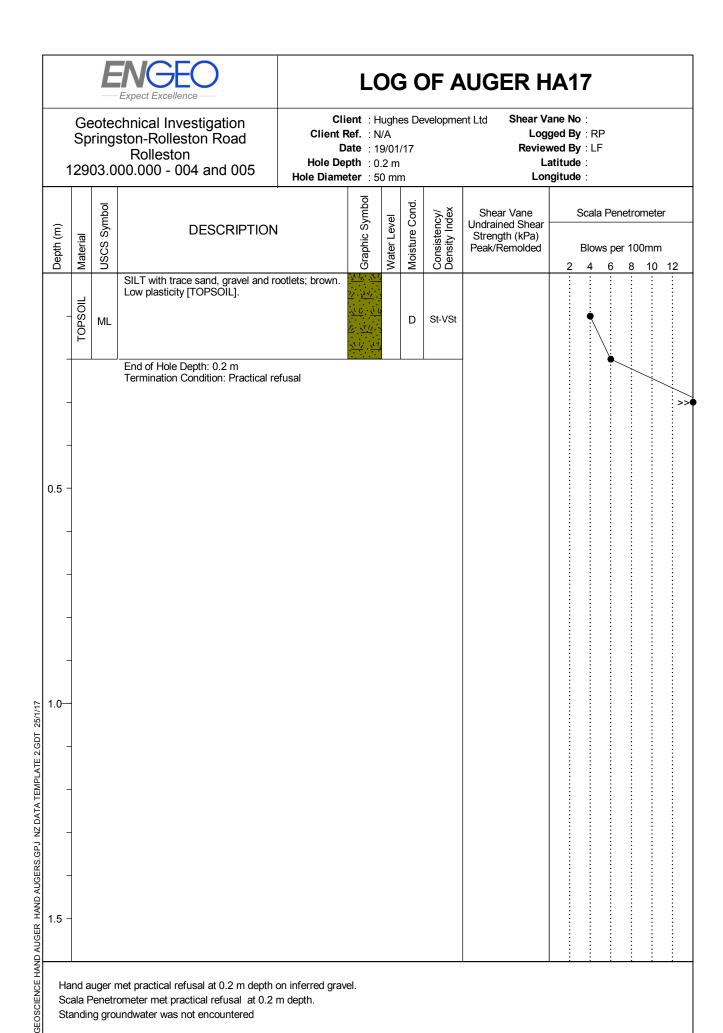
Hand auger met practical refusal at 0.2 m depth on inferred gravel. Scala Penetrometer met practical refusal at 0.2 m depth.

Standing groundwater was not encountered

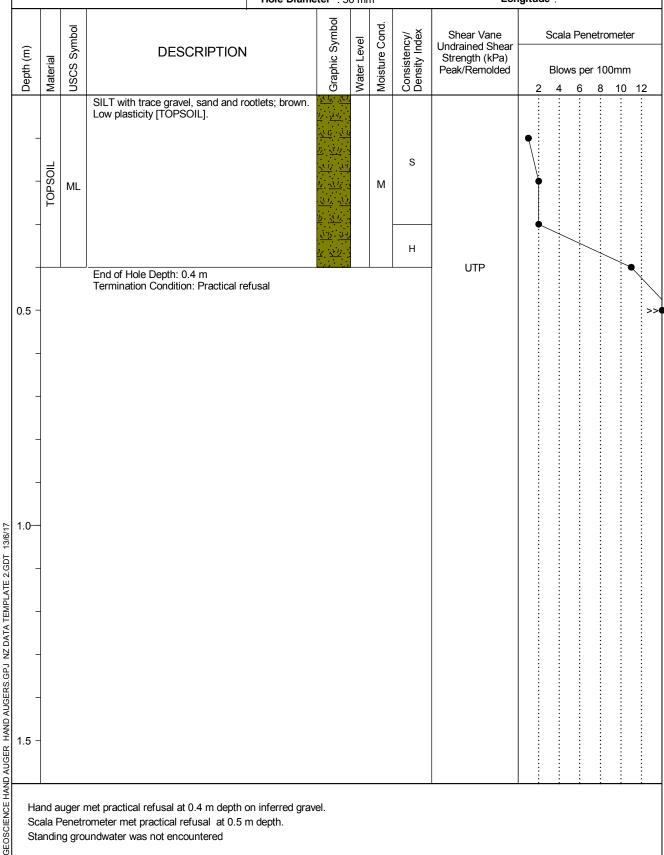
Hand auger met practical refusal at 0.4 m depth on inferred gravel.

Scala Penetrometer met practical refusal at 0.5 m depth.

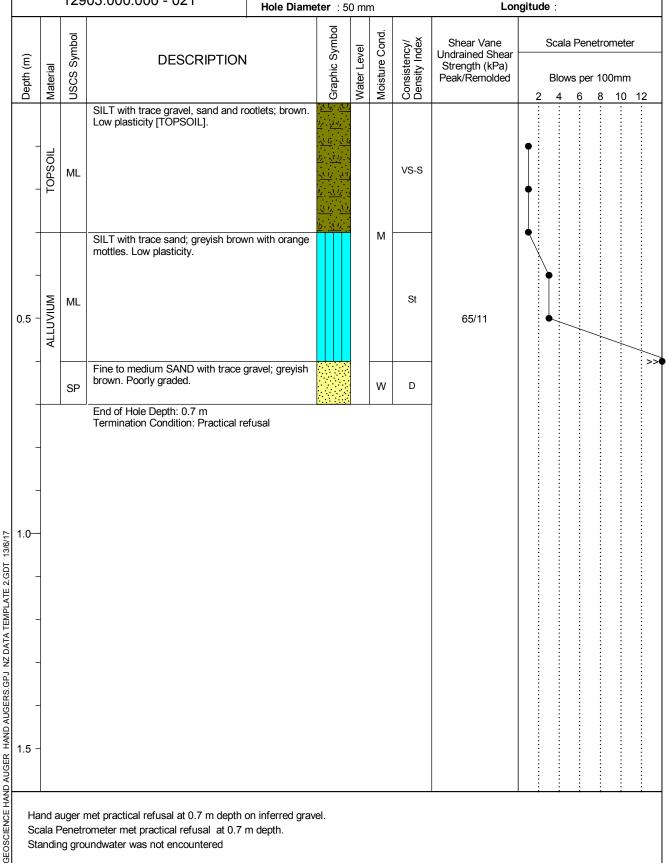
Hand auger met practical refusal at 0.7 m depth on inferred gravel.

Scala Penetrometer met practical refusal at 0.7 m depth.
