Geotechnical Investigation

583 East Maddisons Road

Rolleston

06.12.2017

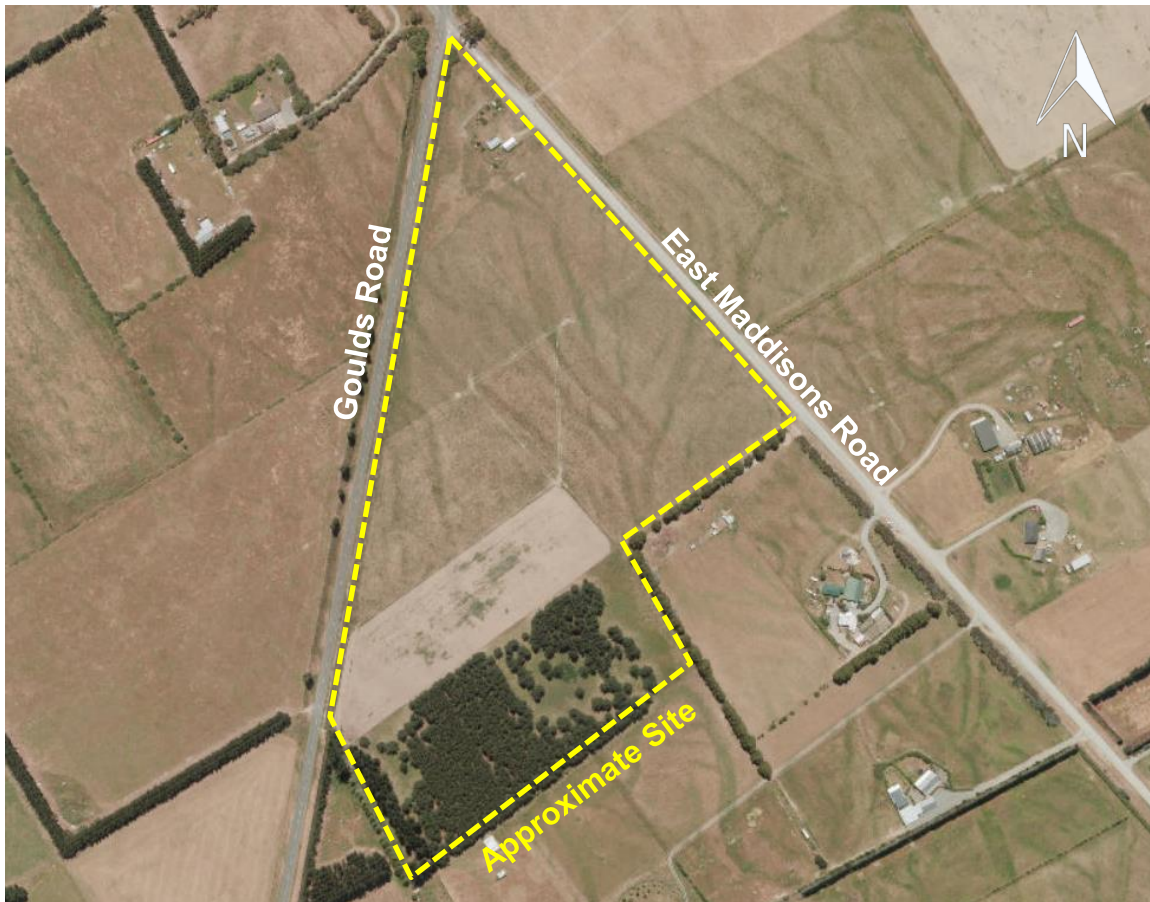
Figure 1: Site Location

It is located approximately 3.5 km south of Rolleston town centre, and is bound to the northeast by East Maddisons Road and the west by Goulds Road. Rural properties border the site on the remaining sides (Figure 1).

Aerial photograph sourced from Canterbury Maps (retrieved December 2017). Not to scale.

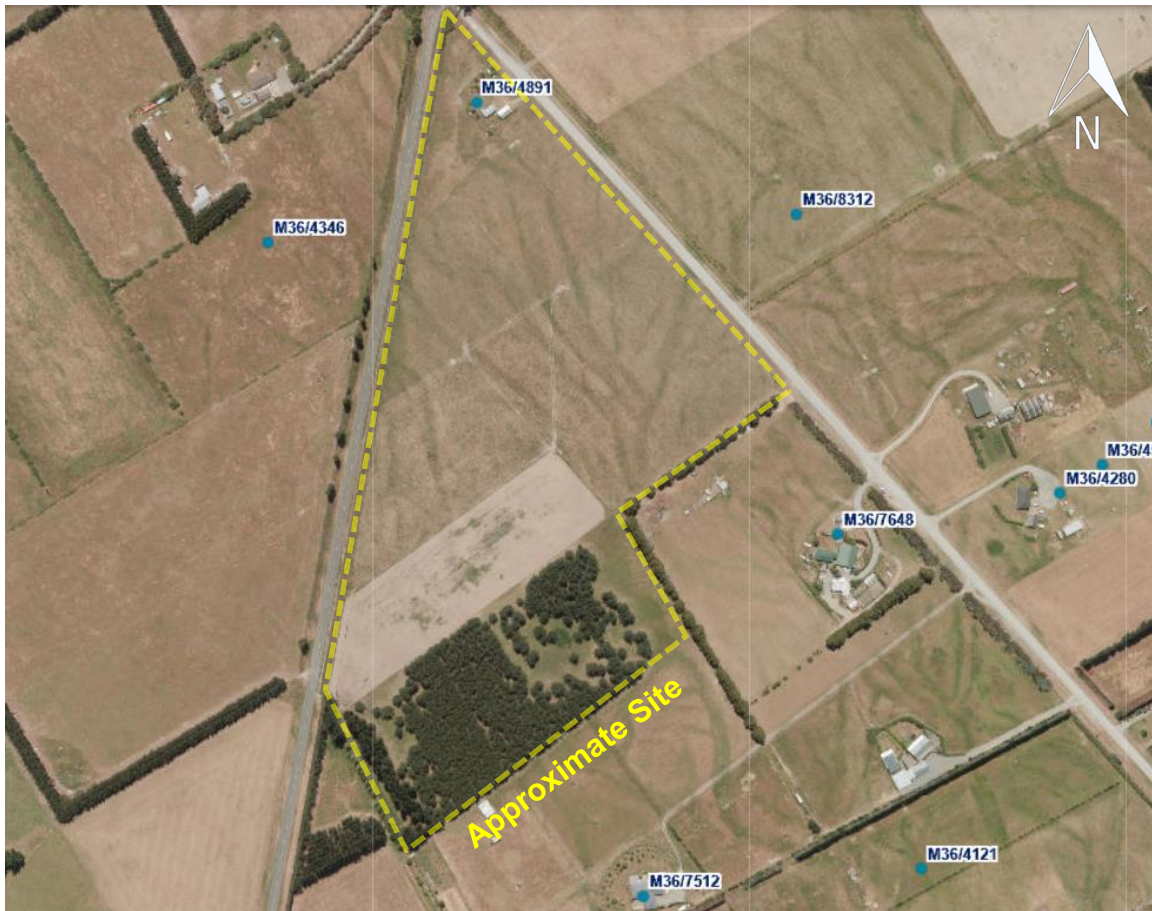
Figure 2: Nearby ECan Borehole Locations

A review of two deep ECan borehole logs; one located near the northern end of the site (M36/4891), west of the site (M36/4346) and two to the south (M36/7648) was conducted (Canterbury Maps). The location of these boreholes is presented in Figure 2 and includes the well points on site that have no log data available. The logs from the three holes of interest are presented in Appendix 4 and indicate the site is broadly underlain by a mixture of sandy gravels to depths of at least 28.5 m below ground level. Layers of silt are recorded in the bore well west of the site (M36/4346).

Aerial photograph sourced from Canterbury Maps (retrieved December 2017). Not to scale.

Groundwater is recorded in the surrounding boreholes between approximately 7 m and 8 m depth.

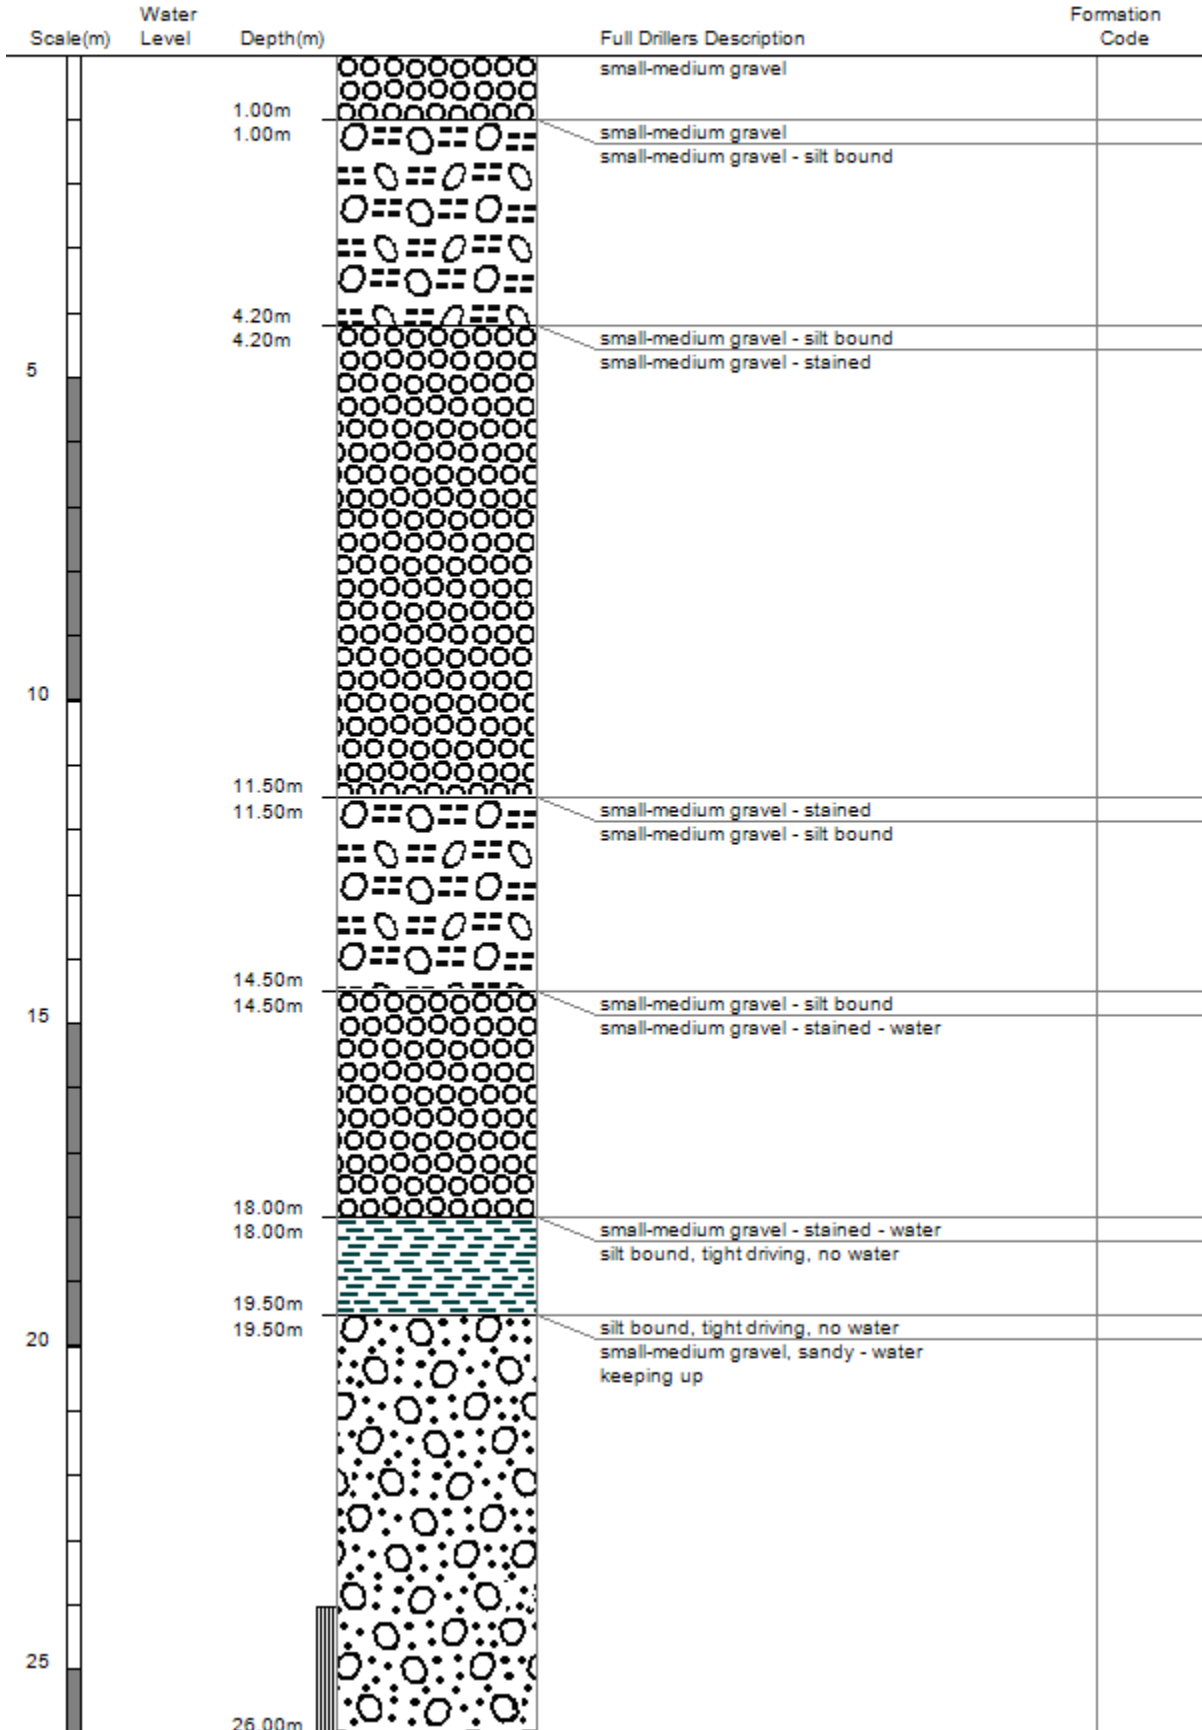
Borelog for well M36/7648

Grid Reference (NZTM): 1550378 mE, 5169691 mN
 Location Accuracy: 50 - 300m
 Ground Level Altitude: 35.7 m +MSD Accuracy: < 0.5 m
 Driller: Dynes Road Drilling
 Drill Method: Cable Tool
 Borelog Depth: 26.0 m Drill Date: 15-May-2004
