## Geotechnical Investigation

858 Selwyn Road

Rolleston

Hughes Developments Ltd

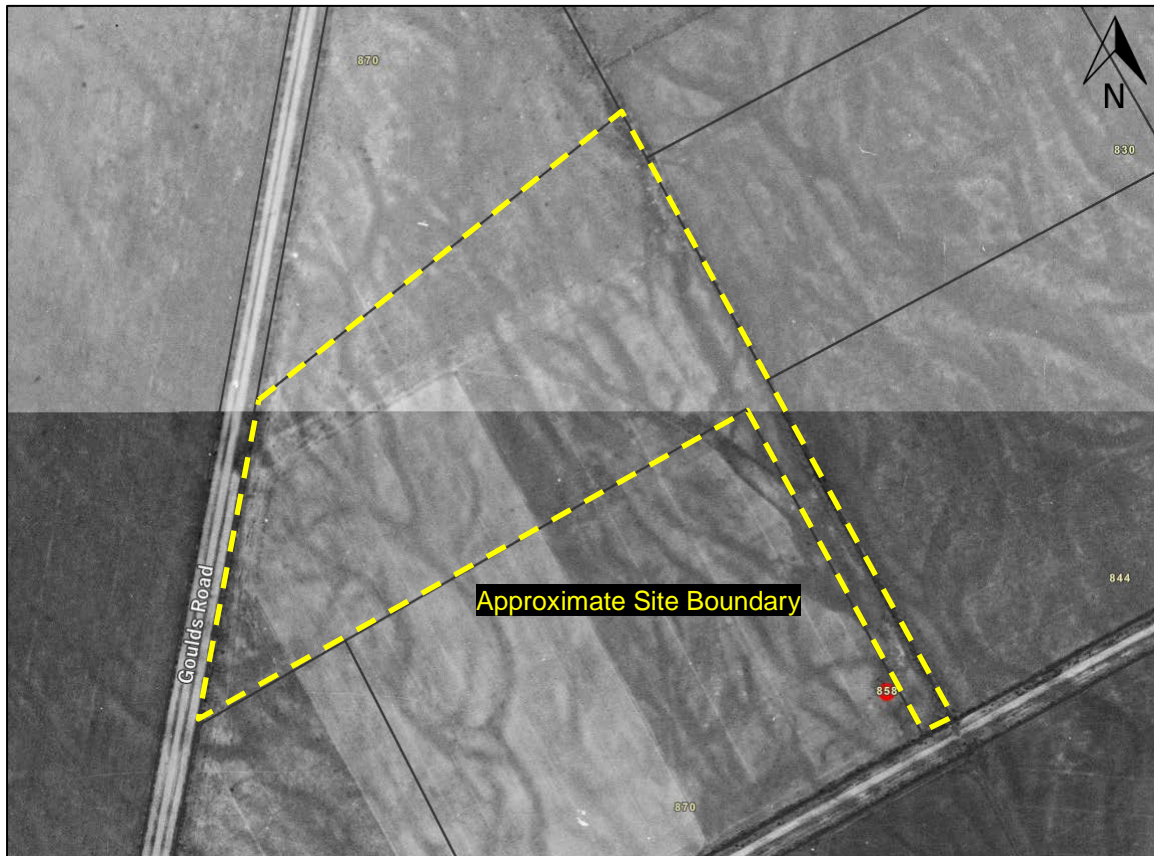
**Figure 2: Historical Aerial Photo – 1940 - 1944**

The site comprises relatively flat ground, with gentle undulations and depressions in some areas. As evident on aerial imagery (Canterbury Maps, 2019) and observed during our site walkover conducted on 5 August 2020, undulating and depressed ground can be attributed to paleo-channels, which traverse the site in a general northwest to southeast direction (Figure 2). Based on observations, sandy silt deposits with variable thickness are expected to have in-filled the paleo-channels where they have not remained as channel features. Inferred paleo-channels have been mapped to give an indication of areas with potential channel in-fill (Appendix 1).

Image sourced from Canterbury Maps. Not to scale.

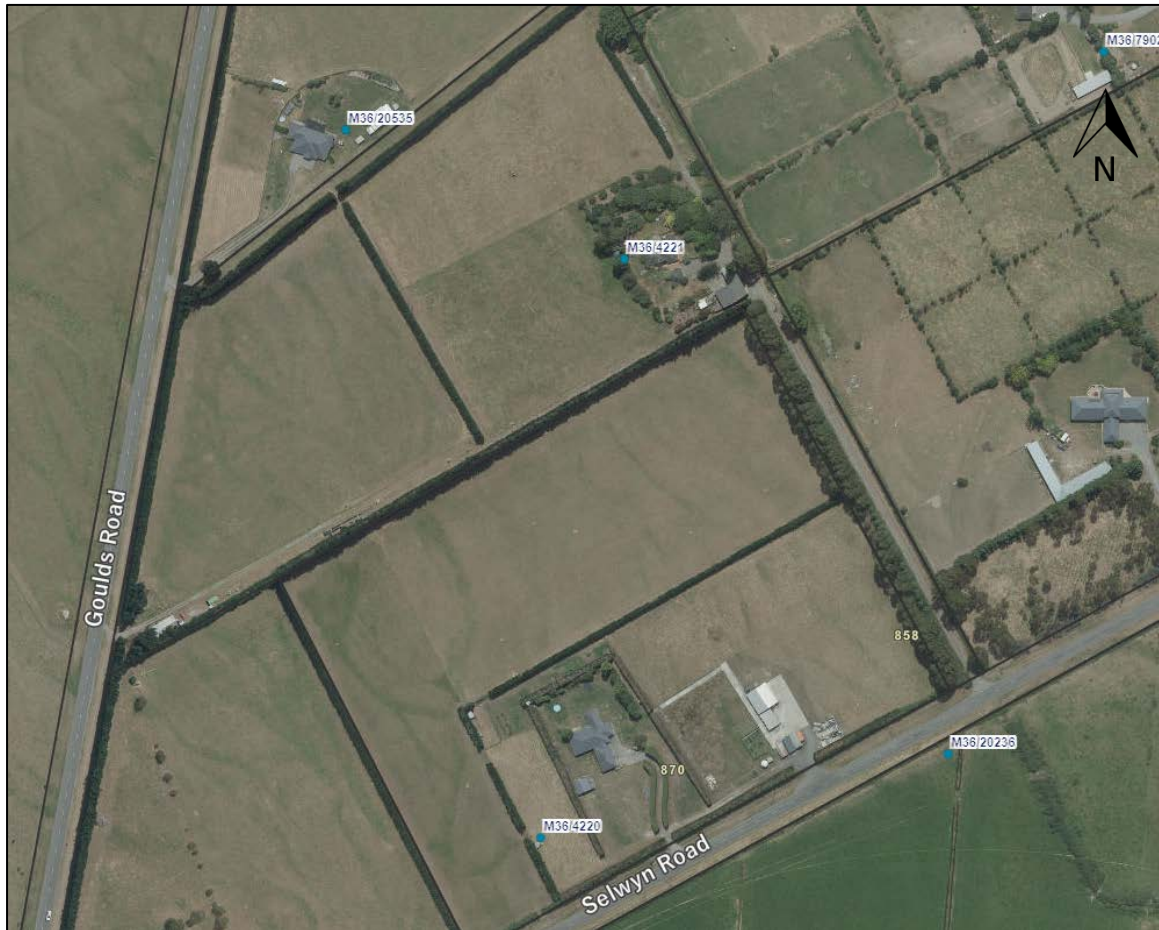
Figure 3: Nearby ECan Borehole Locations

A review of six, deep ECan borehole logs was conducted. The first (M36/4449 & M36/4387), are located on-site, and appear to be water wells providing the properties irrigation and domestic supply. The other boreholes are located to the north (M36/4450), east (M36/20535), south (BX23/0895) and west (M36/7416) of the site.

Aerial photograph sourced from Canterbury Maps. Not to scale.

ECan Borehole	Total Depth (m)	Water Level Below Ground Level (m)	Generalised Borelog as Logged by Driller
M36/5041	21.4	9.07	Gravel with clay and sand to 21.4 m depth.
M36/0016	30	9.12	Claybound gravel to 30 m depth.
M36/5042	21.3	8.81	Sandy and claybound gravel to 21.3 m depth.

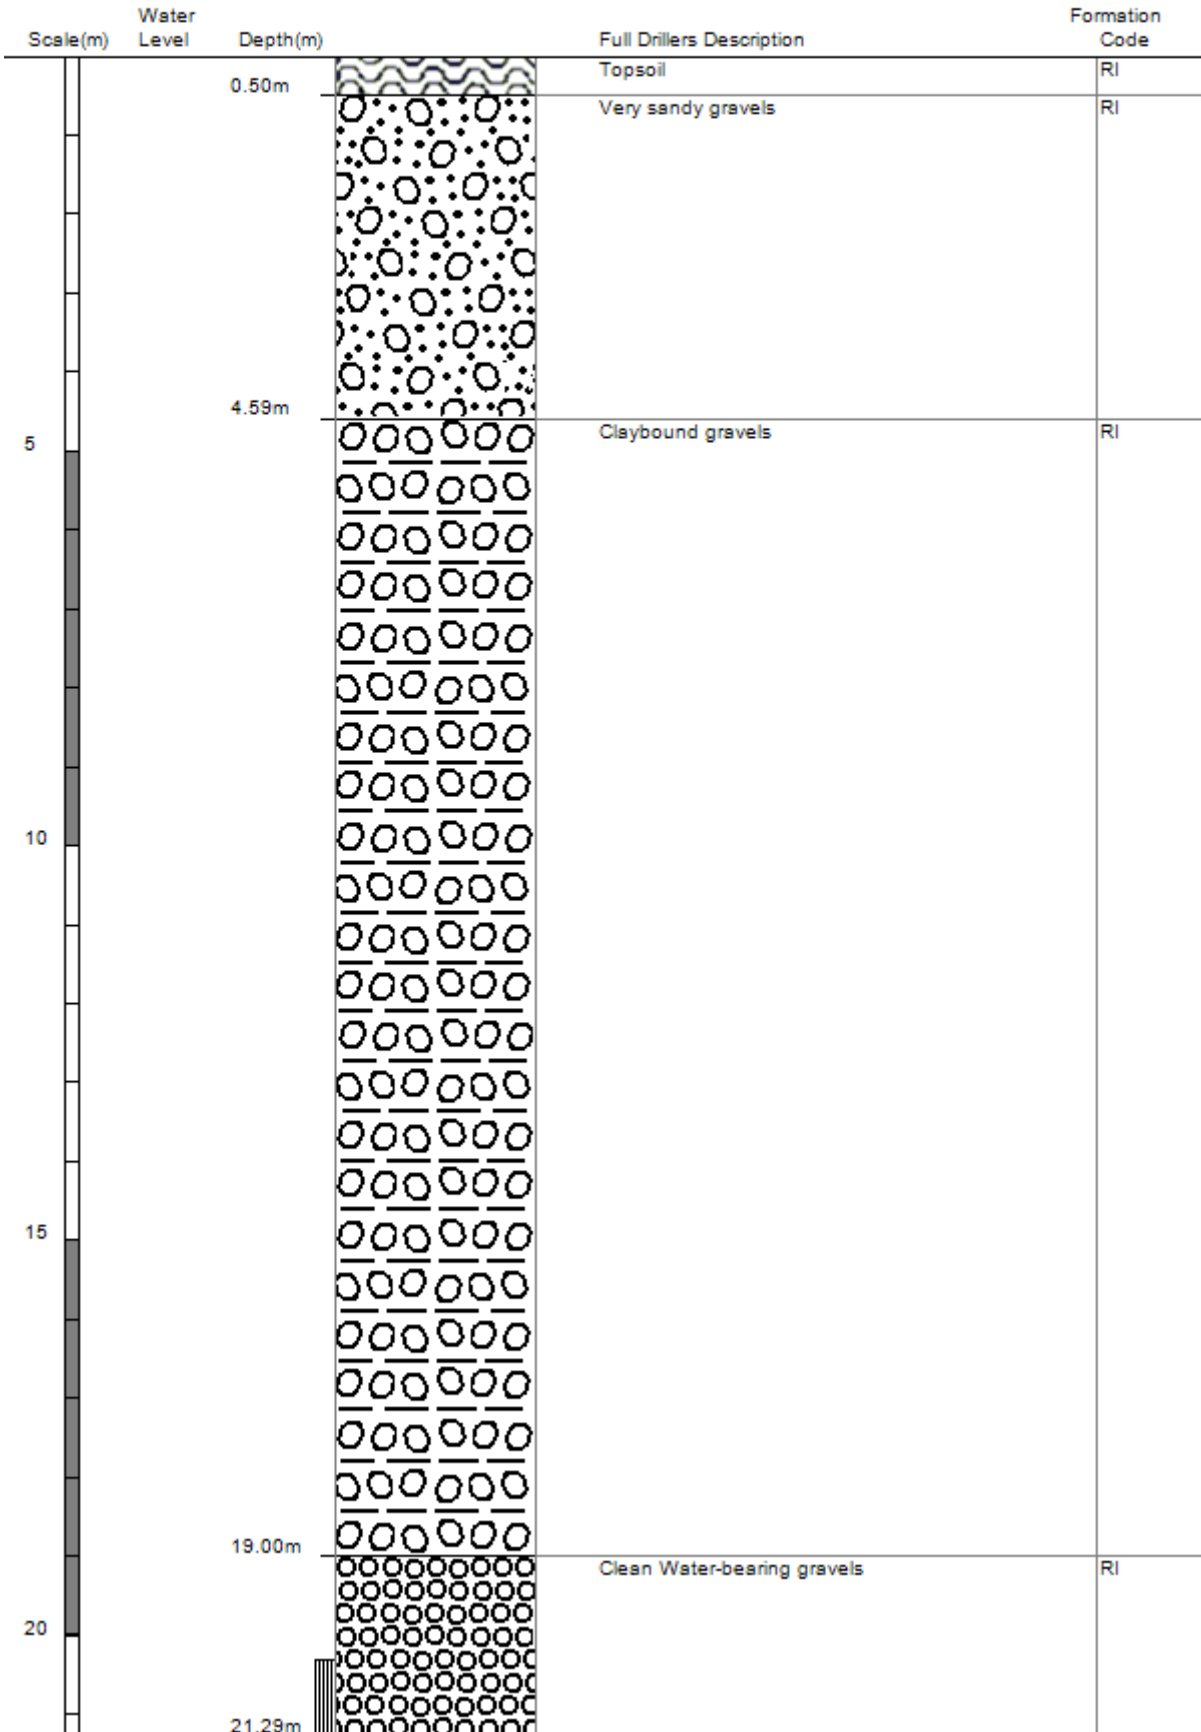
### Borelog for well M36/4220

Grid Reference (NZTM): 1550118 mE, 5168868 mN  
 Location Accuracy: 2 - 15m  
 Ground Level Altitude: 34.3 m +MSD Accuracy: < 2.5 m  
 Driller: Weedons WellDrilling  
 Drill Method: Rotary/Percussion  
 Borelog Depth: 21.3 m Drill Date: 05-Feb-1991
