Hughes Developments Ltd
Christchurch

**ENGEO Limited**

Report Title	Geotechnical Investigation - 708 &	710 Selwyn Road	, Rolleston	
Project No.	12903.000.000	Doc ID	67	
Client	Hughes Developments Ltd	Client Contact	Kelvin Back	(
Distribution (PDF)	Kelvin Back			
Date	Revision Details/Status	WP	Author	Reviewer
03/10/2019	Issued to Client	DF	JW	GM

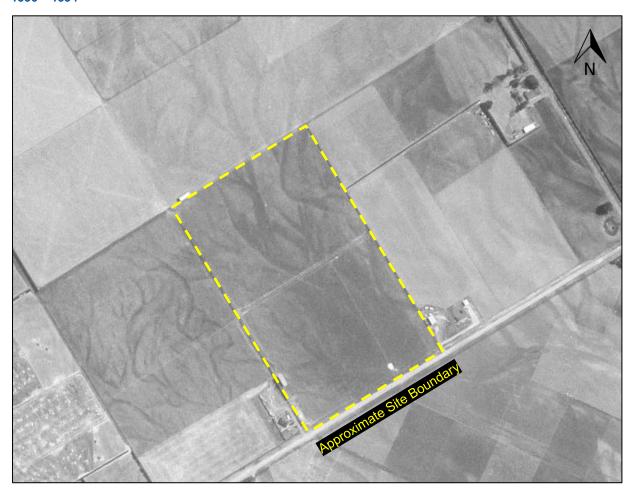
Figure 2: Historical Aerial Photography

The site comprises relatively flat ground, with gentle undulations and depressions in some areas. As evident on aerial imagery (Canterbury Maps, 2019) and observed during our site walkover conducted on 19 September 2019, undulating and depressed ground can be attributed to paleo-channels, which traverse the site in a general northwest to southeast trend. Based on observations, silt and sand deposits with variable thickness (up to 1.2 m) are expected to have in-filled the paleo-channels where they have not remained as channel features. Inferred paleo-channels have been mapped to give an indication of areas with potential channel in-fill (Appendix 1).

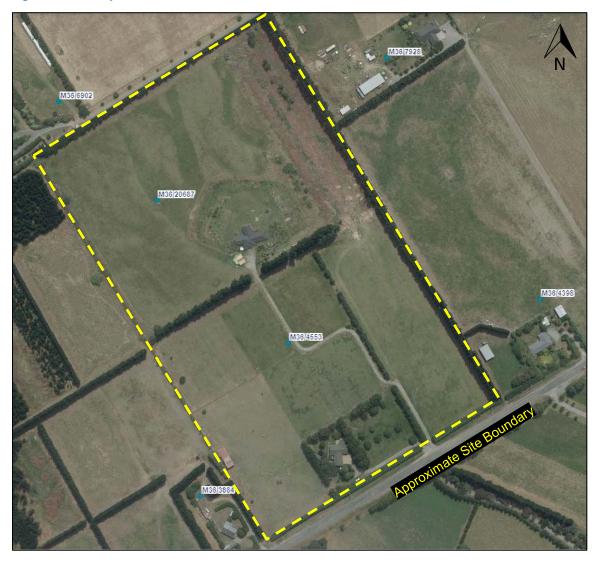
Figure 3: Nearby ECAN Borehole Locations

A review of three deep ECan borehole logs was conducted. The first (M36/5254), is located on-site, and appears to be a water well servicing the existing dwelling. The other boreholes are located on the northern boundary (M36/7902) and western boundary (M36/4221). A borehole is located south of Selwyn Road (M36/20236) but has no borehole log associated with it on Canterbury Maps.

ECan Borehole	Total Depth (m)	Water Level (m)	Generalised borelog as logged by driller
M36/4553	33	8.3	Clay to 0.9 m and gravel to 33 m with a layer of clay at 28 m to 29.5 m.
M36/20687	36	Not recorded	Sand to 2.5 m depth and gravel to 36 m depth.
M36/3884	30	7.9	Gravel to 30 m with a layer of peat and clay at 27 m to 28.5 m.
M36/6902	42	12	Gravel to 42 m depth.
M36/7928	37	7.2	Gravel to 37 m depth.

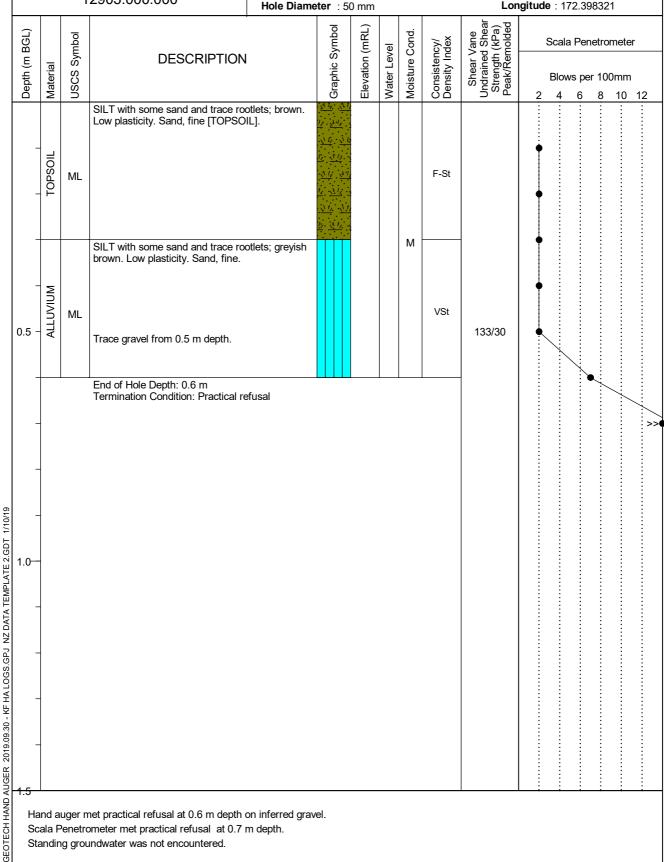
Latitude : -43.623809 Longitude: 172.398321

Hand auger met practical refusal at 0.6 m depth on inferred gravel.

Scala Penetrometer met practical refusal at 0.7 m depth.

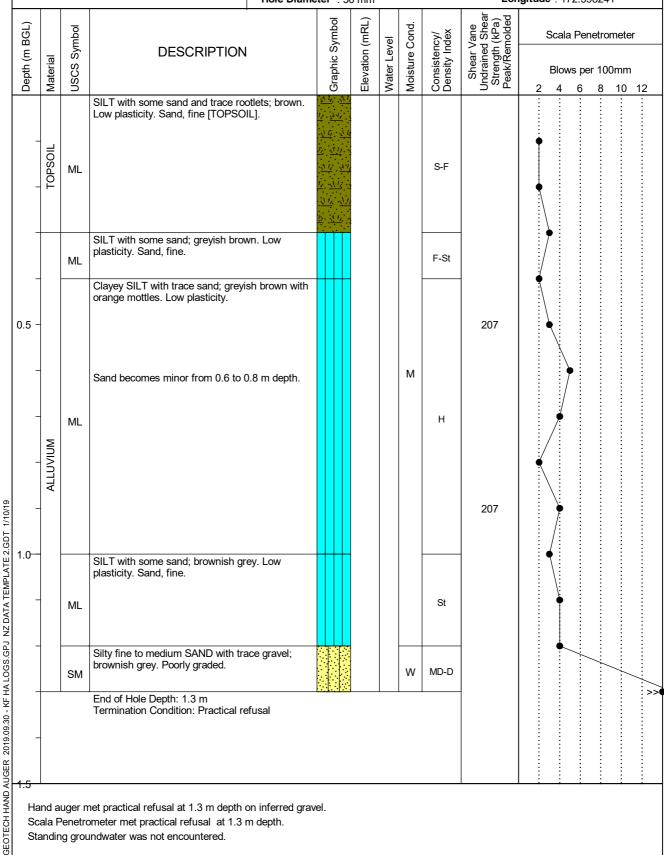
Longitude: 172.398241

Hand auger met practical refusal at 1.3 m depth on inferred gravel.

Scala Penetrometer met practical refusal at 1.3 m depth.

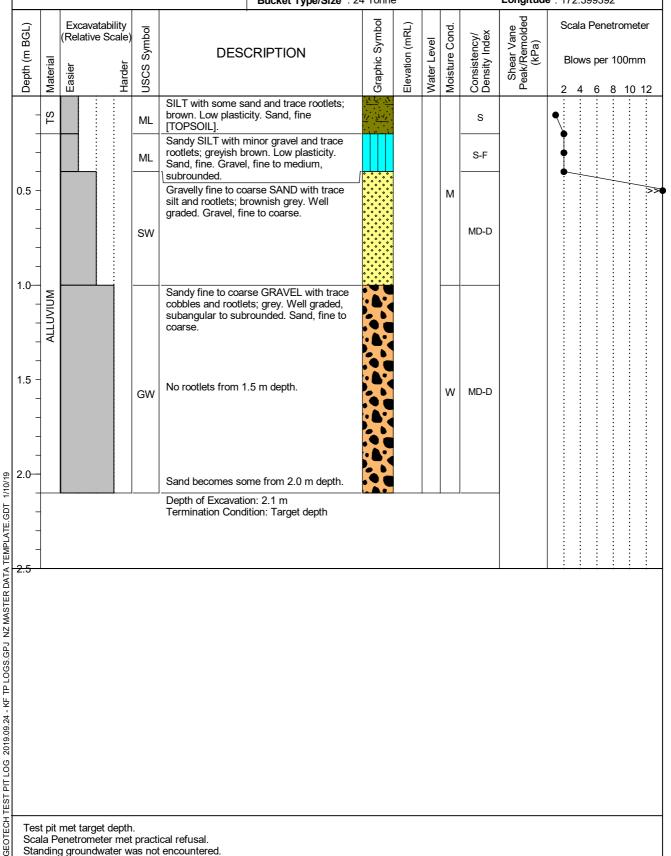
Max Test Pit Depth: 2.1 m Reviewed By: JRW Digger Type/Size : Bucket Excavator Latitude: -43.622307 Bucket Type/Size : 24 Tonne Longitude: 172.399392

Test pit met target depth. Scala Penetrometer met practical refusal. Standing groundwater was not encountered

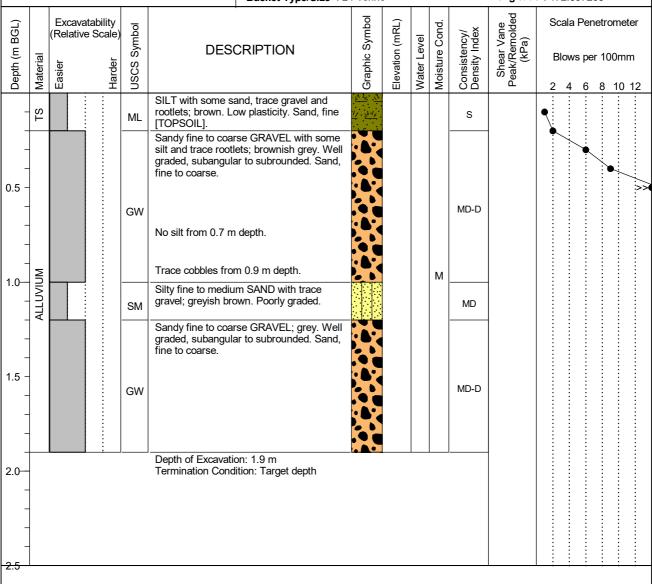
Digger Type/Size : Bucket Excavator Latitude : -43.622695
Bucket Type/Size : 24 Tonne Longitude : 172.397203

Test pit met target depth. Scala Penetrometer met practical refusal. Standing groundwater was not encountered

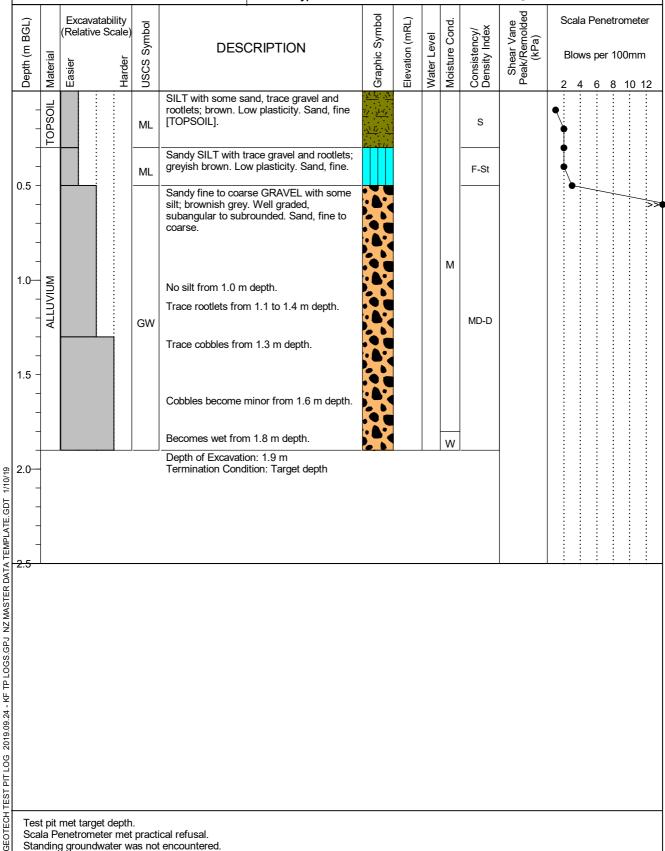
Max Test Pit Depth : 1.9 m Digger Type/Size : Bucket Excavator Latitude: -43.622004 Bucket Type/Size : 24 Tonne Longitude: 172.398351

Test pit met target depth. Scala Penetrometer met practical refusal.

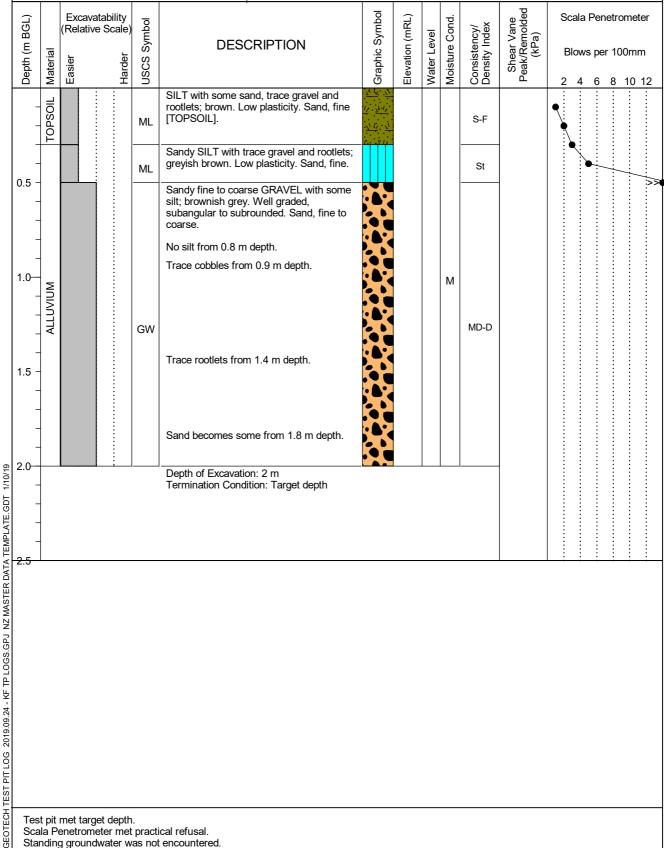
Latitude: -43.621142 Bucket Type/Size : 24 Tonne Longitude: 172.39774

Test pit met target depth. Scala Penetrometer met practical refusal.

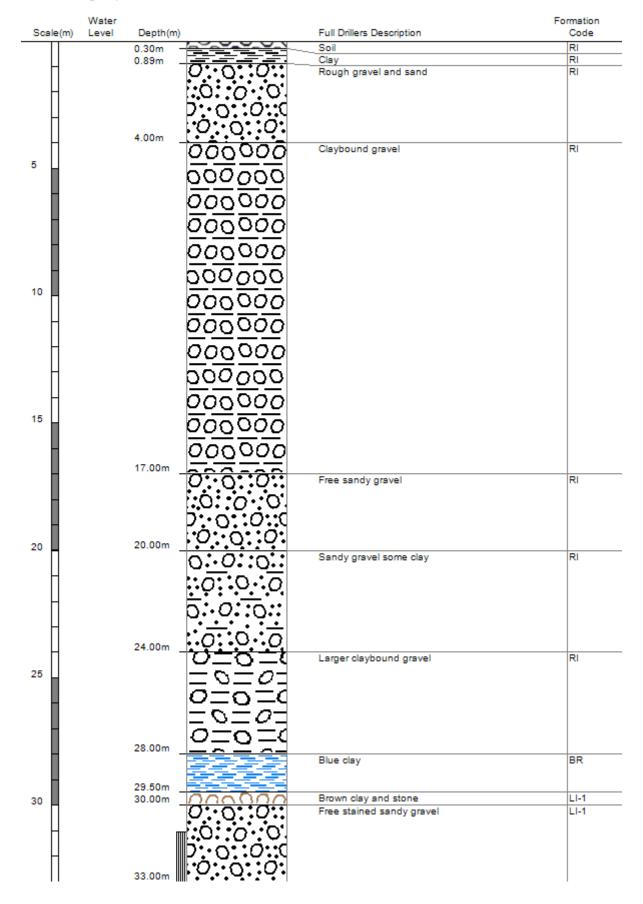
Bore or Well No	M36/20687
Well Name	SELWYN ROAD
Owner	MR G M SOLE

Borelog Depth: 33.0 m Drill Date: 01-Nov-1992
