Geotechnical Investigation

Faringdon Subdivision

697 Selwyn Road & 417 Springston-Rolleston Road

Rolleston

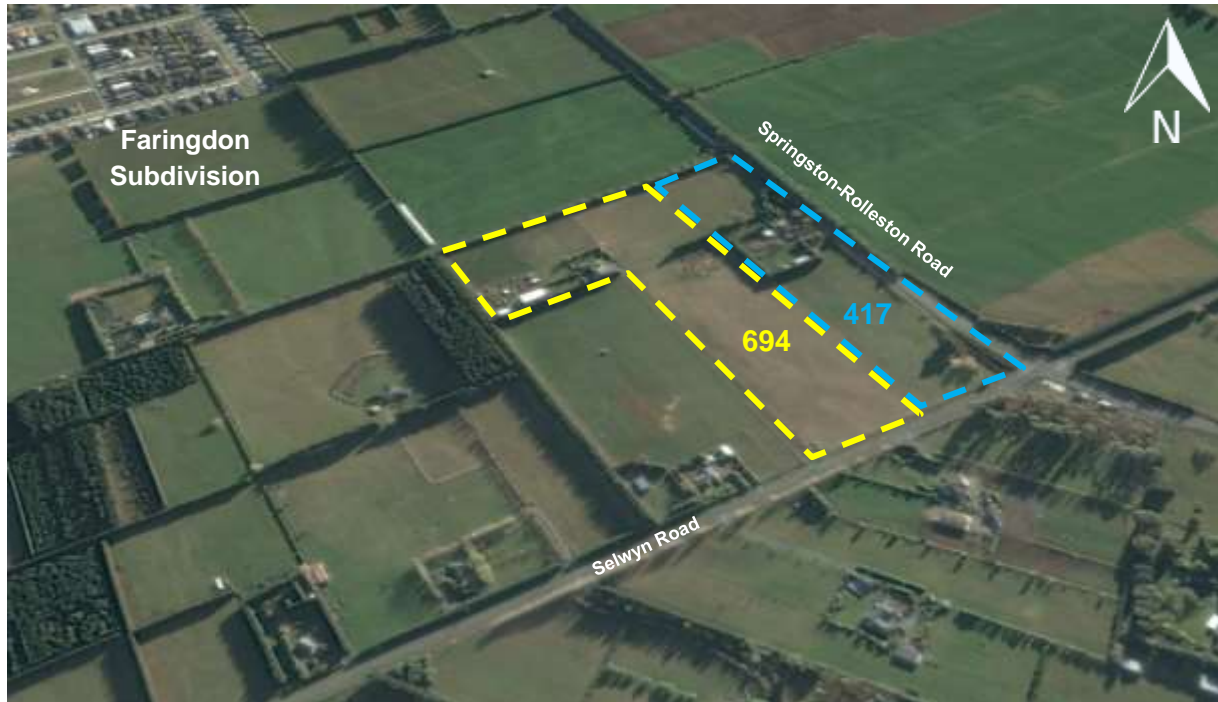
Figure 1: Site Location

The two sites proposed to be subdivided are located approximately 3.1 km south-east of Rolleston town centre and are bound to the south by Selwyn road, the east by Springston-Rolleston Road, and farmland to the north and west (Figure 1).

Image obtained from Google Earth.

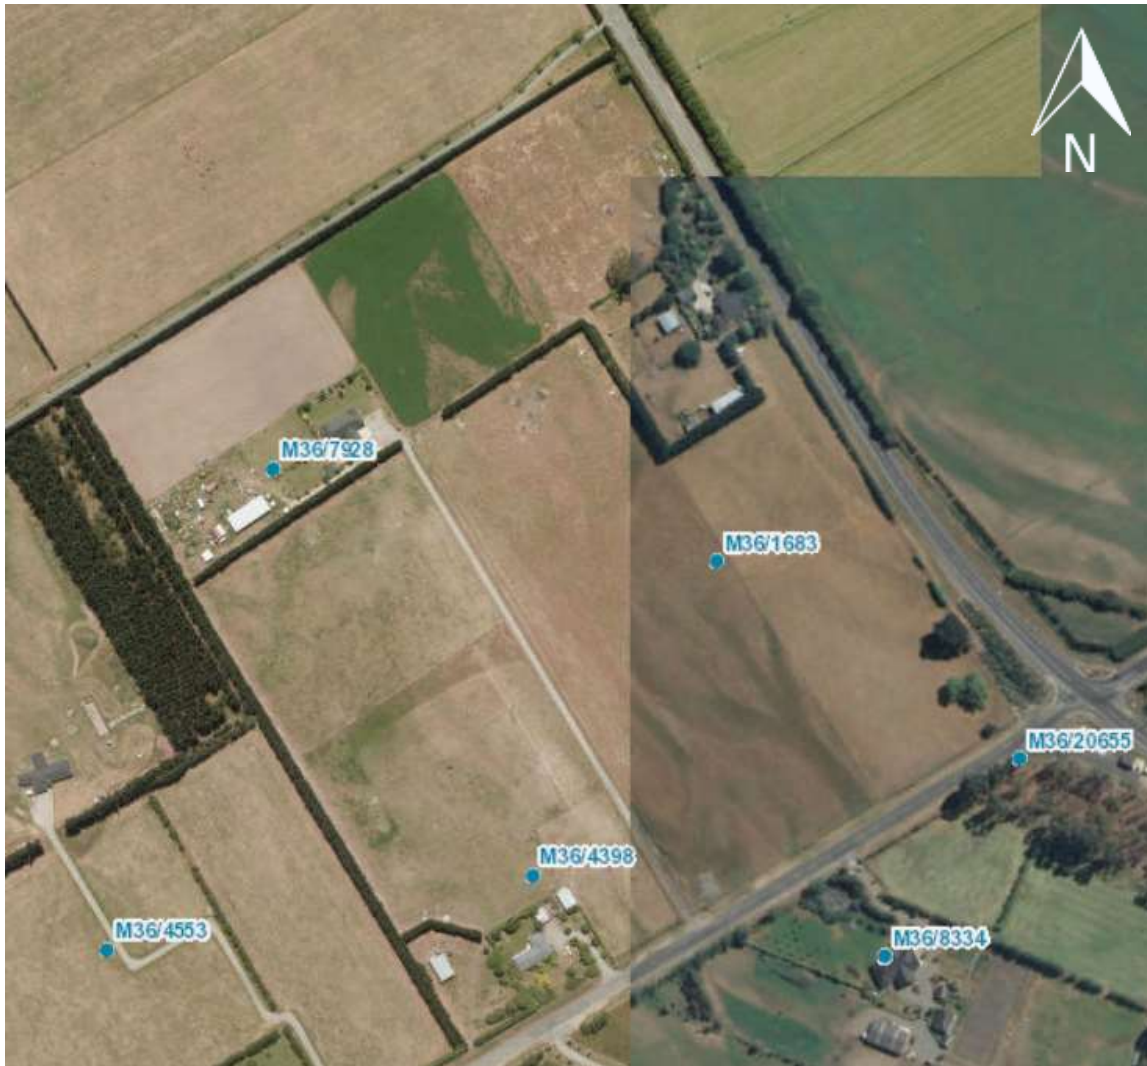
Figure 2: Nearby ECan Borehole Locations

A review of three representative deep ECan borehole logs on the site and in the surrounding area has been conducted. The logs from these holes are presented in Appendix 4 and indicate the site is underlain by a mixture of silt bound gravels to depths of at least 37 m below ground level.

All images sourced from Google Maps. Not to scale.

Groundwater is recorded in the ECan borehole M36/7928 at 7.6 m depth.

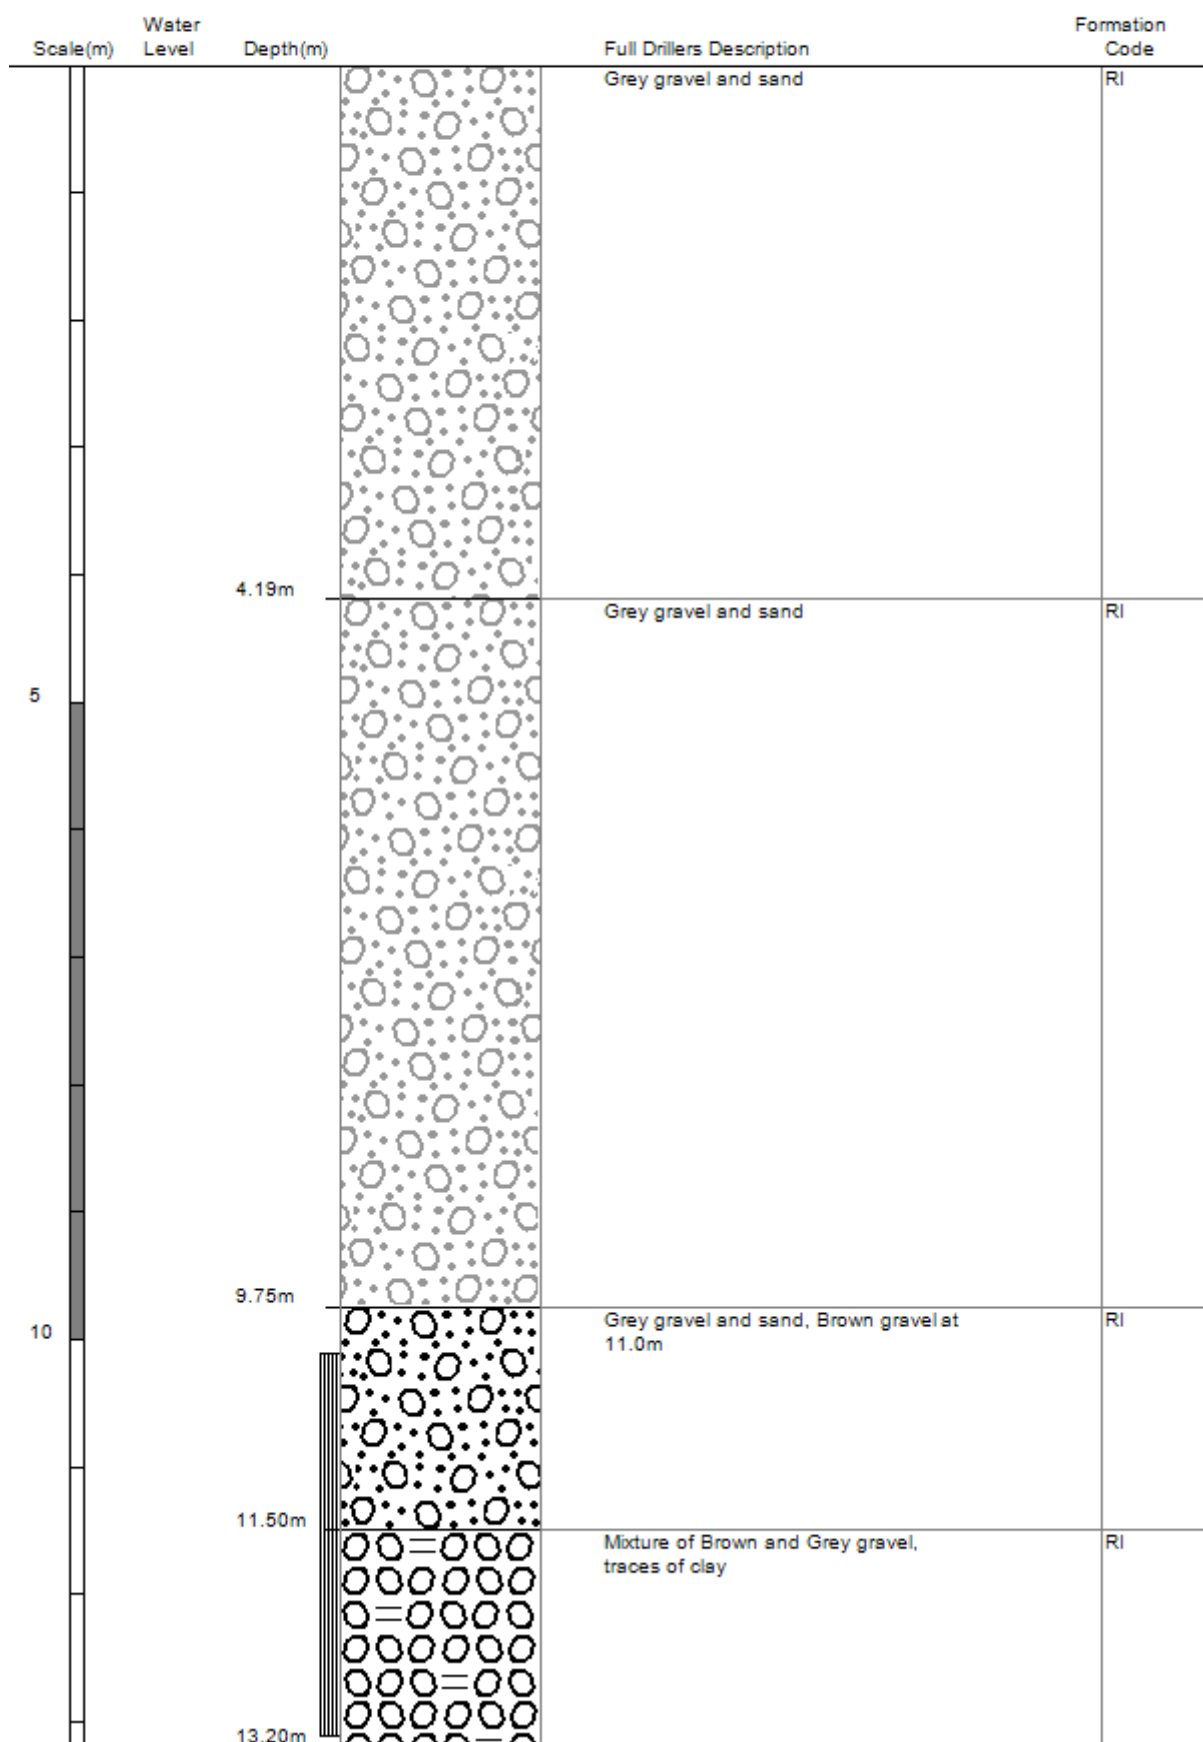
Borelog for well M36/1683

Grid Reference (NZTM): 1551807 mE, 5169991 mN
 Location Accuracy: 50 - 300m
 Ground Level Altitude: 34.8 m +MSD Accuracy: < 2.5 m
 Driller: Smith, J R & I G
 Drill Method: Unknown
 Borelog Depth: 13.2 m Drill Date:

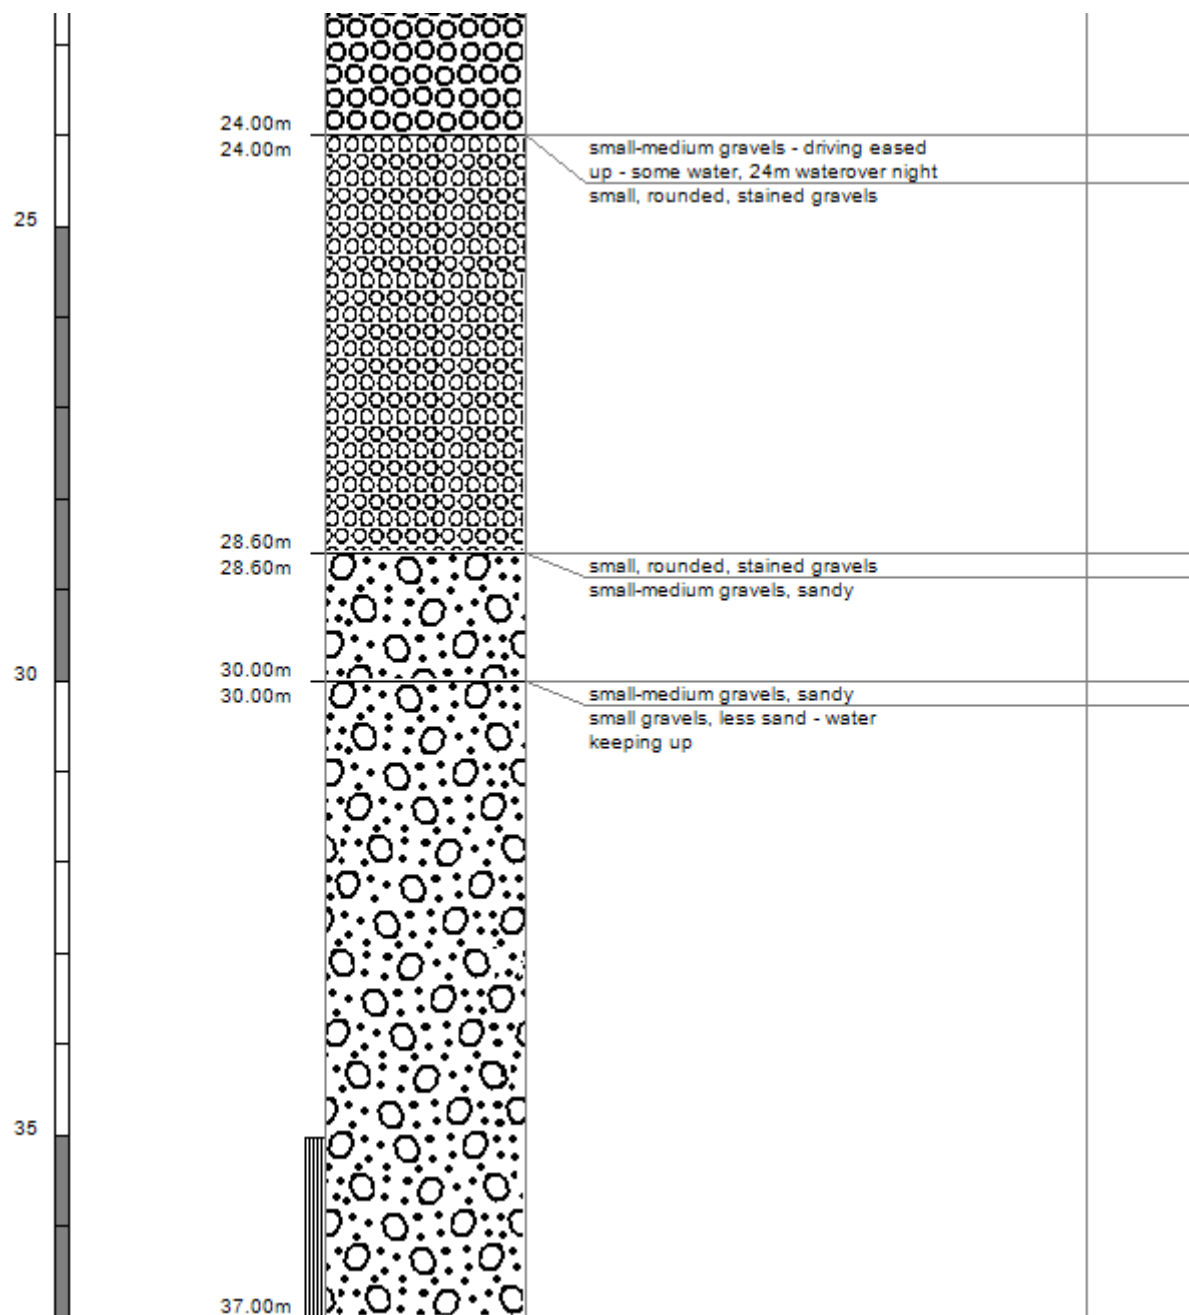
Bore or Well No: M36/7928

Scale(m)	Level	Depth(m)	Full Drillers Description	Code
		0.30m	topsoil	
		0.30m	topsoil medium-large gravels	
5		4.00m	medium-large gravels	
		4.00m	small-medium gravels, silt bound	
		6.00m	small-medium gravels, silt bound	
		6.00m	small-medium gravels, firm silt	
10		8.00m	small-medium gravels, firm silt	
		8.00m	medium gravels, wet silt	
15				
20				
		20.70m	medium gravels, wet silt	
		20.70m	small-medium gravels - driving eased up - some water, 24m waterover night
