## Soil Validation Report

Southeast Faringdon

Selwyn Road, Rolleston

09.03.2021

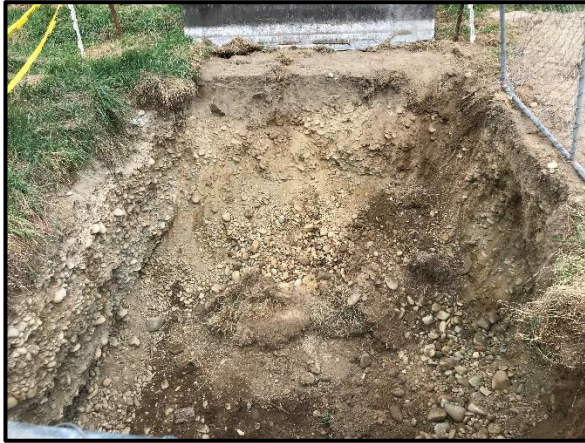
Photo 1: Area 1: Waste pit after removal

Area 1: All samples collected from the waste pit have reported below the NES SCS concentrations for residential land use and below the site specific regional background levels for heavy metals.

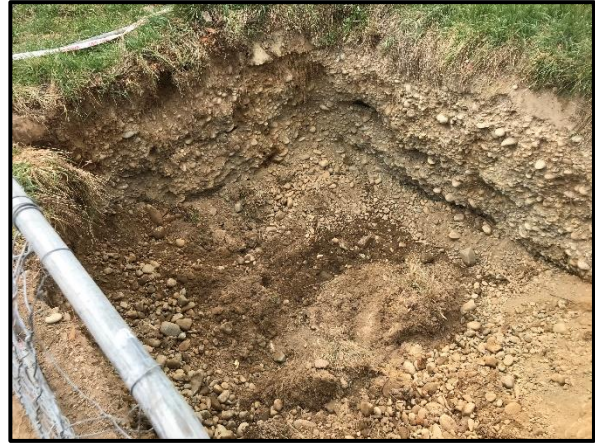
Photo 2: Area 1: Waste pit after removal

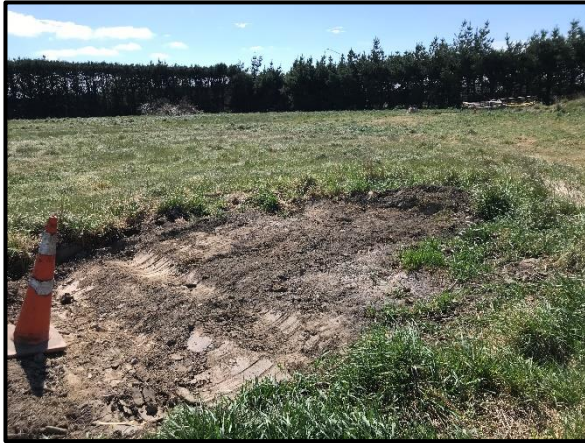
Photo 3: Area 2: Burn pile after removal

Area 2: Burn pile – one sample, SV3, returned concentrations of arsenic above the NES residential land use criteria. This sample also reported arsenic, chromium, copper and zinc above the site specific regional background values. All other samples collected from the burn pile were below the applicable NES SCS and below the background values for the site. After the additional removal of the hotspot in the burn pile, one additional sample was collected from the eastern wall of the burn pile which returned concentrations below the NES residential criteria. The sample collected from the mixed stockpile reported copper and zinc above the site specific regional background values. As these values were below the NES SCS, further remediation was not required. These soils were subsequently placed into an on-site borrow pit. Please refer to Figure 3 attached for the location of the Borrow Pit.

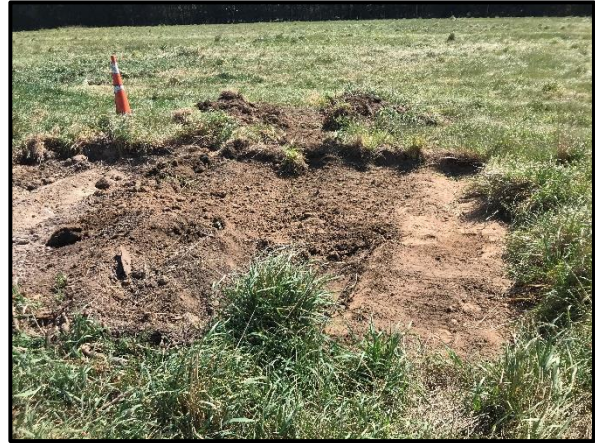
Photo 4: Area 2: Burn pile after removal

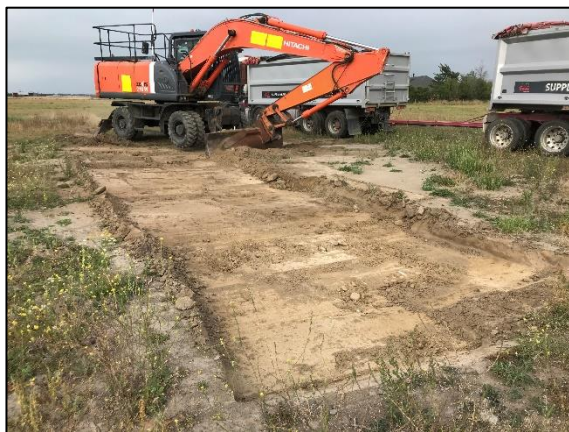
Photo 5: Area 7: Burn pile after removal

Area 7: All samples collected from the waste pit have reported below the NES SCS concentrations for residential land use and below the site specific regional background levels for heavy metals.

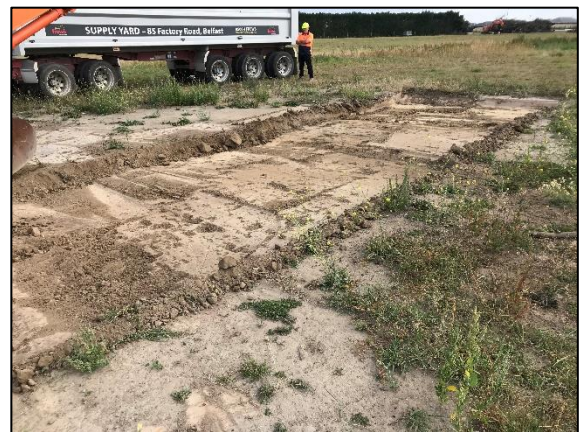
Photo 6: Area 7: Burn pile after removal

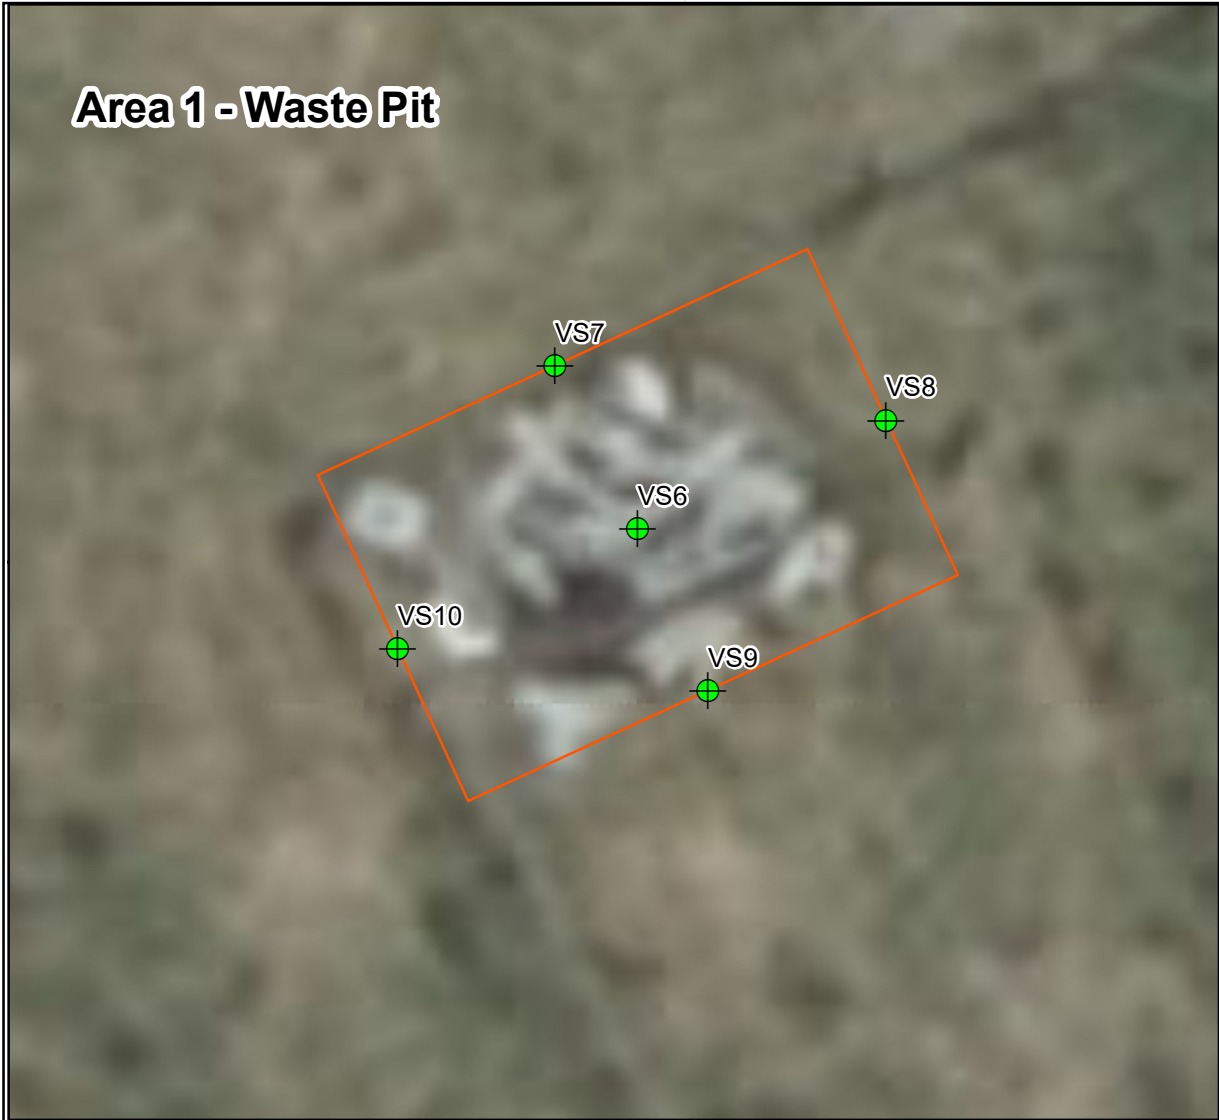
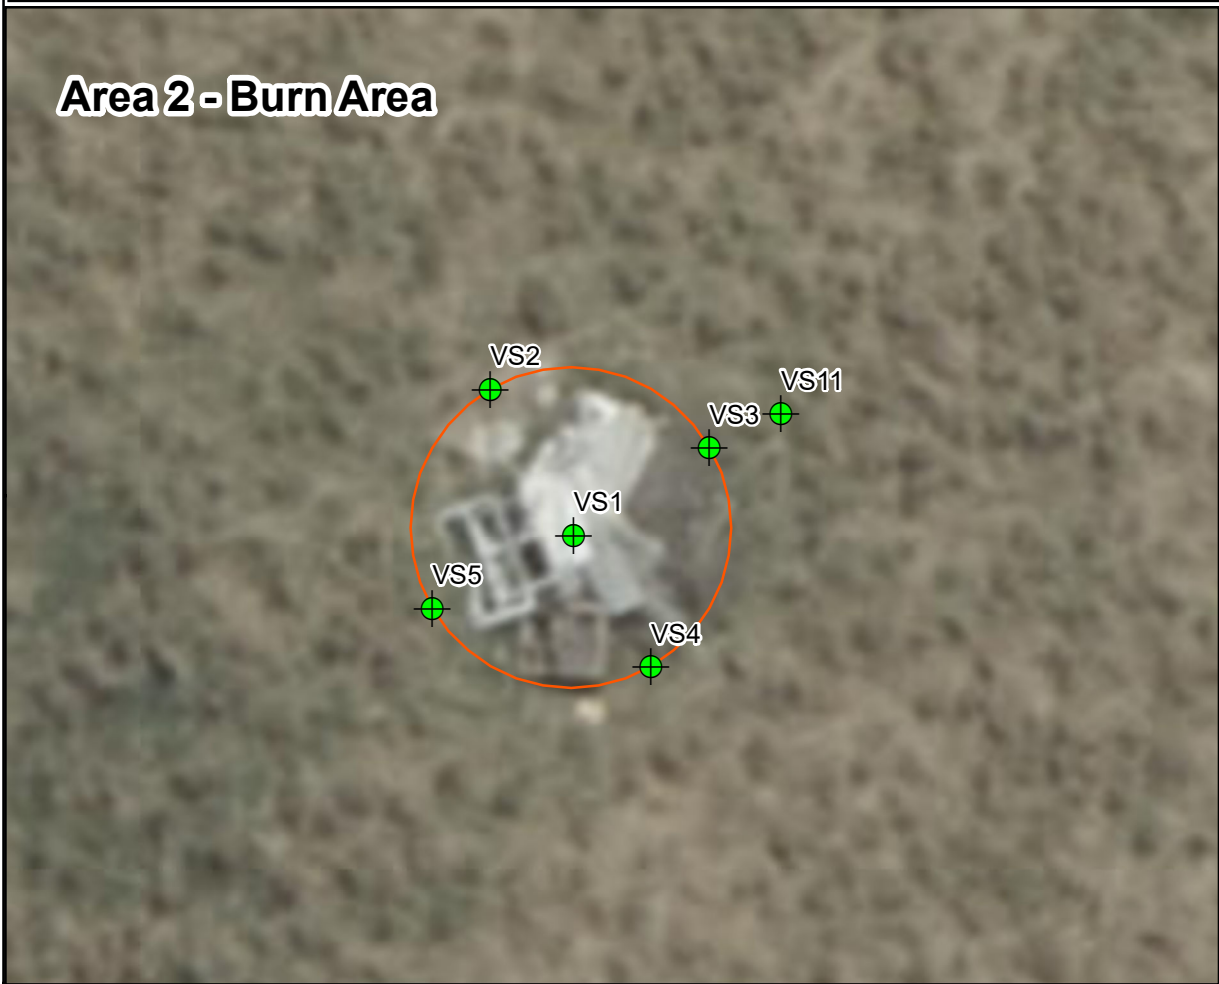
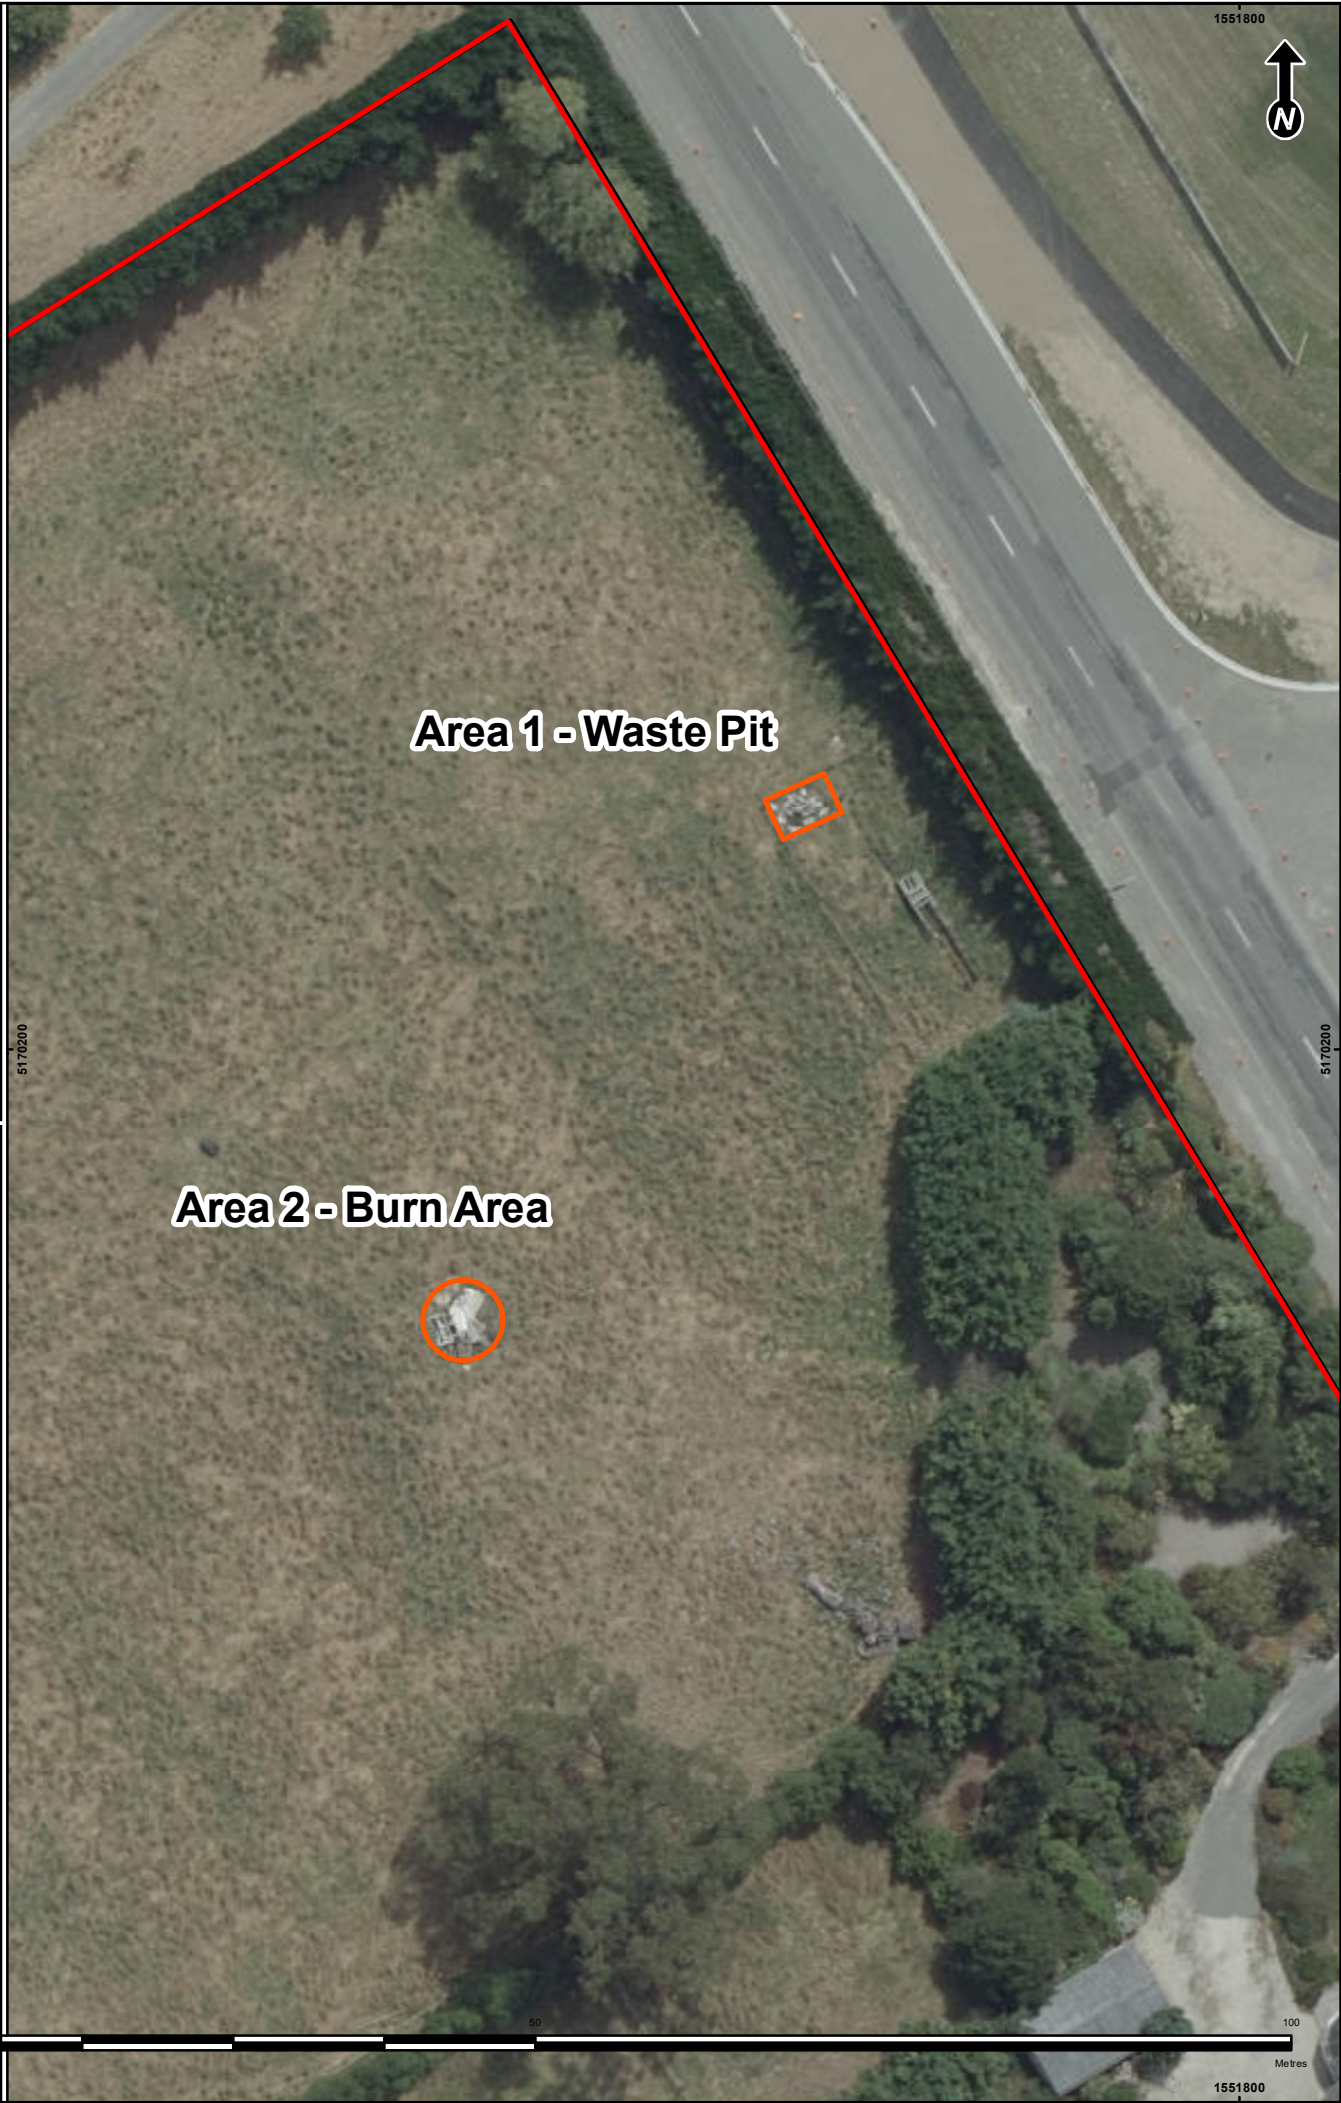
Title:  
**Remedial Areas and Validation Sample Locations**

ENGEO Ltd was requested by Hughes Developments Ltd to prepare a soil validation report of the property at Southeast Faringdon, Selwyn Road, Rolleston (herein referred to as 'the site'). During the intrusive environmental investigation at the site, concentrations of heavy metals were observed in a burn pile and waste pit at 417 Springston Rolleston Road, Rolleston. The concentrations of heavy metals were reported above the proposed residential 10 % produce end use, therefore remedial earthworks were required to enable the redevelopment of the site. Validation samples were performed following the removal of the impacted material from the previously identified areas. Figure 1 and 2 appended shows the areas of validation sampling.

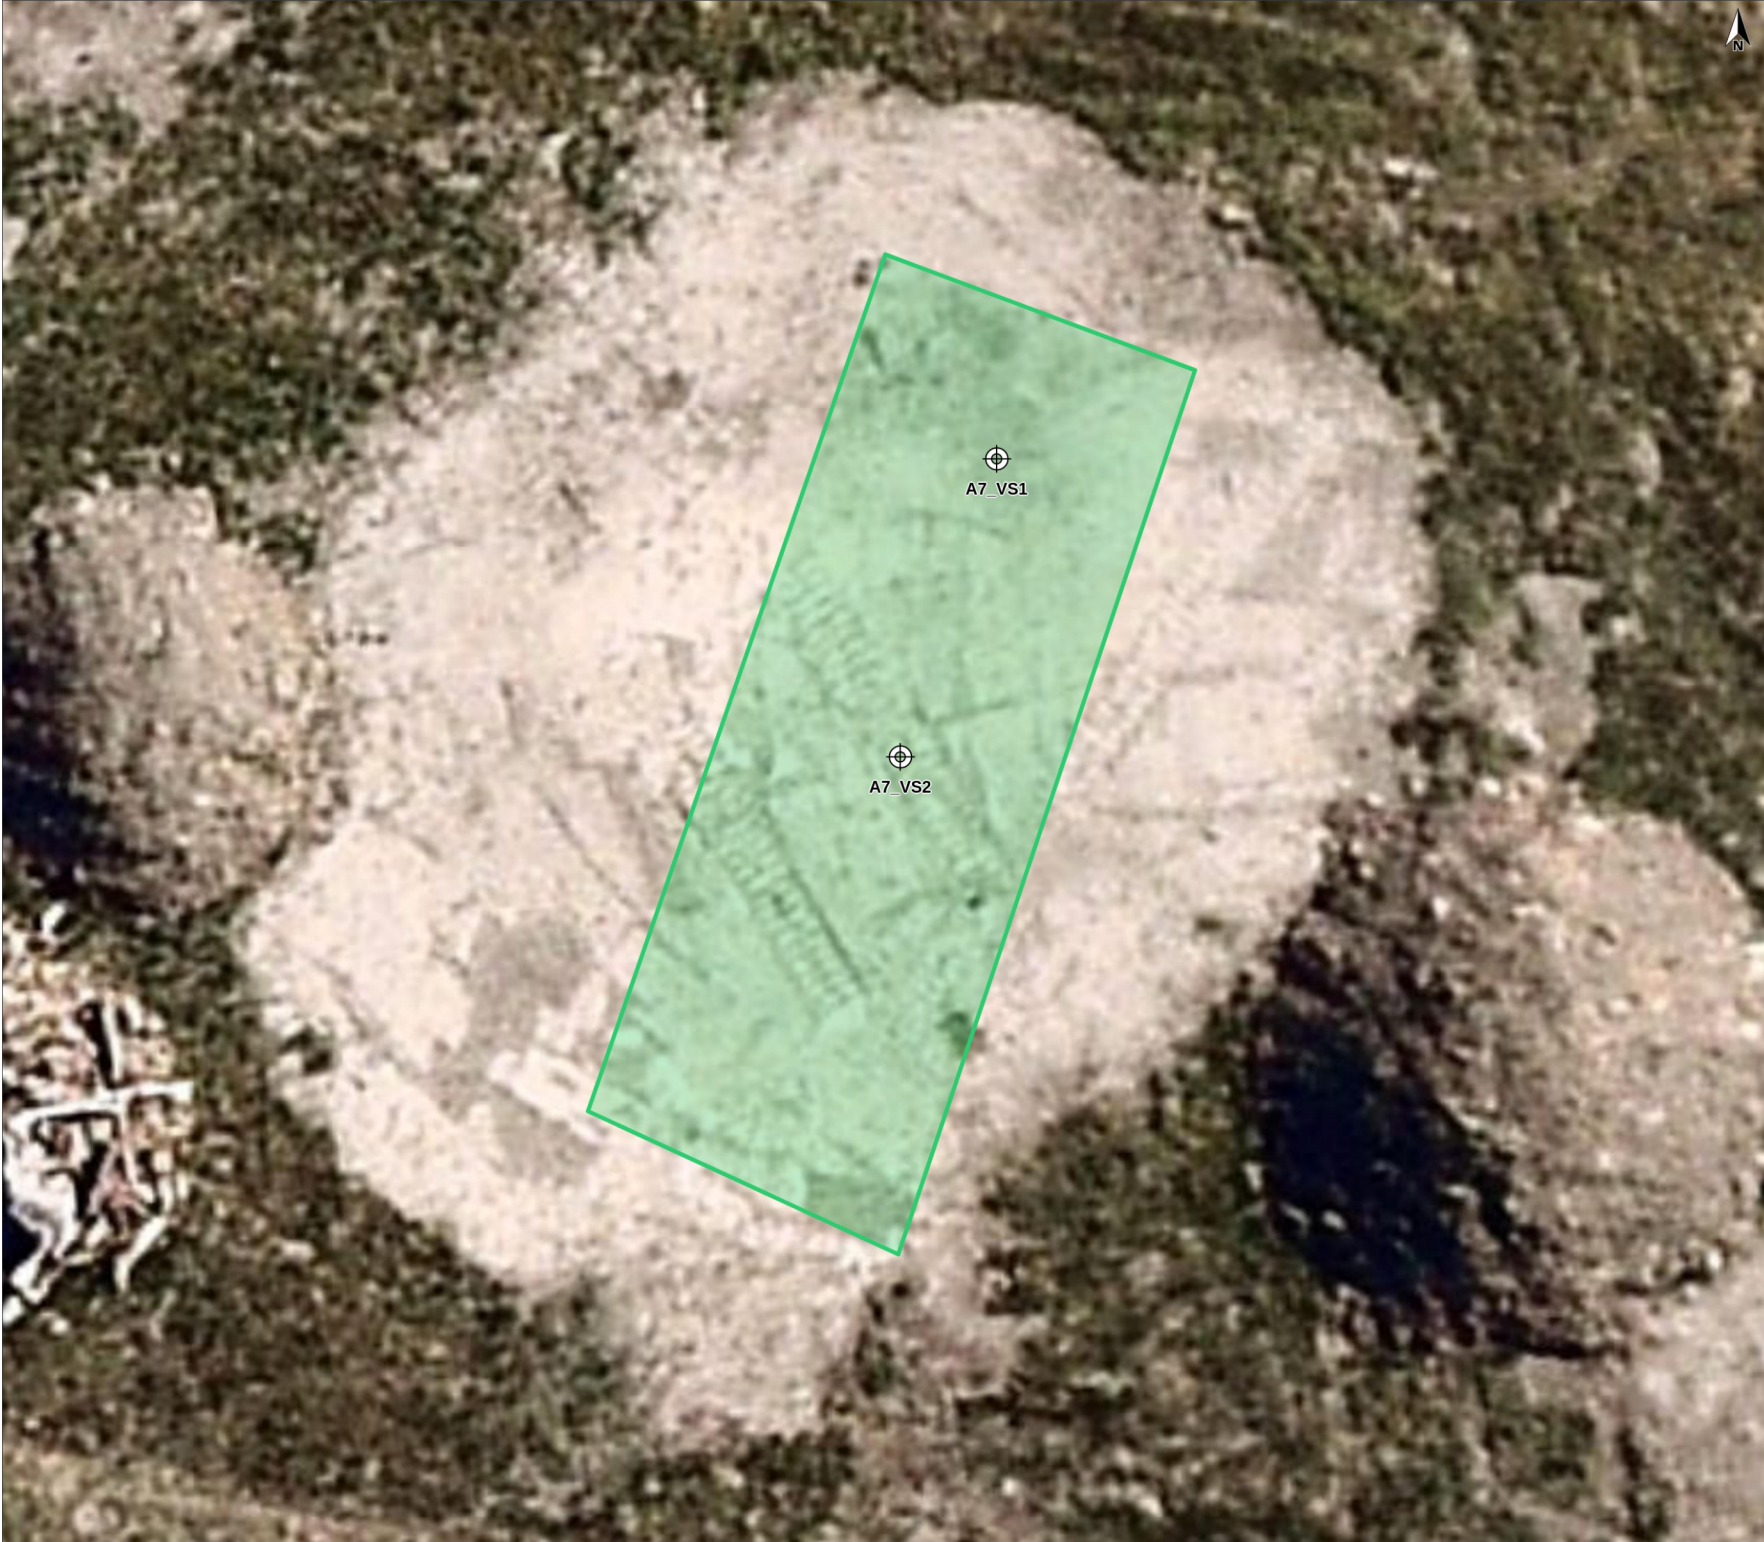
| Title: 694 Selwyn Road - Remedial Area | | |

The preferred remedial method for Area 7 was excavation of the impacted burn pile material with disposal off-site. The soil samples collected from the burn pile during the DSI met the Frews Hororata acceptance criteria. A total of three soil samples were collected from the base of the burn pile remedial area for validation.
