Geotechnical Investigation

479 East Maddisons Road

Springston

16.05.2019

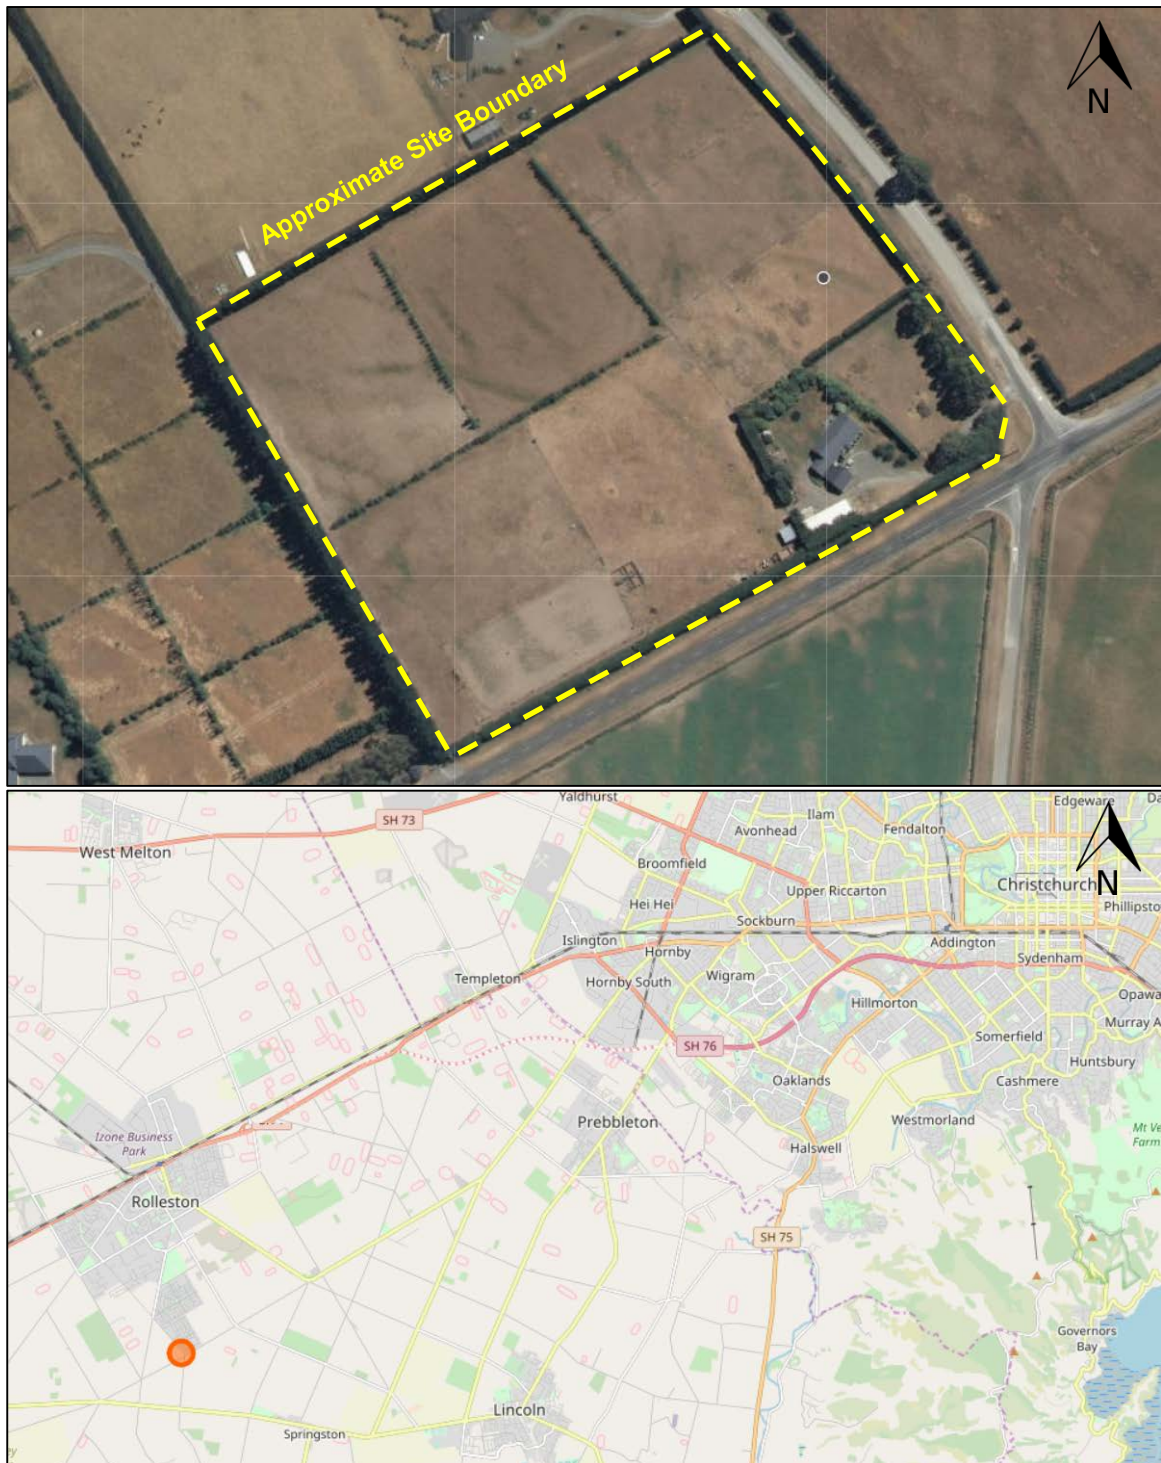
Figure 1: Site Location Plan

It is located approximately 4 km south of Rolleston town centre, rural properties border the site on all sides (Figure 1).

Images sourced from Canterbury Maps and "© OpenStreetMap contributors". Not to scale.

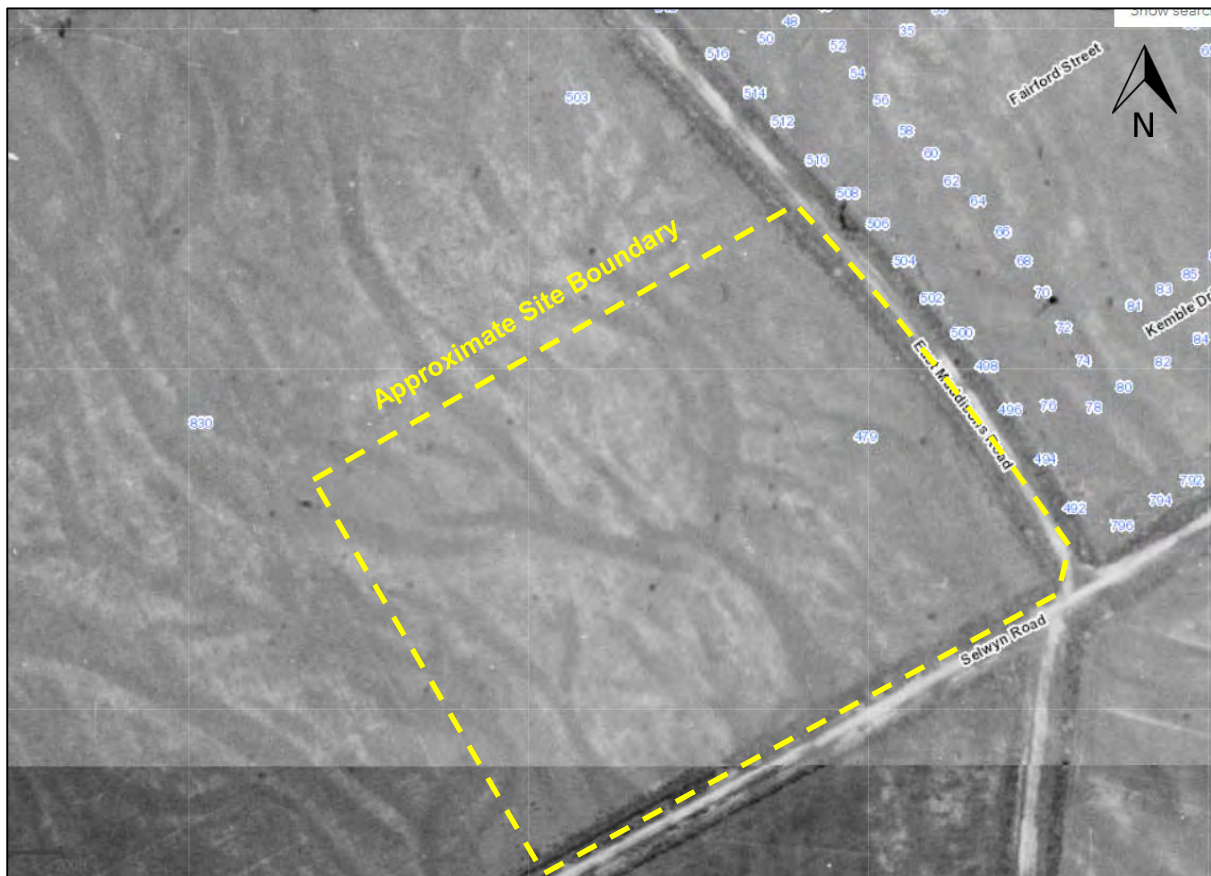
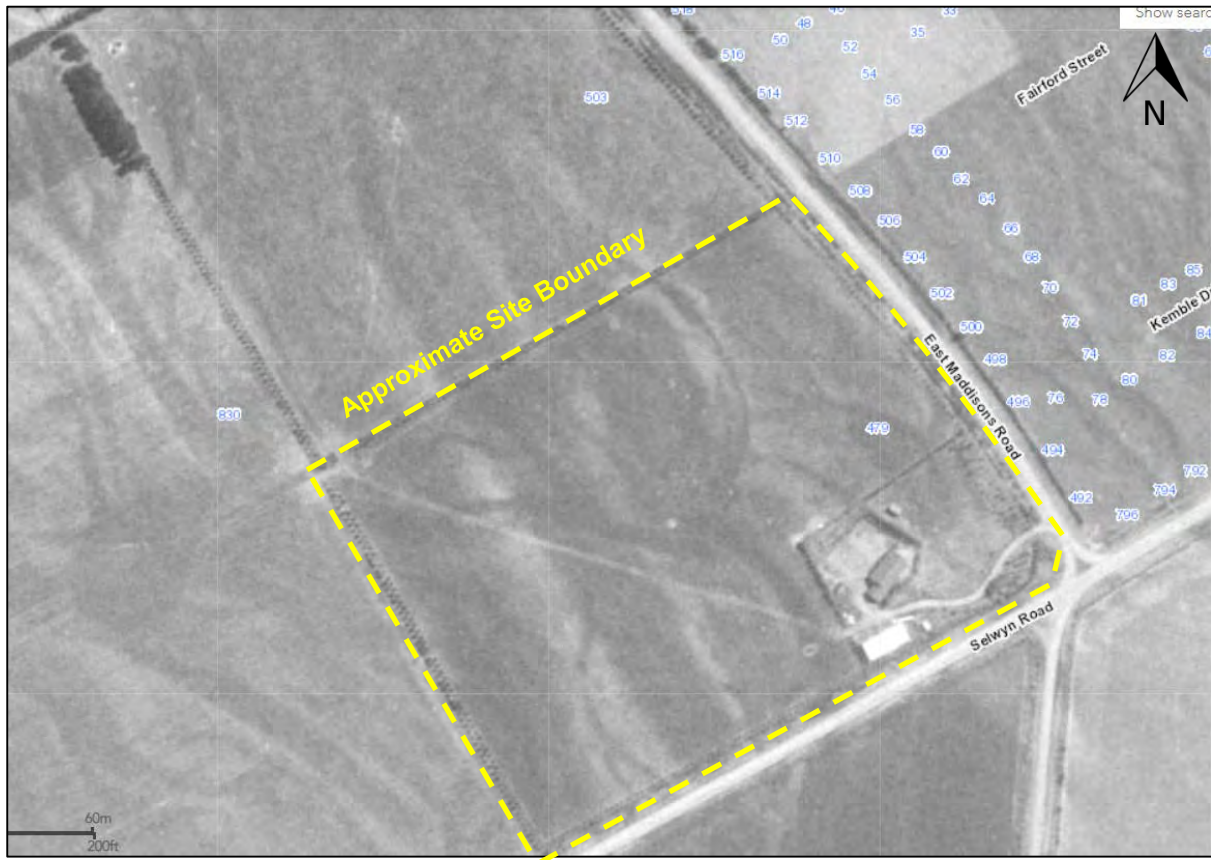
Figure 2: Historical Aerial Photography

The site comprises relatively flat ground, with gentle undulations and depressions in some areas. As evident on aerial imagery (Canterbury Maps, 2019) and observed during our site walkover conducted on 6 May 2019, undulating and depressed ground can be attributed to paleo-channels, which traverse the site in a general northwest to southeast trend. Based on observations, silt and sand deposits with variable thickness (up to 0.6 m) are expected to have in-filled the paleo-channels where they have not remained as channel features. Inferred paleo-channels have been mapped to give an indication of areas with potential channel in-fill (Appendix 1).

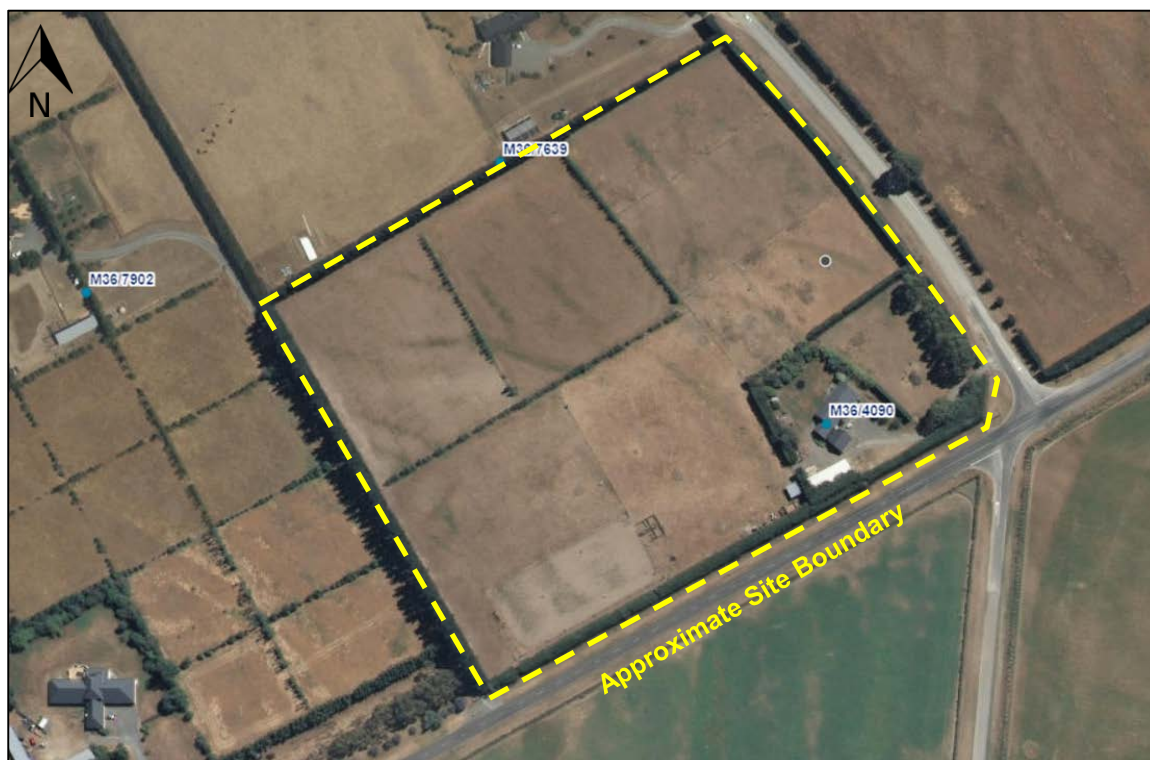
Figure 3: Nearby ECAN Borehole Locations

A review of three deep ECan borehole logs was conducted. The first (M36/4090), is located on site, and appears to be servicing the existing dwelling. The other boreholes are located on the north-western boundary (M36/7639), and approximately 90 m from the western corner boundary (M36/7902).

Well summaries from the three holes of interest are presented in Appendix 3 and indicate the site is broadly underlain by a mixture of alluvial gravels to depths of at least 36 m below ground level. M34/7639 recorded silt from 4 m to 10.5 m depth.

Groundwater is recorded in the surrounding boreholes between approximately 5.2 m and 8.4 m depth.

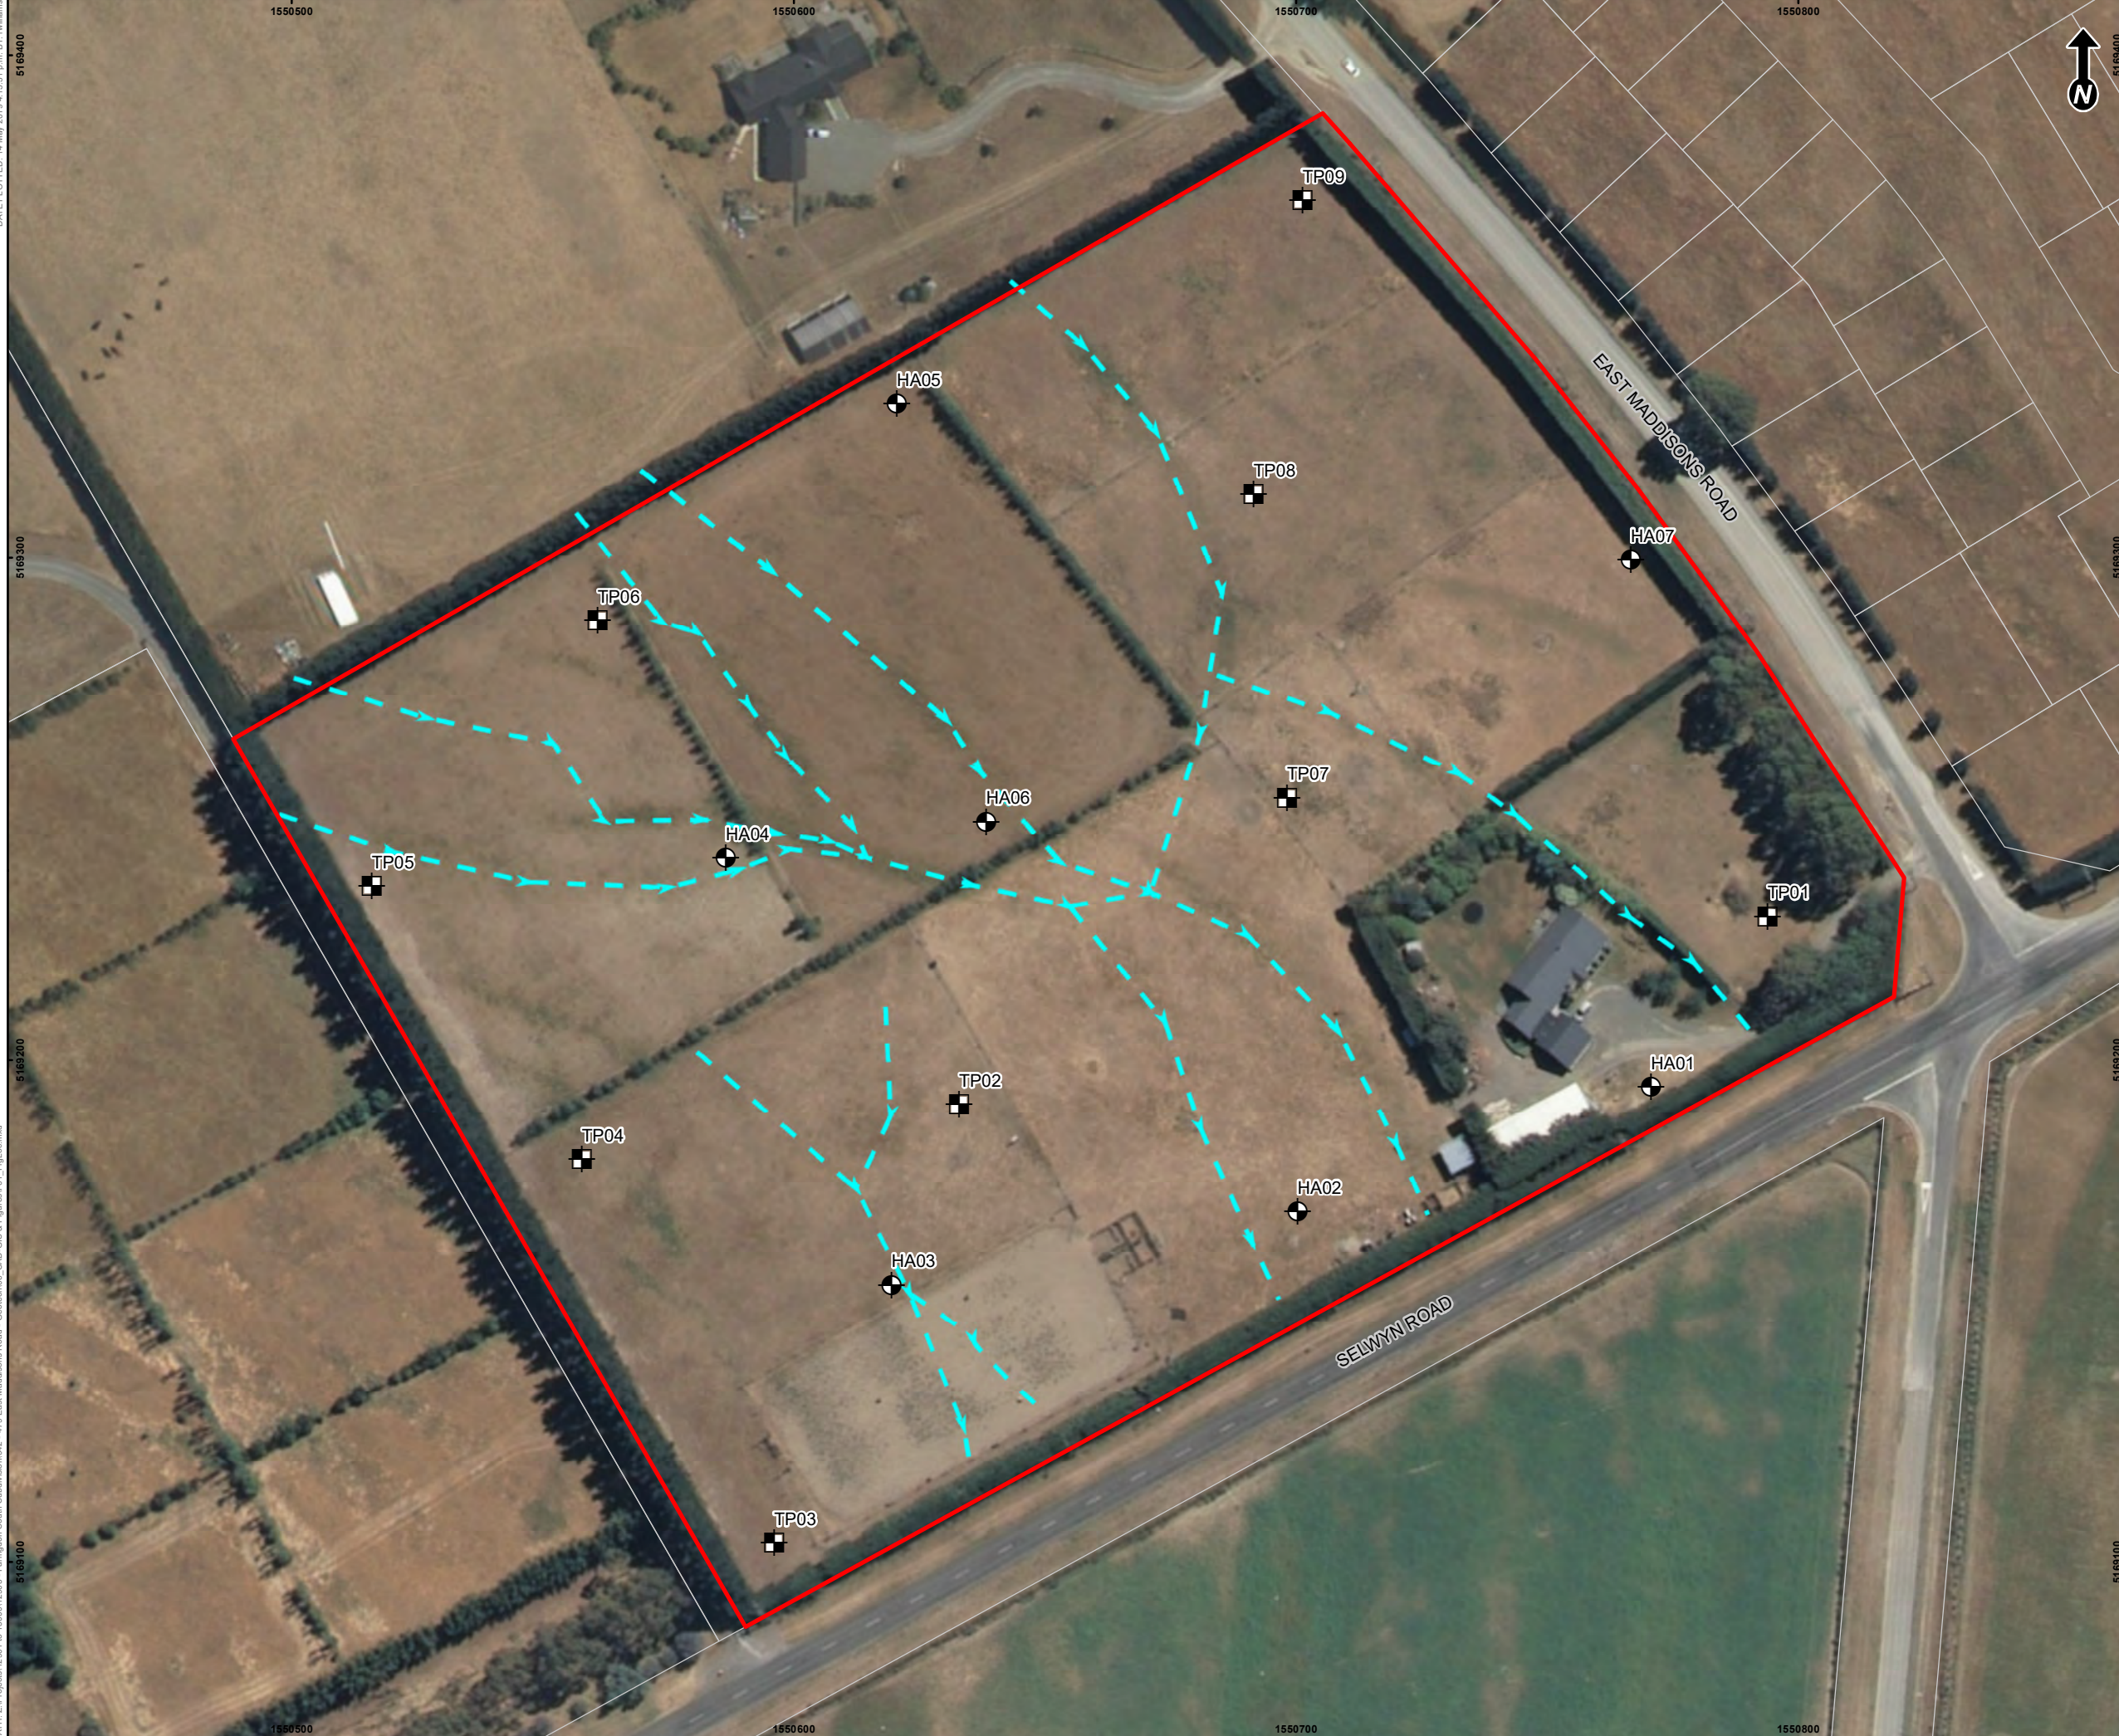
Title:
Site and testing location plan

Site investigations to assess the shallow subsurface material types and strength characteristics were undertaken by ENGEO on 7 and 9 May 2019. The investigations comprised seven hand auger boreholes and nine test pit investigations with associated Scala penetrometer tests.

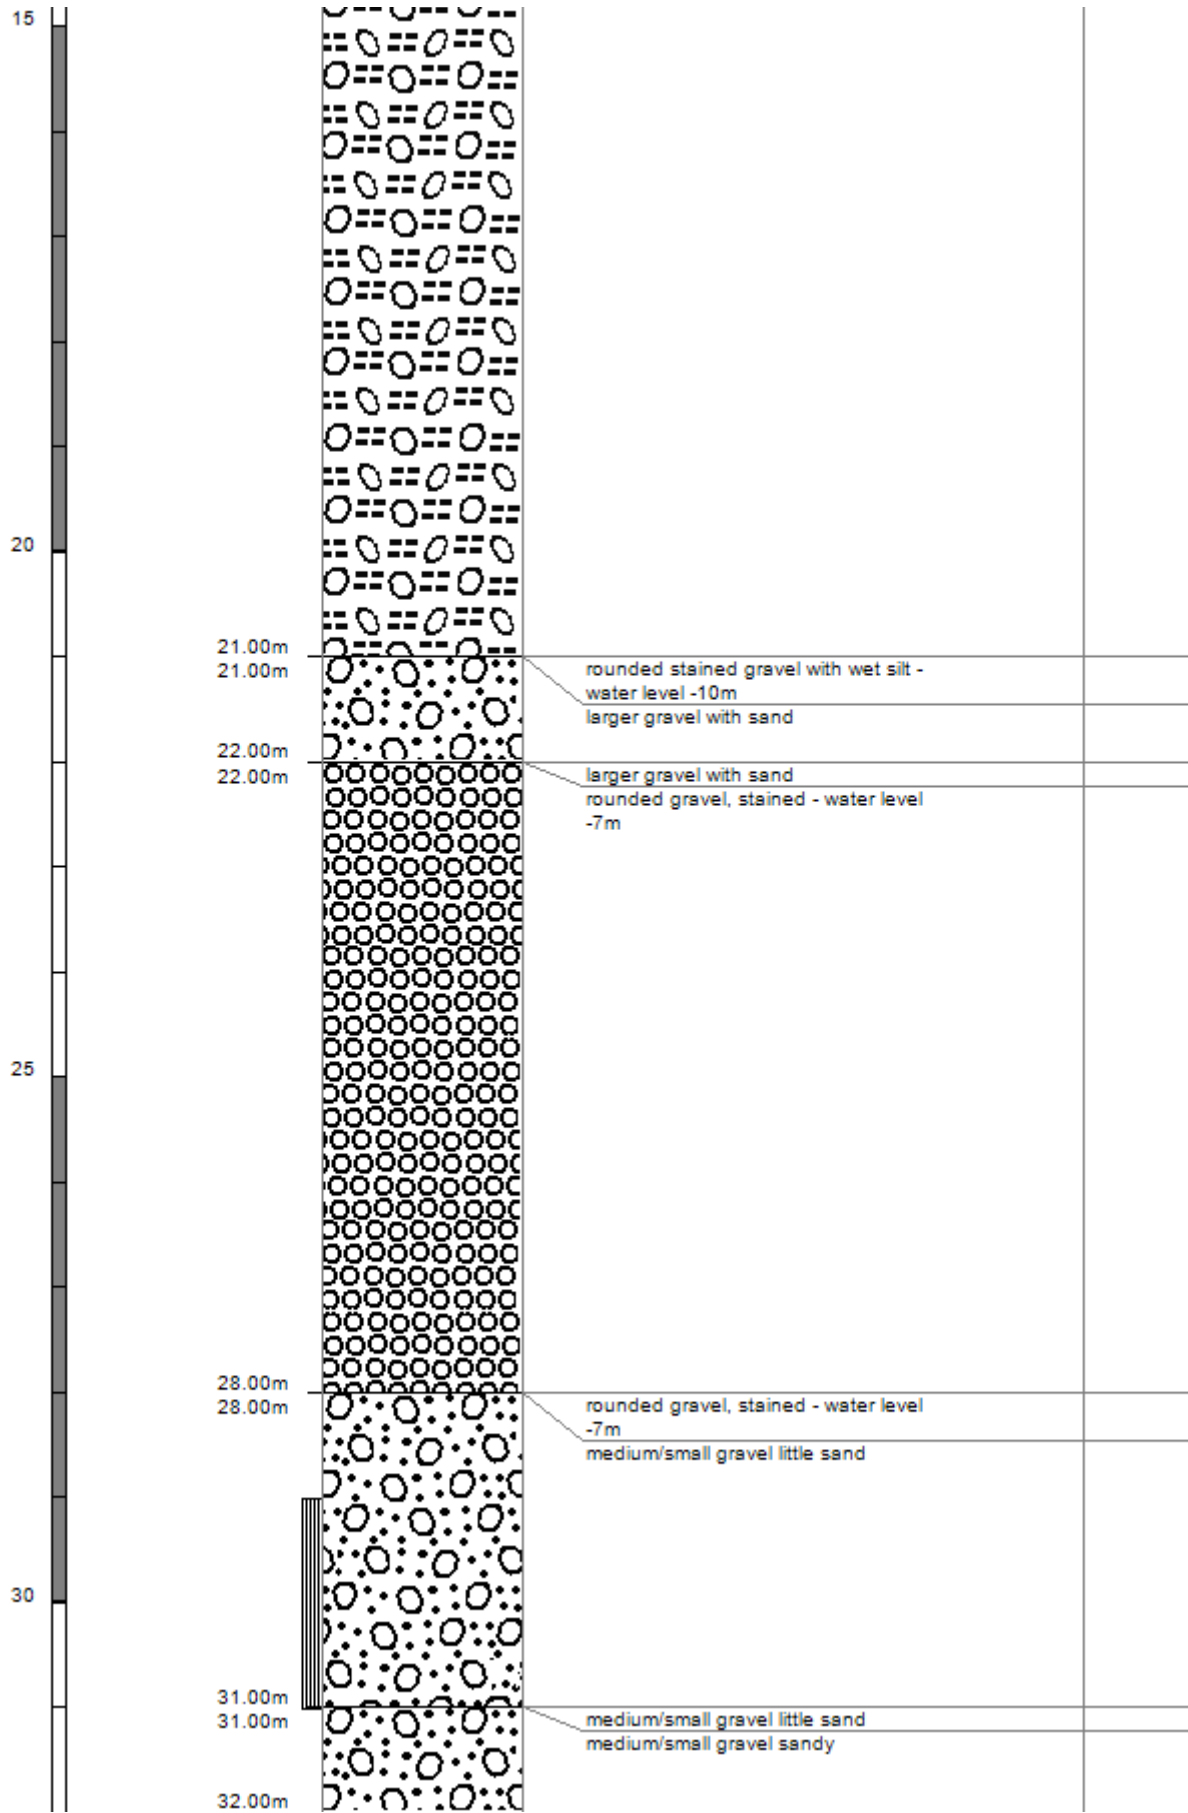
Borelog for well M36/7639

Grid Reference (NZTM): 1550598 mE, 5169331 mN
 Location Accuracy: 50 - 300m
 Ground Level Altitude: 34.3 m +MSD Accuracy: < 0.5 m
 Driller: Dynes Road Drilling
 Drill Method: Cable Tool
 Borelog Depth: 32.0 m Drill Date: 01-Jun-2004

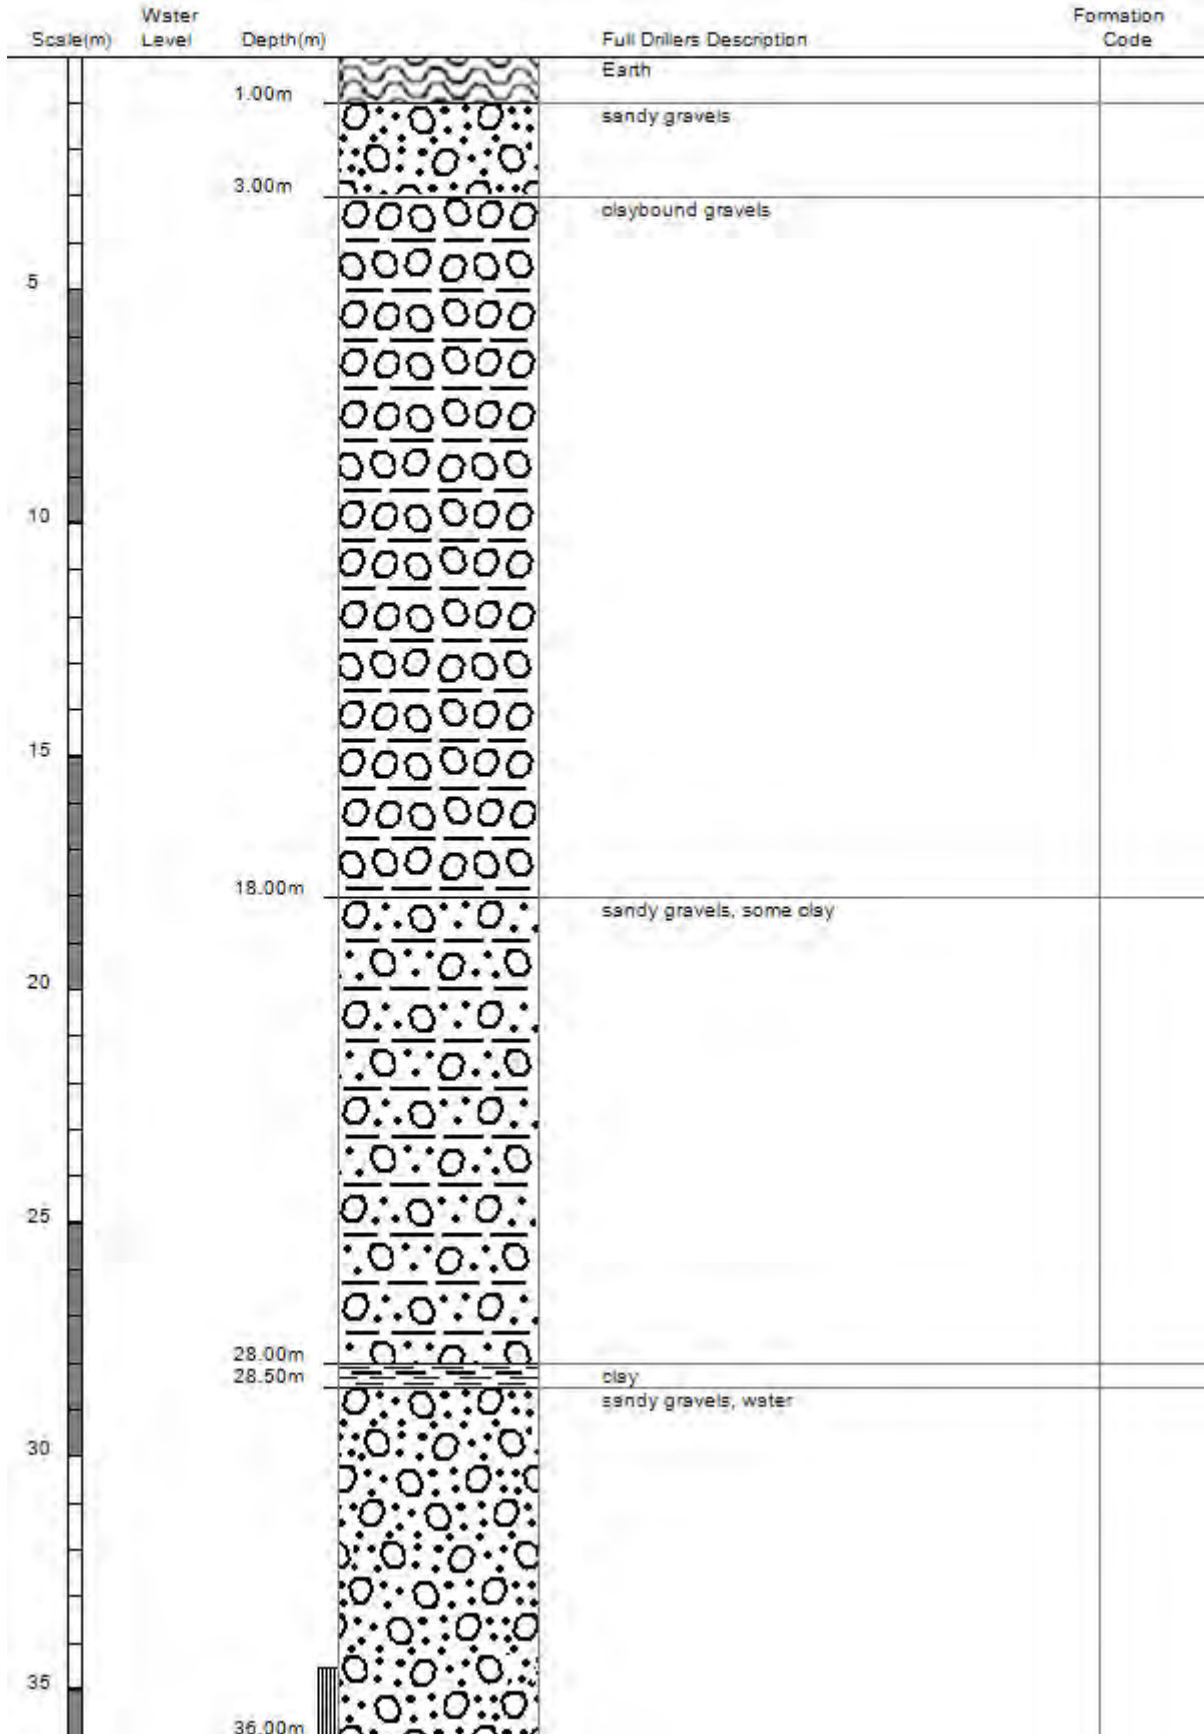
Borelog for well M36/7902

Grid Reference (NZTM): 1550408 mE, 5169271 mN
 Location Accuracy: 10 - 50m
 Ground Level Altitude: 34.7 m +MSD Accuracy: < 2.5 m
 Driller: East Coast Drilling
 Drill Method: Rotary Rig
 Borelog Depth: 36.0 m Drill Date: 09-Aug-2005
