Geotechnical Investigation

830 Selwyn Road

Springston

Hughes Developments Ltd.

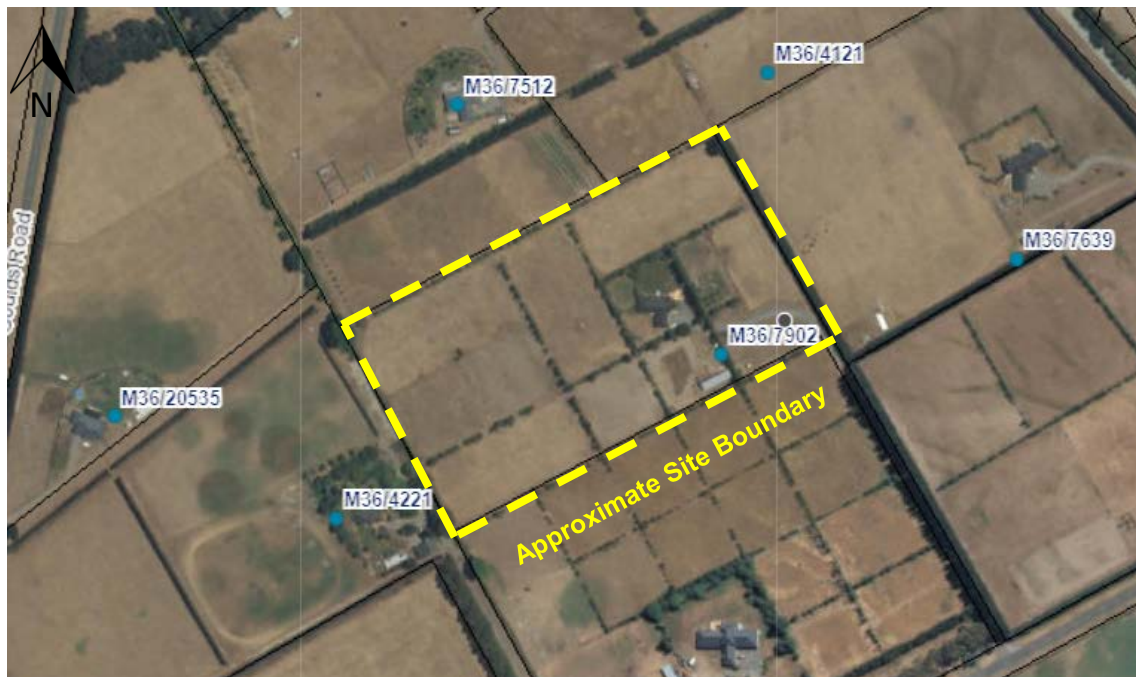
Figure 2: Nearby ECAN Borehole Locations

The locations of these boreholes are indicated in Figure 2, including the well points that have no log data available. The logs from the three holes of interest are presented in Appendix 3 and indicate the site is broadly underlain by a mixture of sandy gravels to depths of at least 36 m below ground level.

A review of three deep ECAN borehole logs was conducted. The first (M36/7902), is located on-site, towards the eastern corner of the property. The second and third ECAN boreholes are located 170 m to the north (M36/7512), and 80 m to the southwest (M36/4221).

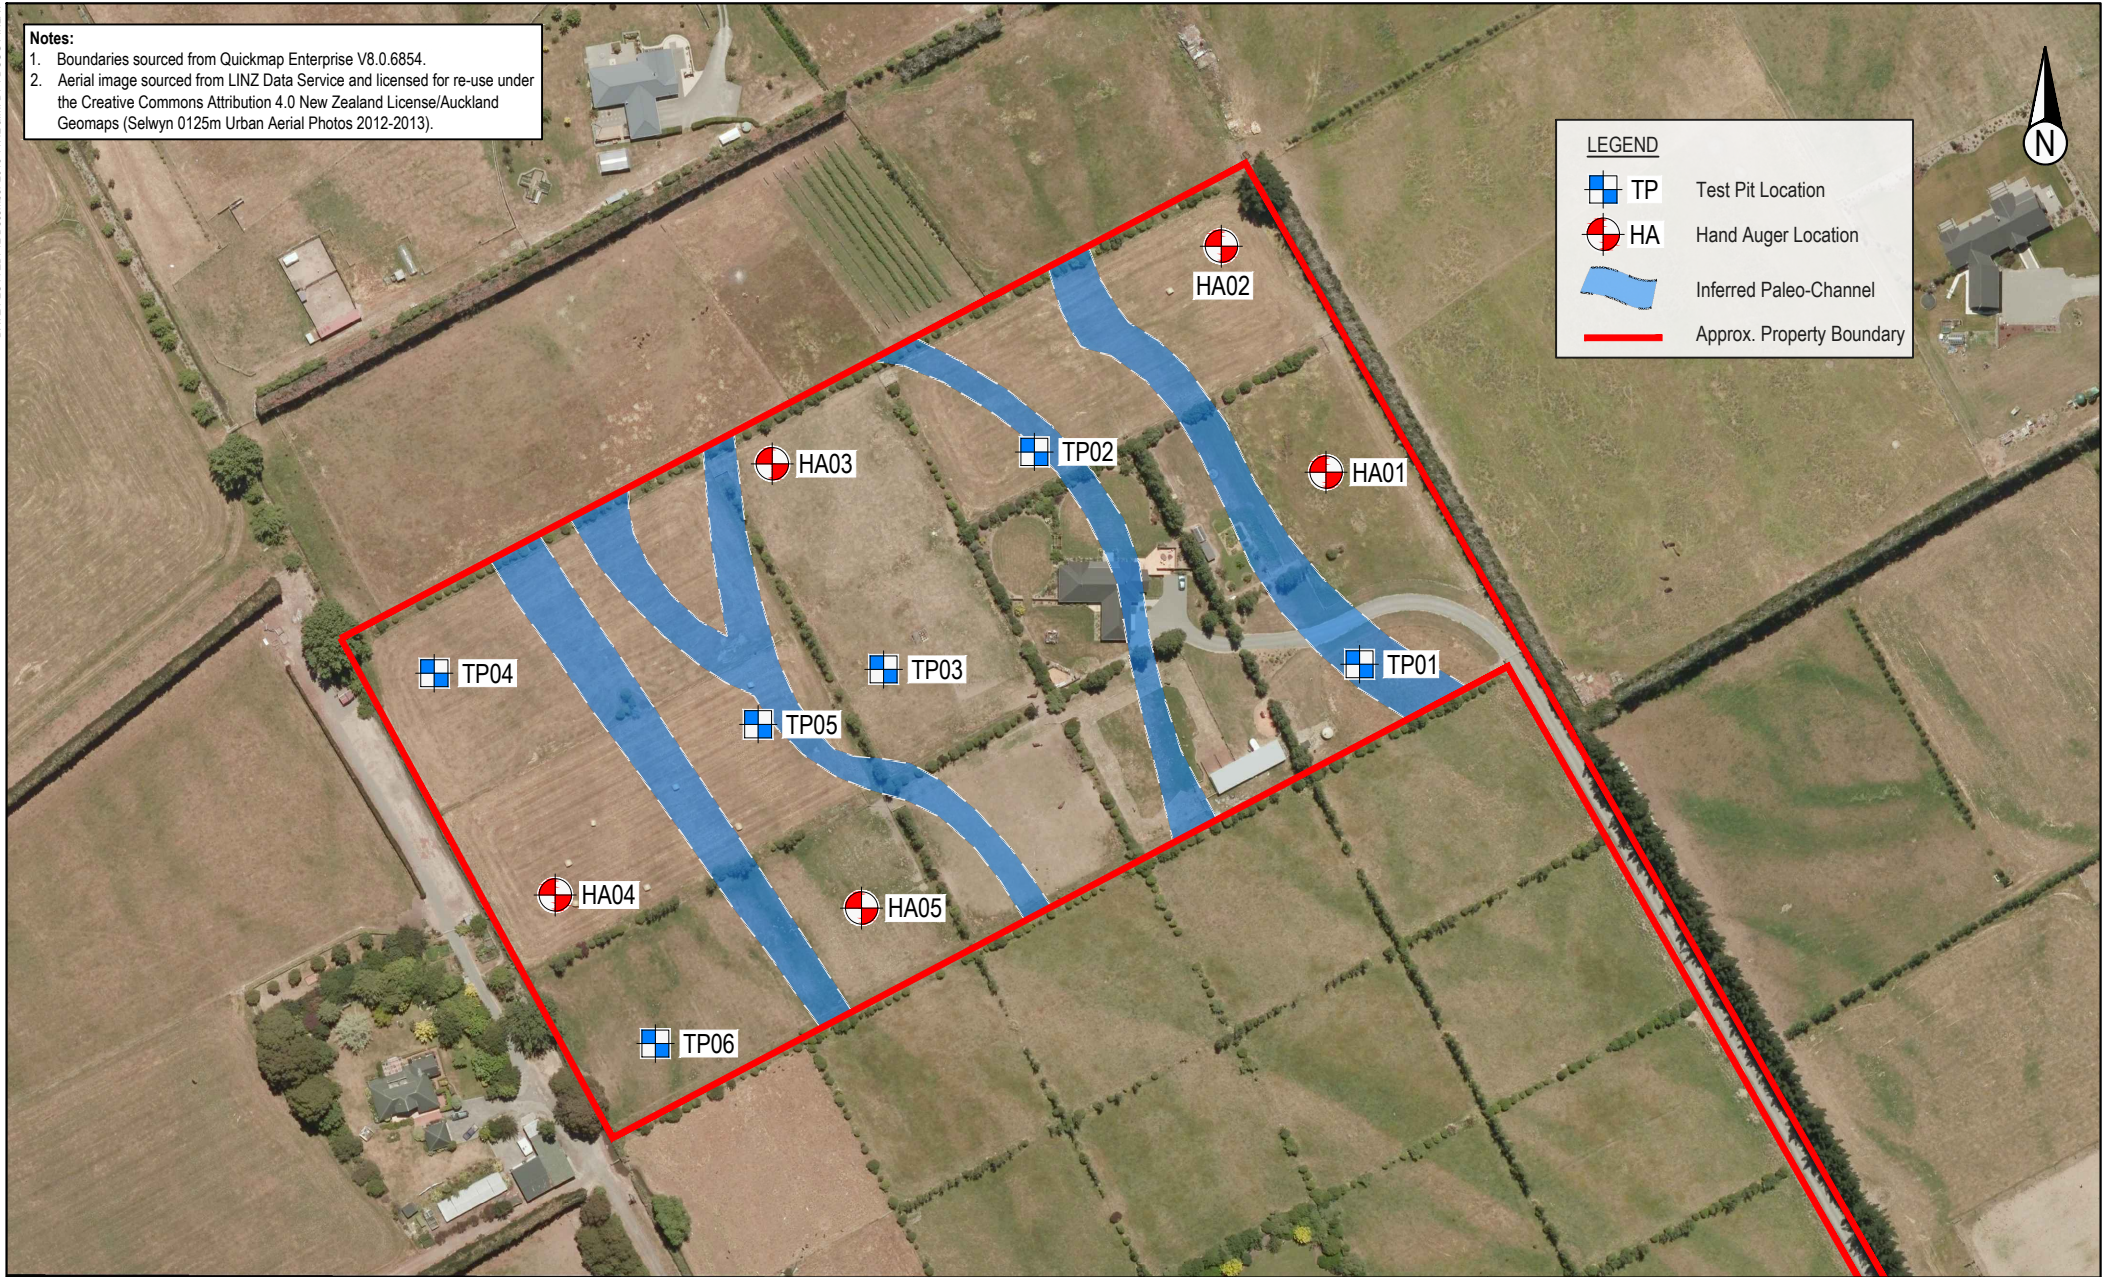
PALEO CHANNELS & TEST LOCATION PLAN

The site comprises relatively flat ground, with gentle undulations and depressions in some areas. As evident on aerial imagery (Canterbury Maps, 2018) and observed during our site walkover conducted on 28 November 2018, undulating and depressed ground can be attributed to paleo-channels, which traverse the site in a general northwest to southeast trend. Based on observations, silt and sand deposits with variable thickness (up to 0.4 m) are expected to have in-filled the paleo-channels where they have not remained as channel features. Inferred paleo-channels have been mapped to give an indication of areas with potential channel in-fill (Appendix 1).

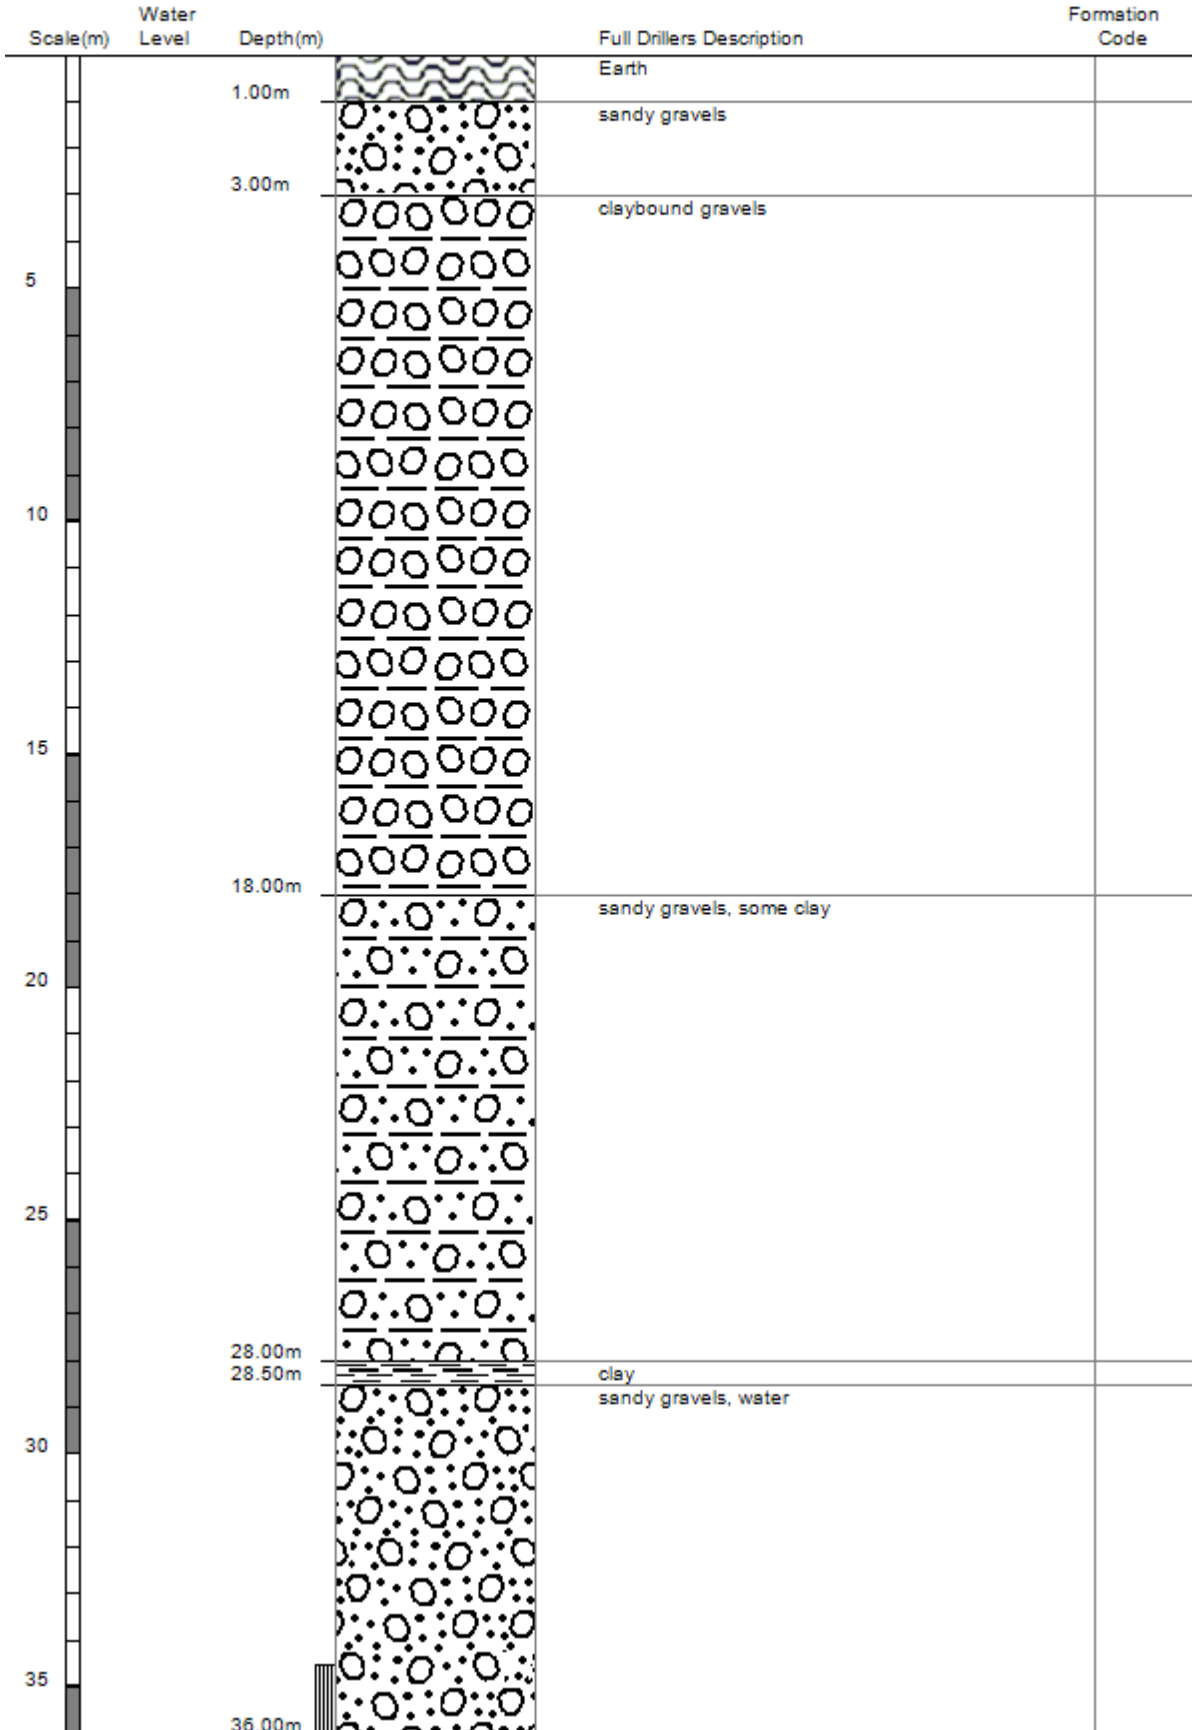
Borelog for well M36/7902

Grid Reference (NZTM): 1550408 mE, 5169271 mN
 Location Accuracy: 10 - 50m
 Ground Level Altitude: 34.7 m +MSD Accuracy: < 2.5 m
 Driller: East Coast Drilling
 Drill Method: Rotary Rig
 Borelog Depth: 36.0 m Drill Date: 09-Aug-2005
