Geotechnical Investigation

844 Selwyn Road

Springston

Hughes Developments Ltd

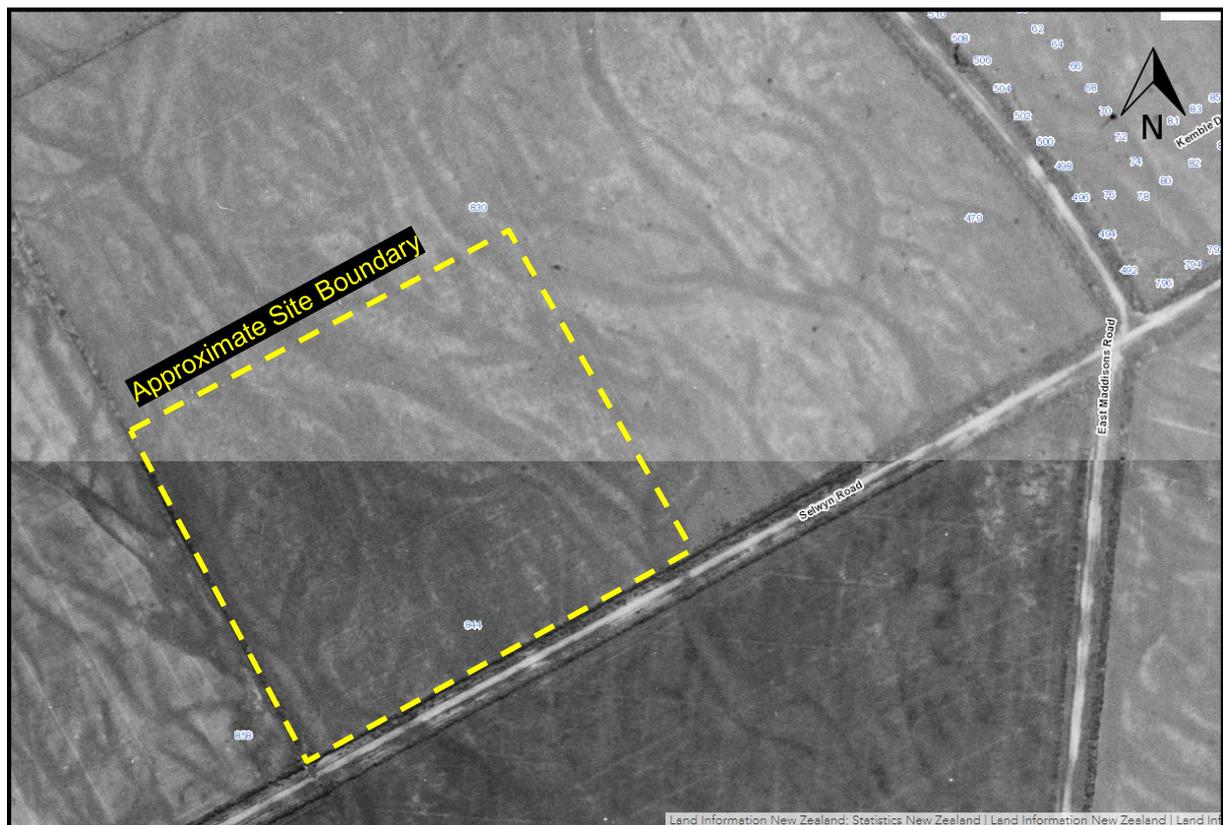
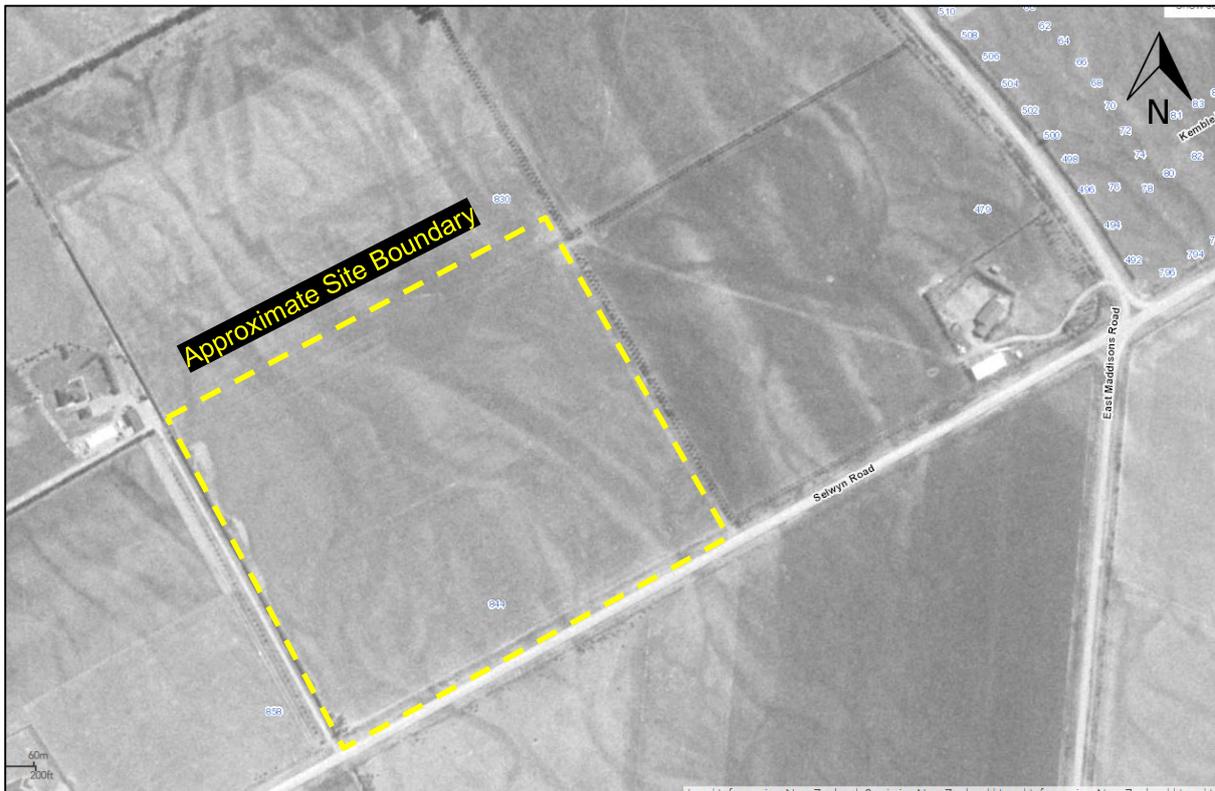
Figure 2: Historical Aerial Photography

The site comprises relatively flat ground, with gentle undulations and depressions in some areas. As evident on aerial imagery (Canterbury Maps, 2019) and observed during our site walkover conducted on 11 July 2019, undulating and depressed ground can be attributed to paleo-channels, which traverse the site in a general northwest to southeast trend. Based on observations, silt and sand deposits with variable thickness (up to 0.6 m) are expected to have in-filled the paleo-channels where they have not remained as channel features. Inferred paleo-channels have been mapped to give an indication of areas with potential channel in-fill (Appendix 1).

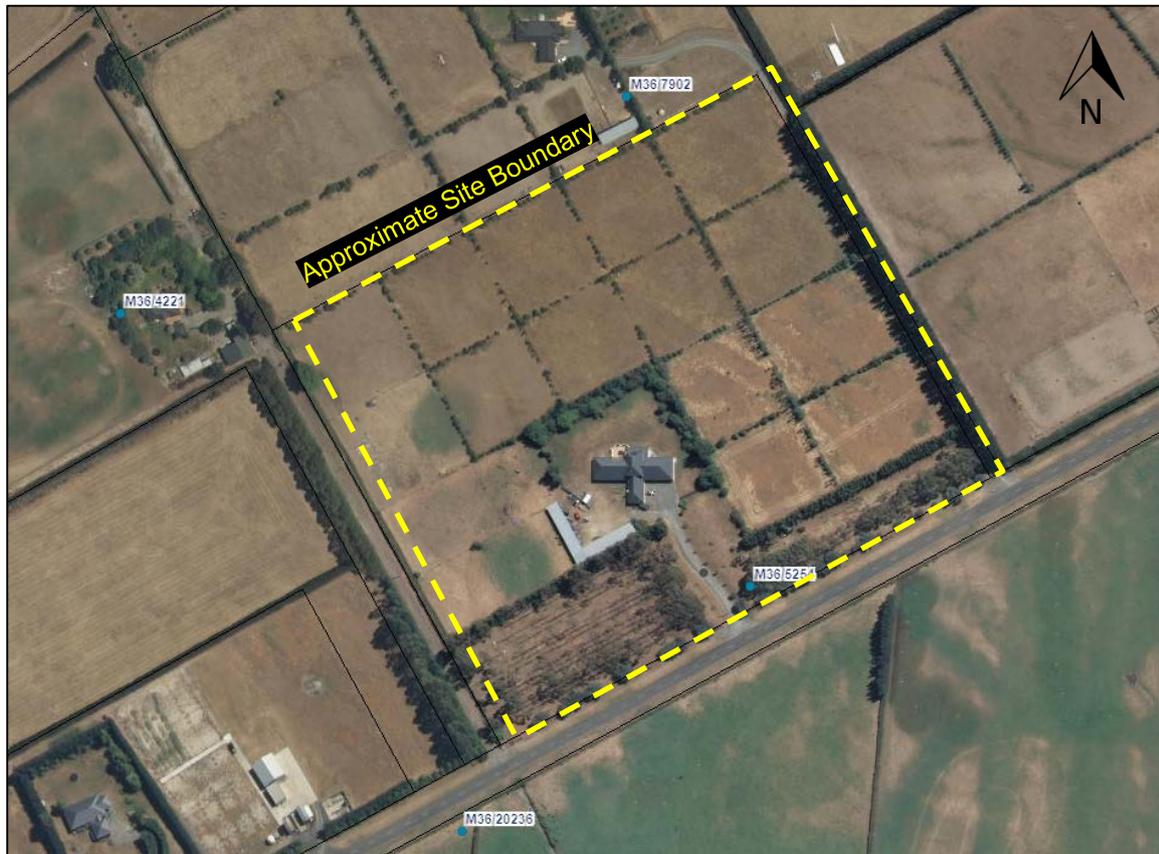
Figure 3: Nearby ECAN Borehole Locations

A review of three deep ECan borehole logs was conducted. The first (M36/5254), is located on site, and appears to be a water well servicing the existing dwelling. The other boreholes are located on the northern boundary (M36/7902) and western boundary (M36/4221). A borehole is located south of Selwyn Road (M36/20236) but has no borehole log associated with it on Canterbury Maps.

ECan Borehole	Total Depth (m)	Water Level (m)	Generalised borelog as logged by driller
M36/5254	36	6	Clay to 1 m depth underlain by gravel to 36 m depth.
M36/7902	36	8.4	Gravel from 1 m to 36 m depth.
M36/4221	21.44	6.6	Gravel from 0.5 m to 21.44 m depth with a layer of sand between 8 m and 9 m depth.

Groundwater is recorded in the surrounding boreholes between approximately 6 m and 8.4 m depth.

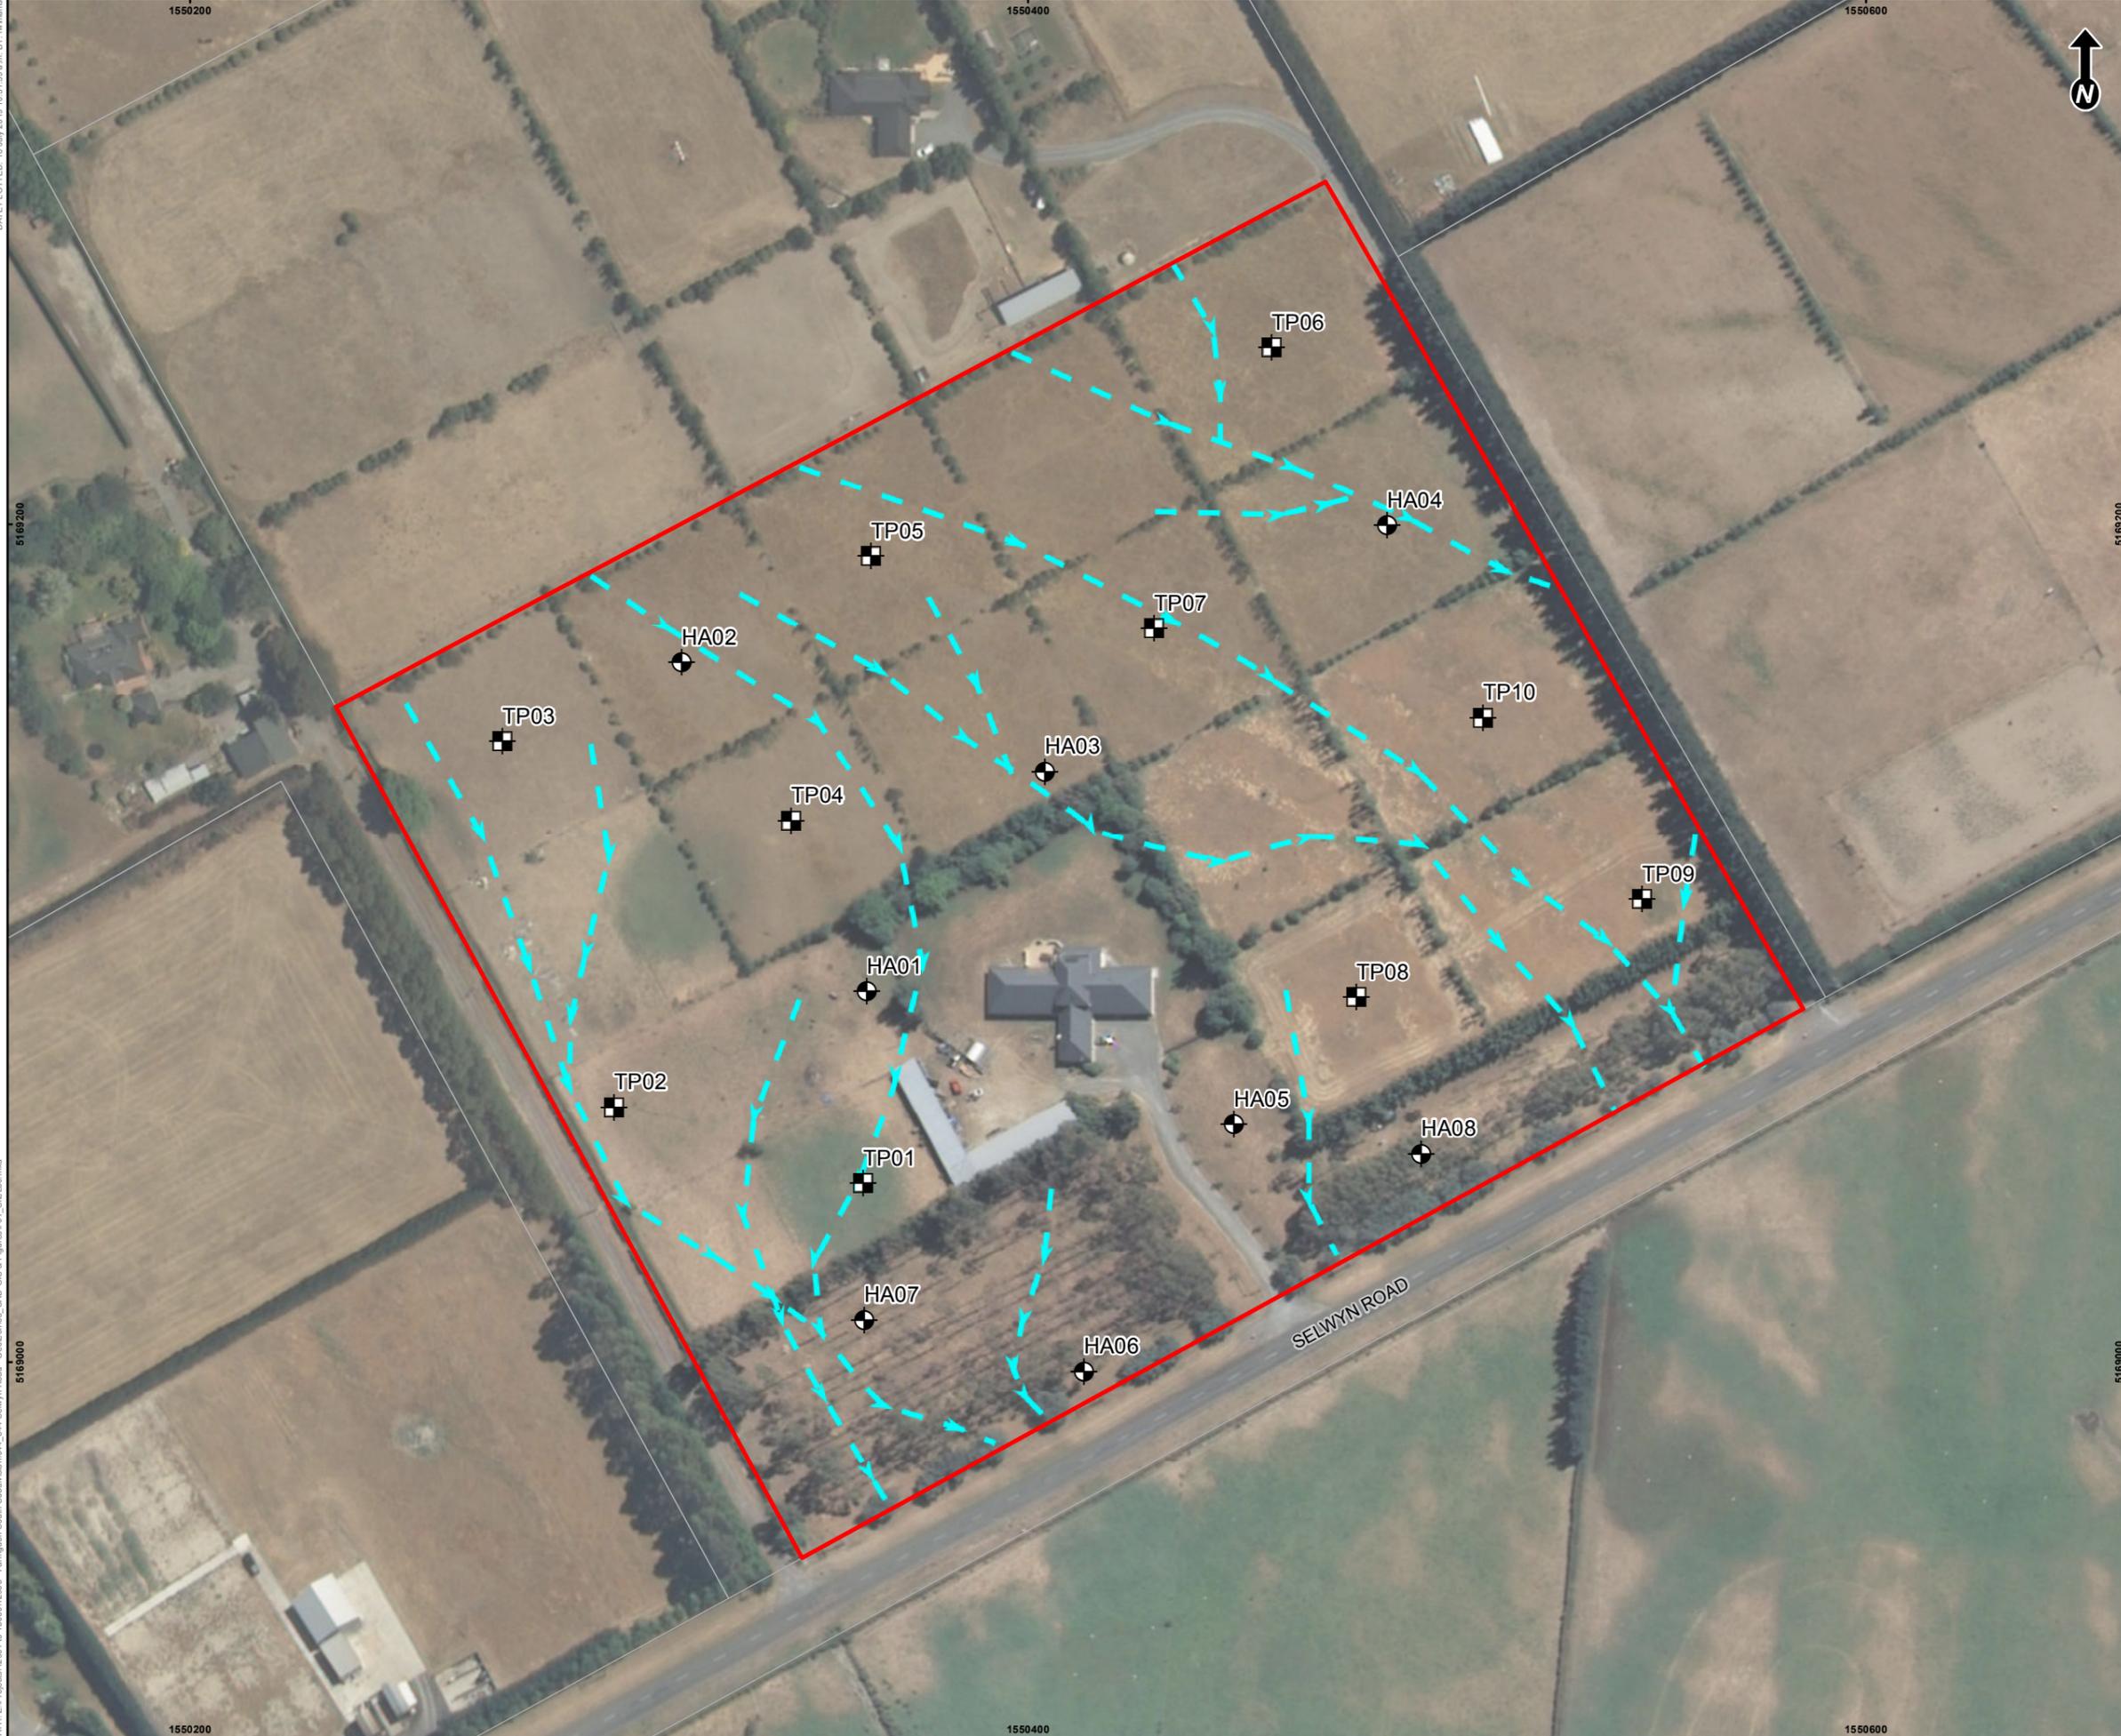
Title:
Site Location and Testing Plan

Site investigations to assess the shallow subsurface material types and strength characteristics were undertaken by ENGEO on 11 July 2019. The investigations comprised eight hand auger boreholes and ten test pit investigations with associated Scala penetrometer tests.

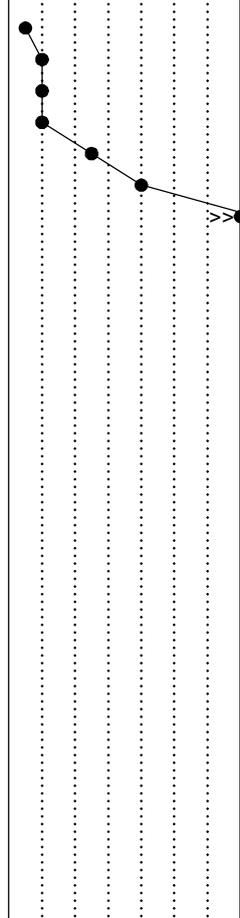
GEOTECH TEST PIT LOG - 844 SELWYN ROAD TEST PIT LOGS GP.J NZ MASTER DATA TEMPLATE.GDT - 17/7/19

Depth (m BGL)	Material	Excavability (Relative Scale)		USCS Symbol	DESCRIPTION	Graphic Symbol	Elevation (mRL)	Water Level	Moisture Cond.	Consistency/ Density Index	Shear Vane Peak/Remoulded (kPa)	Scala Penetrometer					
		Easier	Harder									Blows per 100mm					
	TS			ML	Sandy SILT with trace rootlets, and gravel; brown. Low plasticity [TOPSOIL].					S-F		2	4	6	8	10	12
0.5	ALLUVIUM			GW	Sandy fine to coarse GRAVEL; brownish grey. Well graded, sub-rounded to rounded. Sand, fine to medium.					MD-D							
1.0					Minor cobbles encountered from 1.0 m depth.				M								
2.3					Depth of Excavation: 2.3 m Termination Condition: Target depth

Test pit met target depth
TS = TOPSOIL
Standing groundwater was not encountered

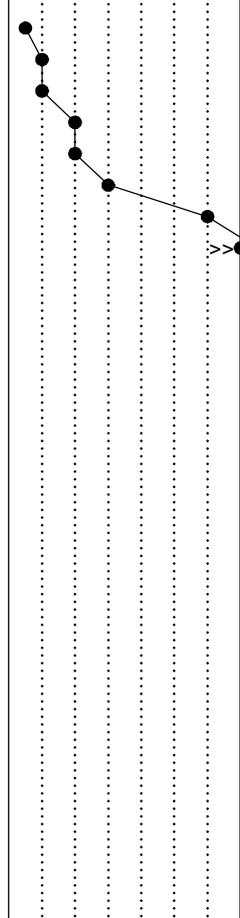
GEOTECH TEST PIT LOG - 844 SELWYN ROAD TEST PIT LOGS.GPJ - NZ MASTER DATA TEMPLATE.GDT - 17/7/19

Depth (m BGL)	Material	Excavatability (Relative Scale)		USCS Symbol	DESCRIPTION	Graphic Symbol	Elevation (mRL)	Water Level	Moisture Cond.	Consistency/ Density Index	Shear Vane Peak/Remoulded (kPa)	Scala Penetrometer					
		Easier	Harder									Blows per 100mm					
												2	4	6	8	10	12
0.0	TS			ML	Sandy SILT with trace rootlets, and gravel; brown. Low plasticity [TOPSOIL].					S-F							
0.5				SM	Silty fine to medium SAND; greyish brown. Poorly graded.					MD							
1.0	ALLUVIUM			GW	Sandy fine to coarse GRAVEL with some cobbles; brownish grey. Well graded, sub-rounded to rounded. Sand, fine to medium.				M	MD-D							
2.1	Depth of Excavation: 2.1 m Termination Condition: Target depth

Test pit met target depth
TS = TOPSOIL
Standing groundwater was not encountered

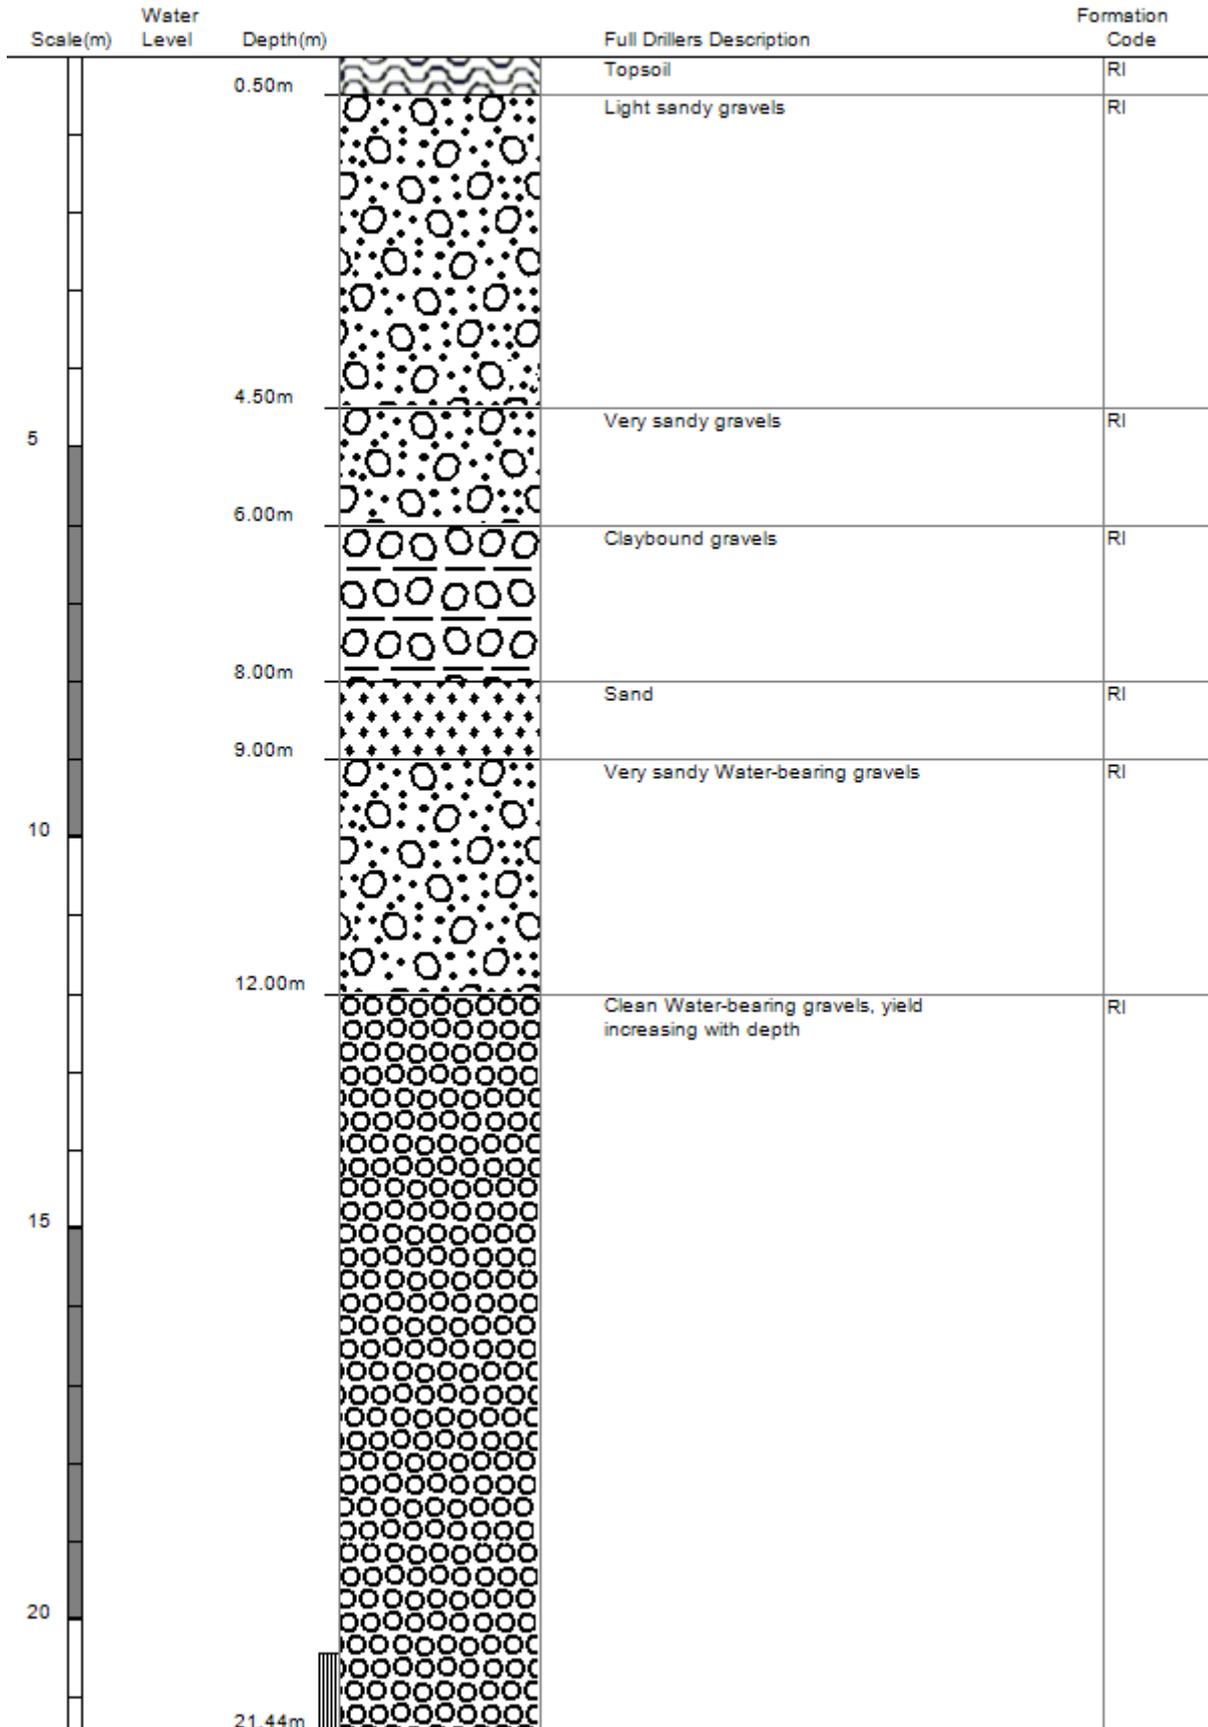
Borelog for well M36/4221

Grid Reference (NZTM): 1550161 mE, 5169165 mN
 Location Accuracy: 2 - 15m
 Ground Level Altitude: 35.5 m +MSD Accuracy: < 2.5 m
 Driller: Weedons WellDrilling
 Drill Method: Rotary/Percussion
 Borelog Depth: 21.4 m Drill Date: 04-Feb-1991
