Geotechnical Investigation

870 Selwyn Road
Springston

21.01.2021
12903.000.008_01

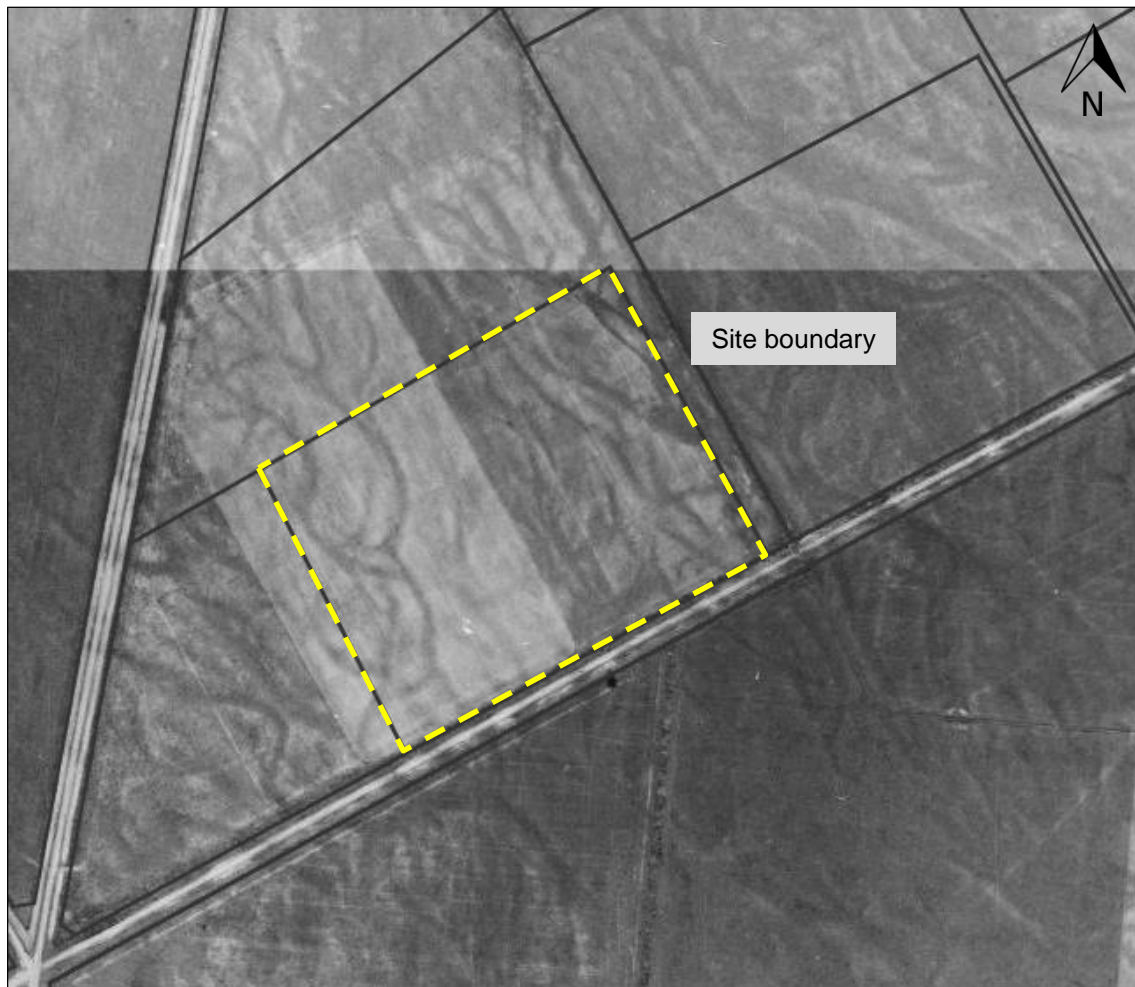
Figure 2: Historical Aerial Photo – 1940 - 1944

The site comprises relatively flat ground, with gentle undulations and depressions in some areas. As evident on aerial imagery (Canterbury Maps, 2019) and observed during our site walkover conducted on 11 January 2021, undulating and depressed ground can be attributed to paleo-channels, which traverse the site in a general northwest to southeast direction (Figure 2). Based on observations, sandy silt deposits with variable thickness are expected to have in-filled the paleo-channels where they have not remained as channel features. Inferred paleo-channels have been mapped to give an indication of areas with potential channel in-fill (Appendix 1).

Image sourced from Canterbury Maps. Not to scale.

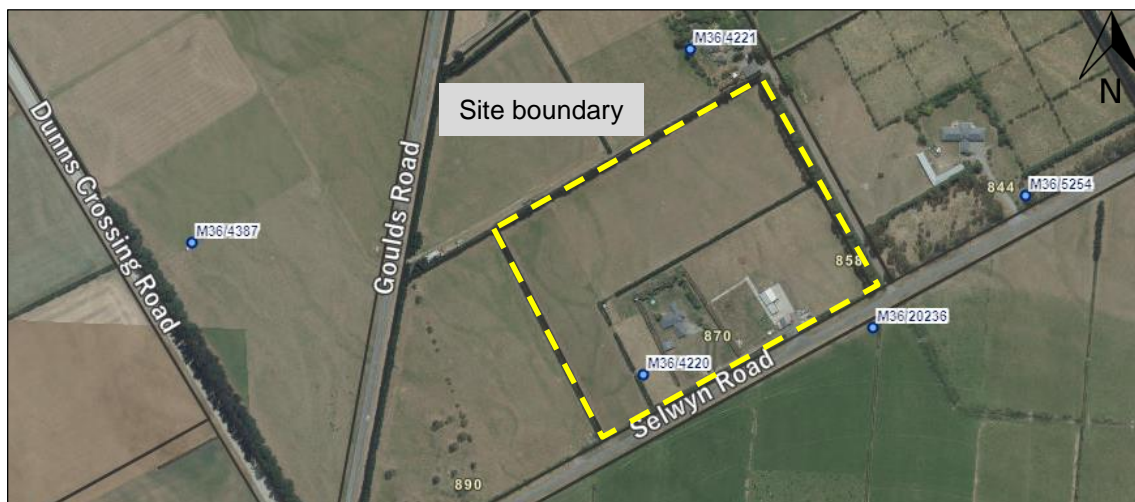
Figure 3: Nearby ECan Borehole Locations

A review of five, deep ECan borehole logs was conducted. The first (M36/4220), is located on-site, and appears to be a water well providing the properties irrigation and domestic supply. The other boreholes are located to the east (M36/5254), north (M36/4221) and west (M36/4387) of the site.

Aerial photograph sourced from Canterbury Maps. Not to scale.

Well logs from the four holes of interest are attached as Appendix 3 and summarised in Table 2.

ECan Borehole	Total Depth (m)	Water Level Below Ground Level (m)	Location relative to the site	Generalised Borelog as Logged by Driller
M36/4220	21.3	5.8	On-site, near the south-western boundary	0.5 m of topsoil underlain by sandy and claybound gravels to 21.3 m depth.
M36/4221	21.44	6.6	50 m north	0.5 m of topsoil underlain by sandy and claybound gravels to 21.44 m depth. Layer of sand recorded from 8.0 to 9.0 m depth.
M36/4387	35.59	5.56	300 m west	0.3 m of topsoil underlain by sandy and claybound gravels to 35.59 m depth.
M36/5254	36.0	6.0	150 m east	0.3 m of topsoil underlain by a layer of clay to 1 m depth. Sandy and claybound gravels continue to 36.0 m depth.

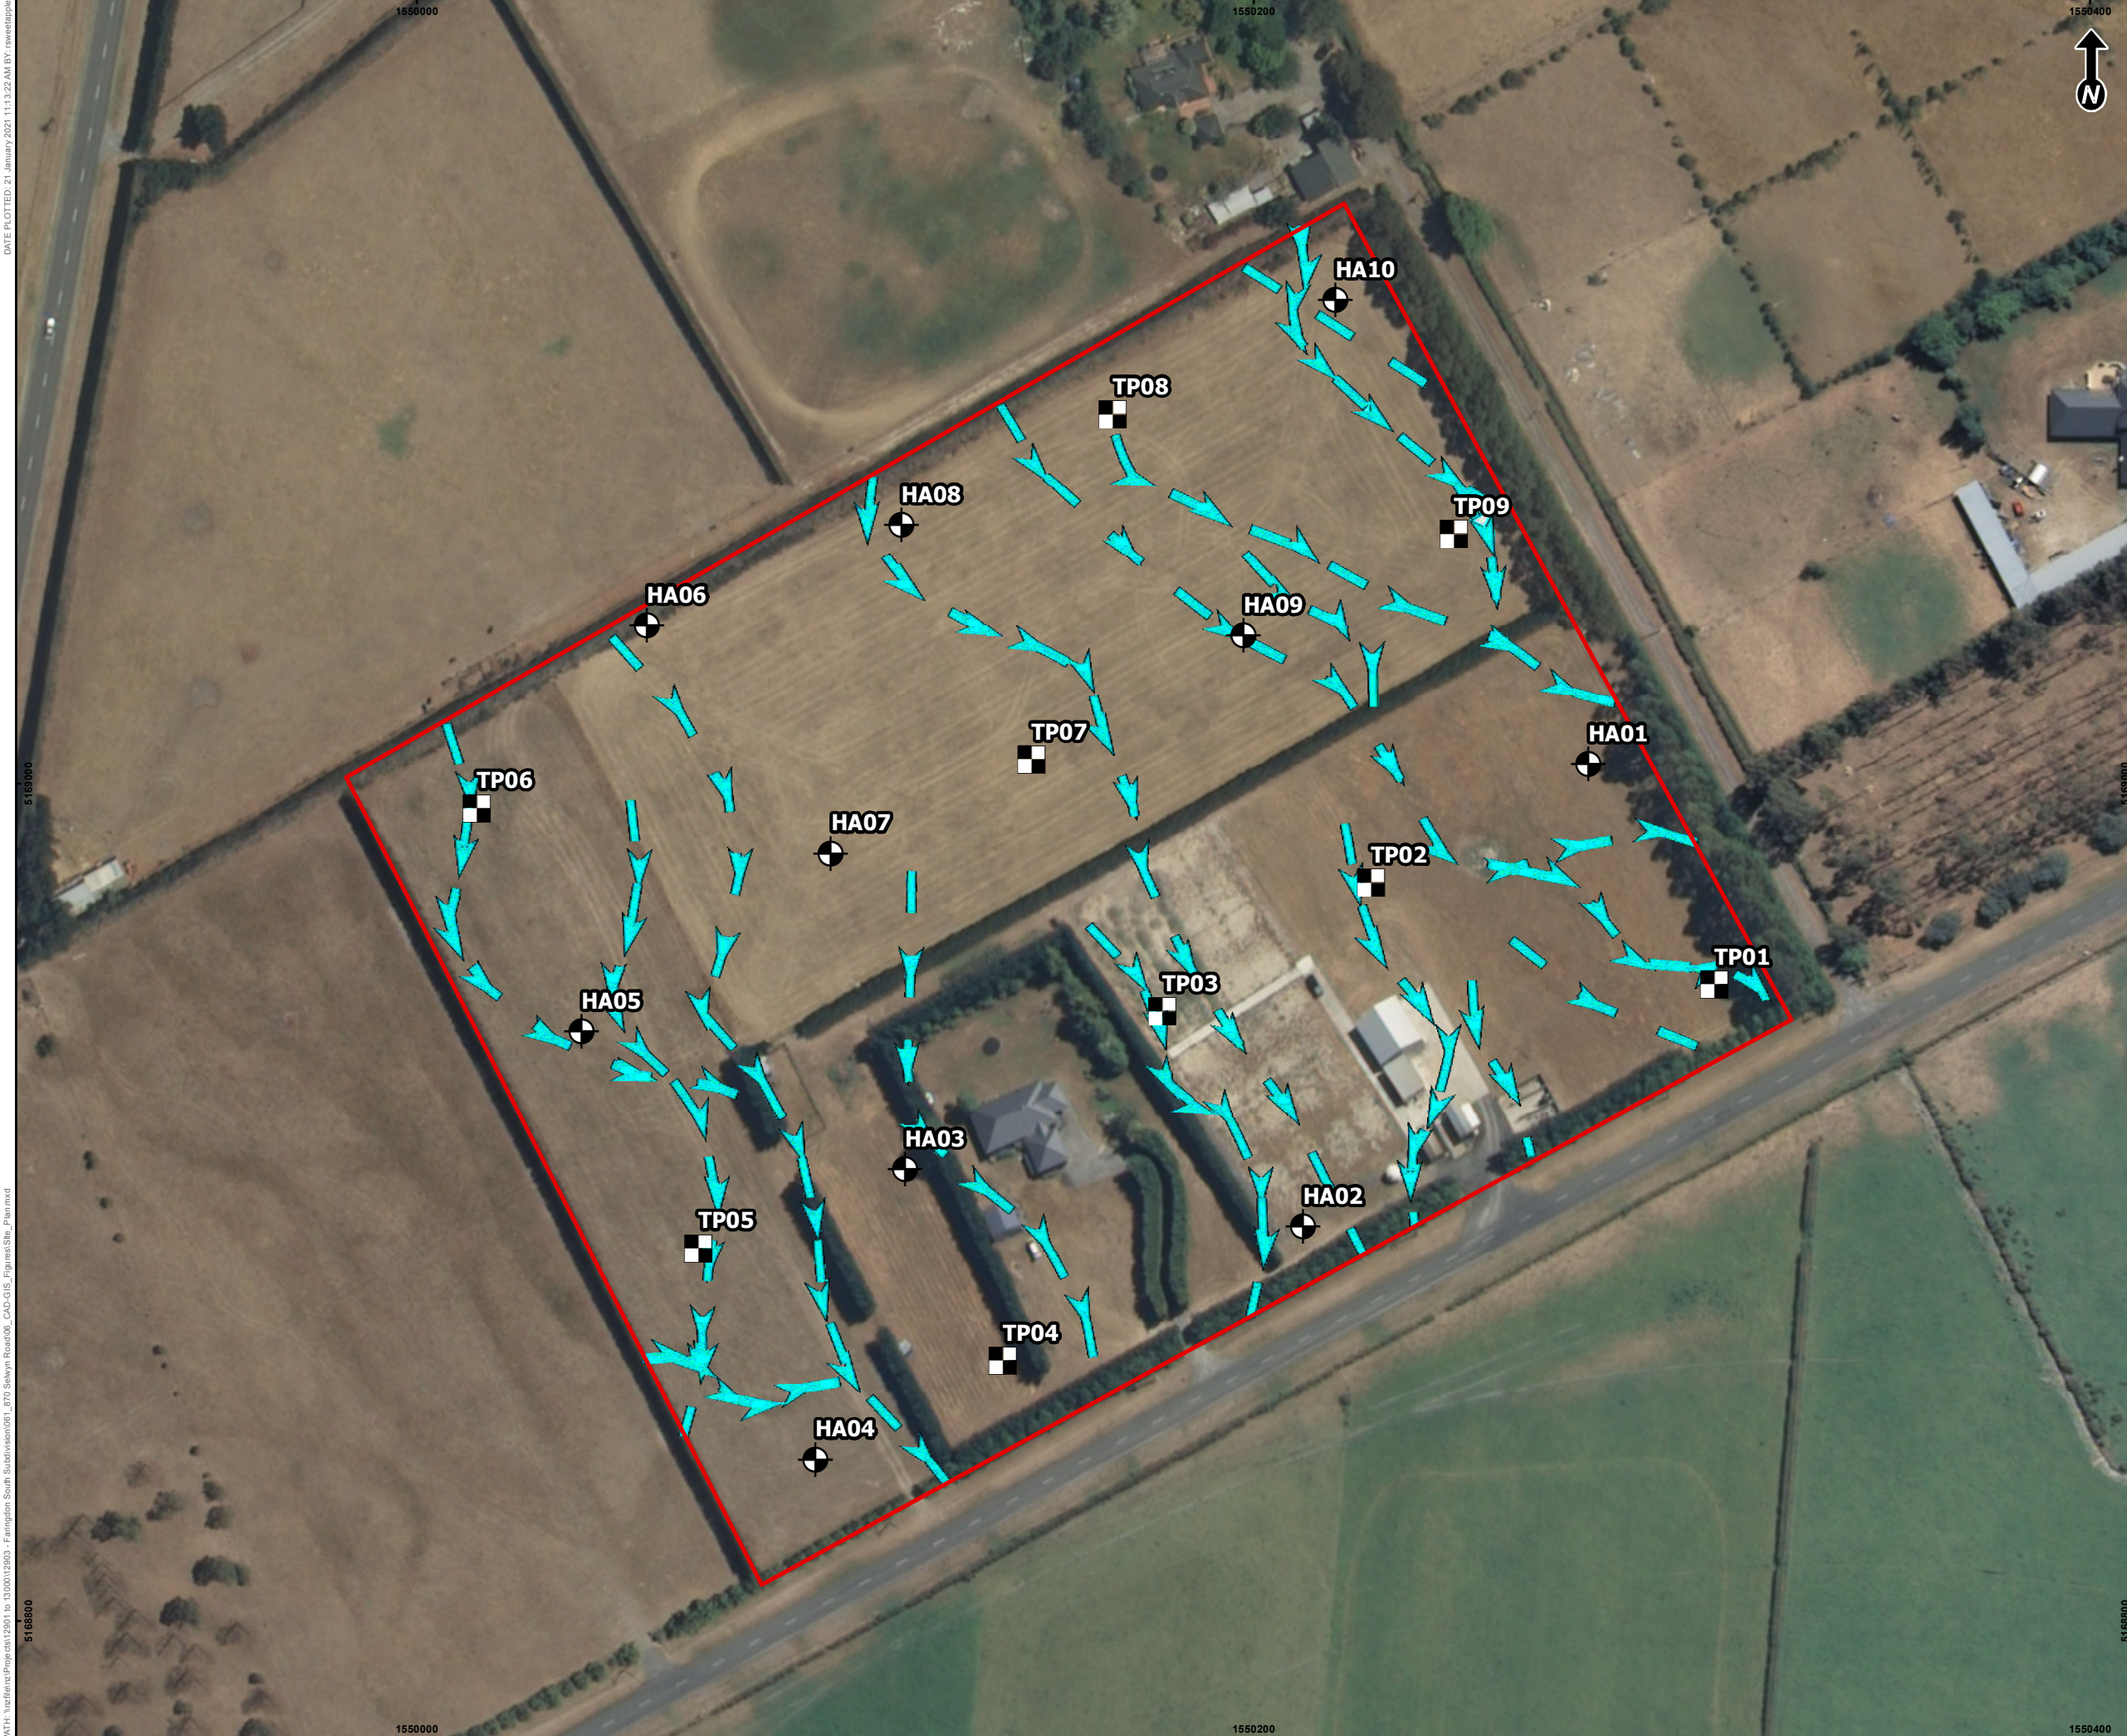
APPENDIX 1: Paleo Channels

- Site Boundary
- Hand Auger Locations
- Test Pit Locations
- Flow paths

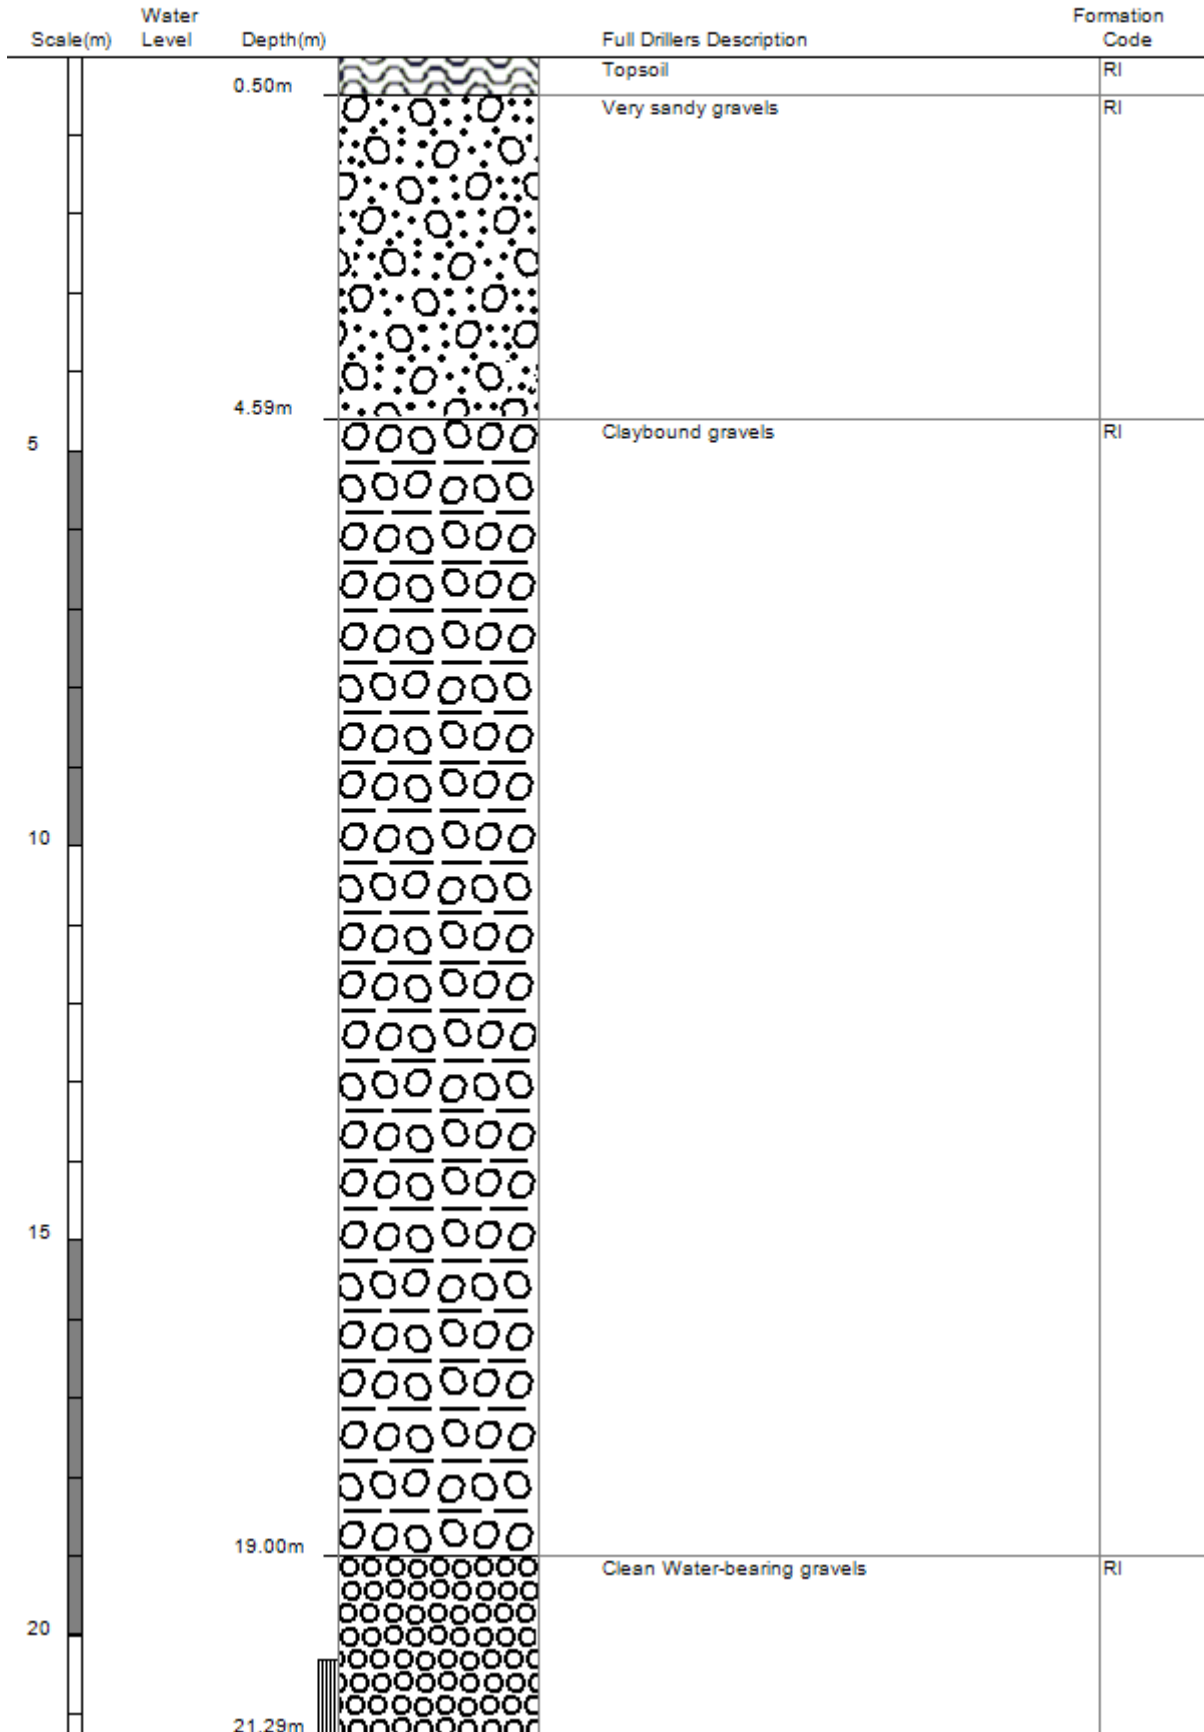
Borelog for well M36/4220

Grid Reference (NZTM): 1550118 mE, 5168868 mN
 Location Accuracy: 2 - 15m
 Ground Level Altitude: 34.3 m +MSD Accuracy: < 2.5 m
 Driller: Weedons WellDrilling
 Drill Method: Rotary/Percussion
 Borelog Depth: 21.3 m Drill Date: 05-Feb-1991

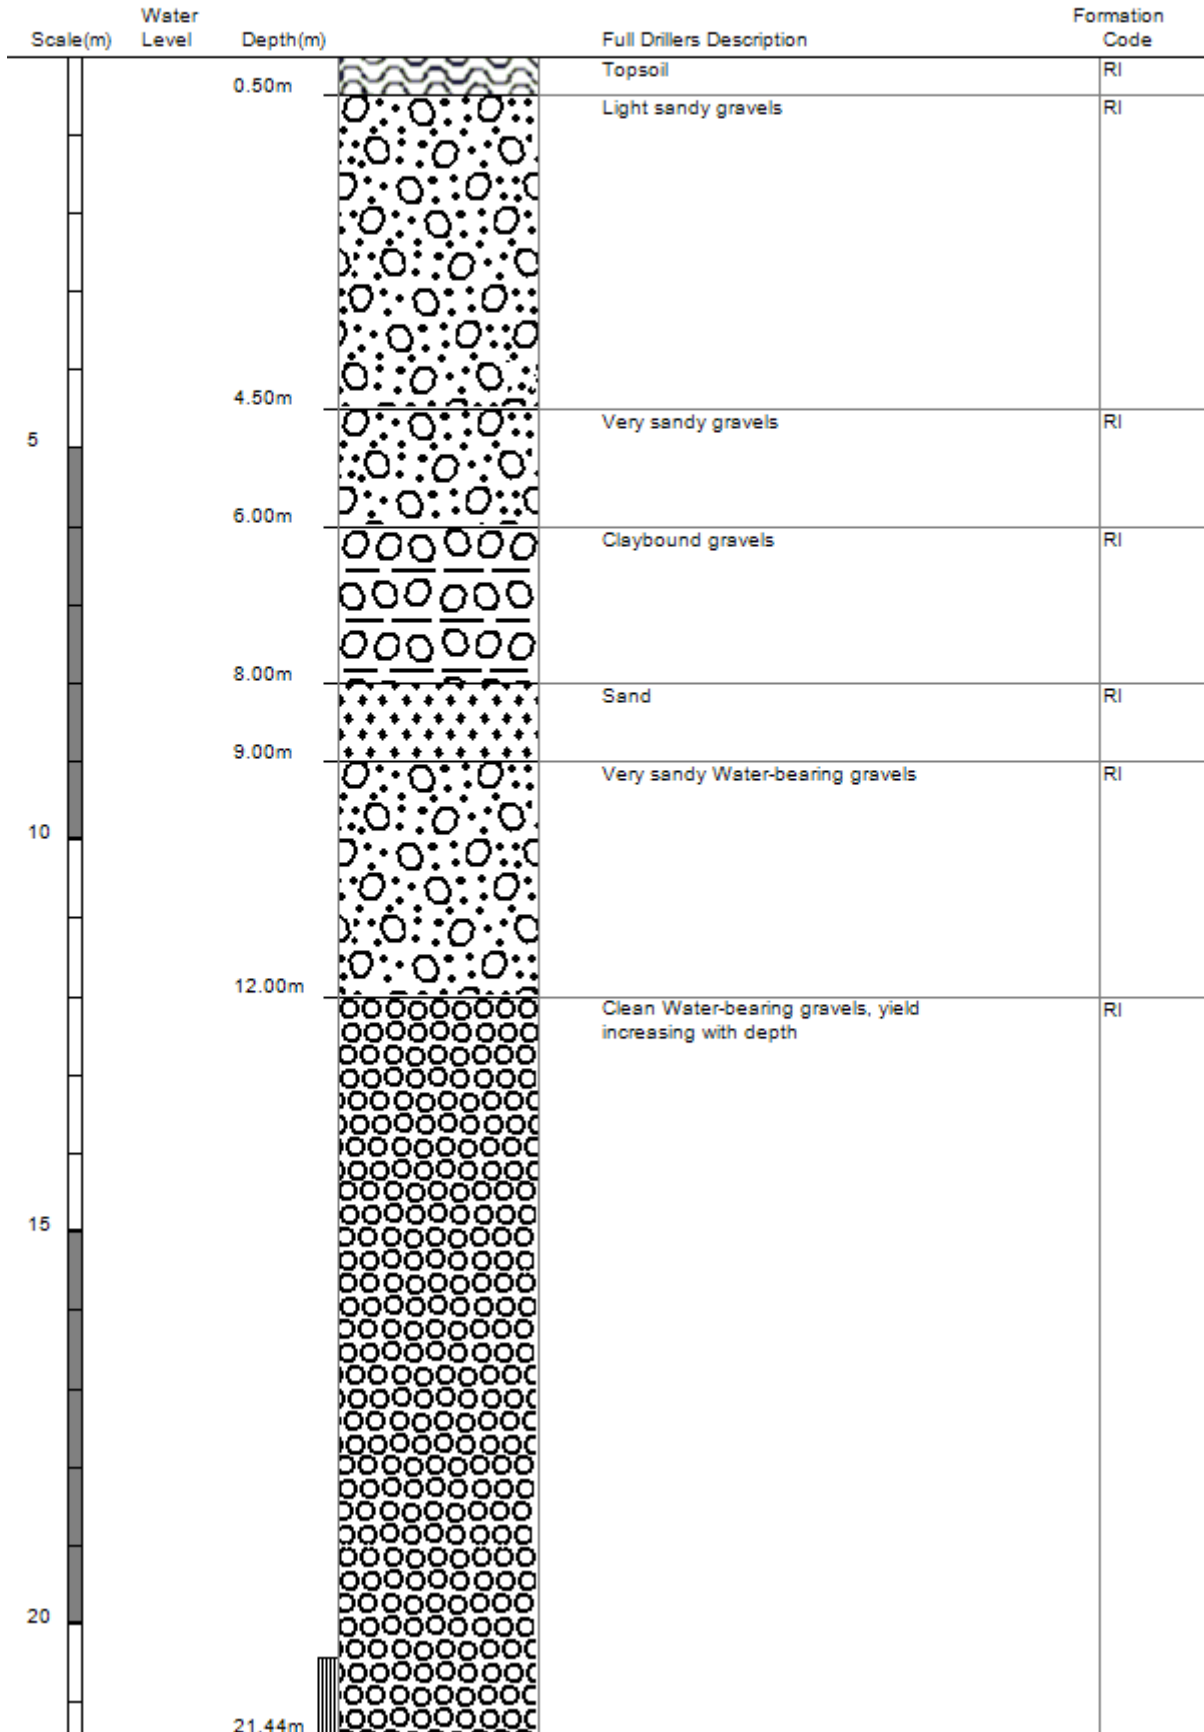
Borelog for well M36/4221

Grid Reference (NZTM): 1550161 mE, 5169165 mN
 Location Accuracy: 2 - 15m
 Ground Level Altitude: 35.5 m +MSD Accuracy: < 2.5 m
 Driller: Weedons WellDrilling
 Drill Method: Rotary/Percussion
 Borelog Depth: 21.4 m Drill Date: 04-Feb-1991

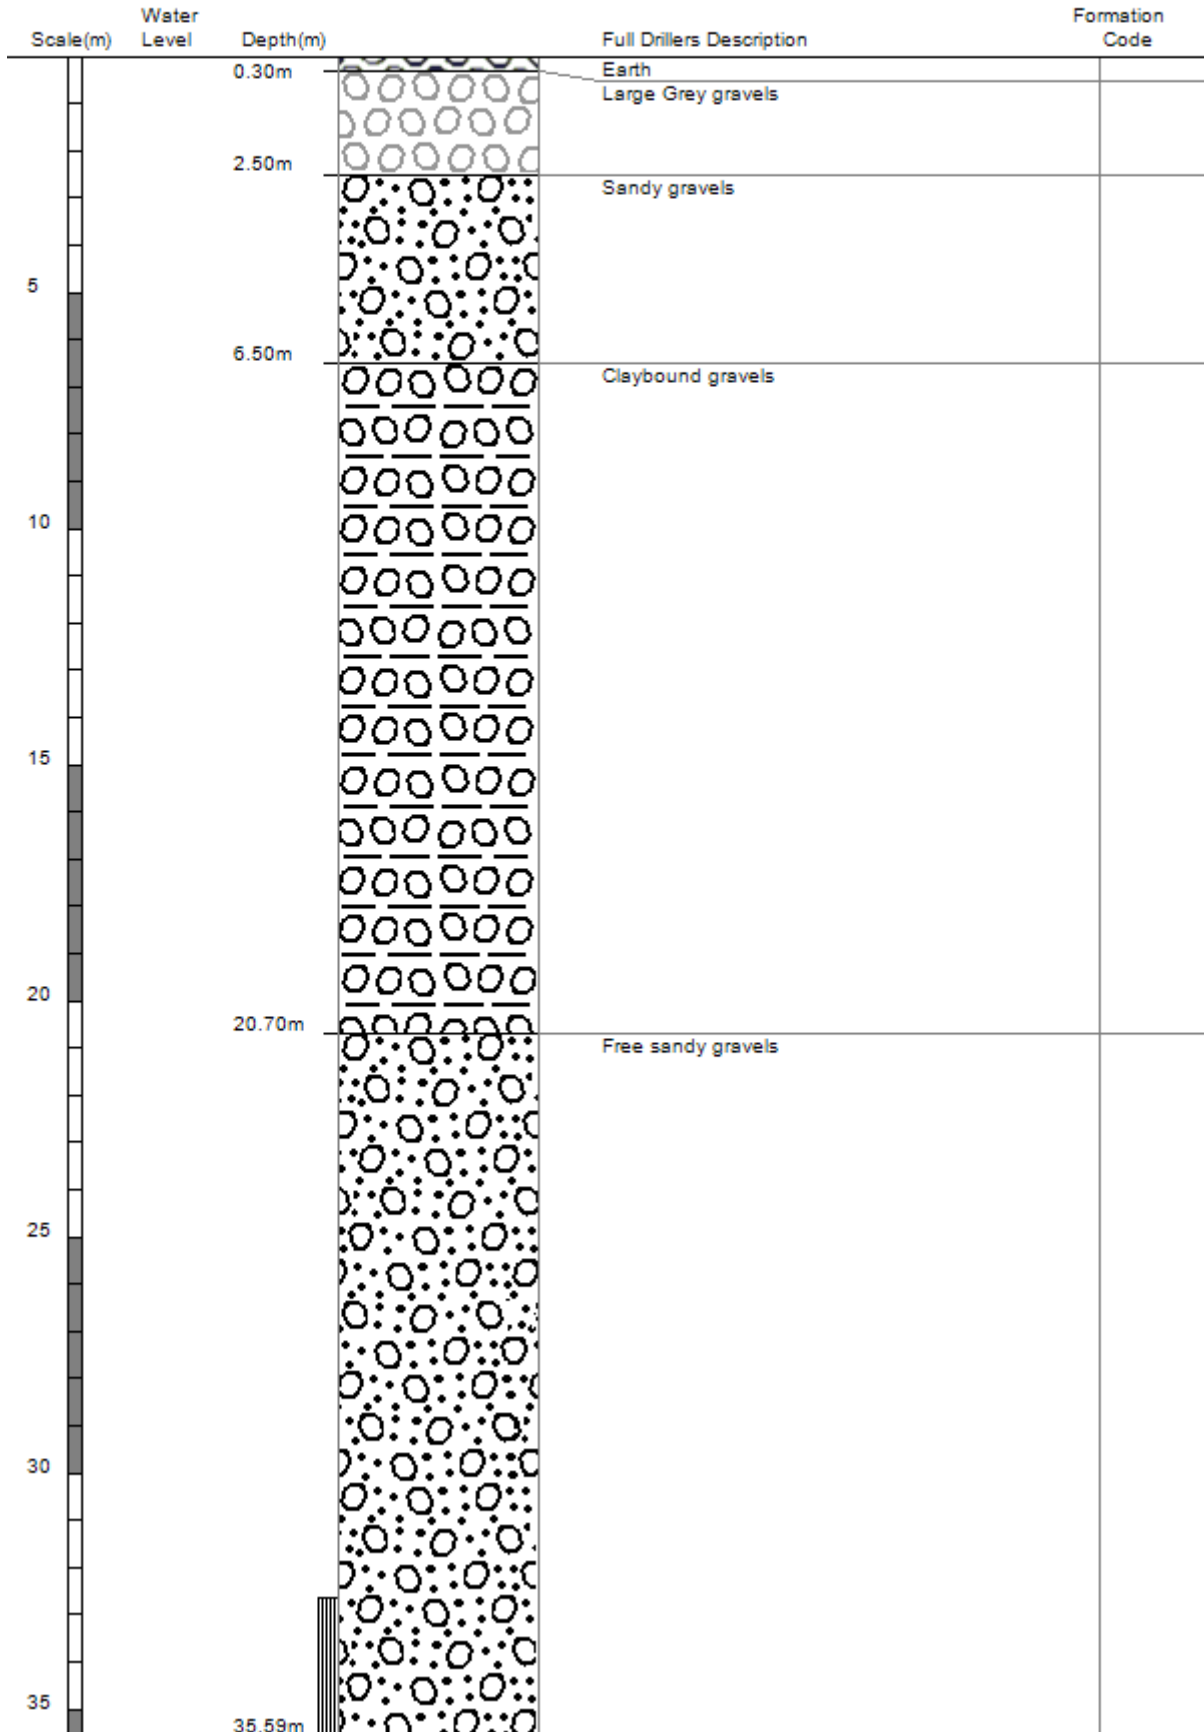
Borelog for well M36/4387

Grid Reference (NZTM): 1549704 mE, 5168988 mN
 Location Accuracy: 2 - 15m
 Ground Level Altitude: 36.5 m +MSD Accuracy: < 2.5 m
 Driller: McMillan Drilling Ltd
 Drill Method: Rotary/Percussion
 Borelog Depth: 35.6 m Drill Date: 11-Oct-1991

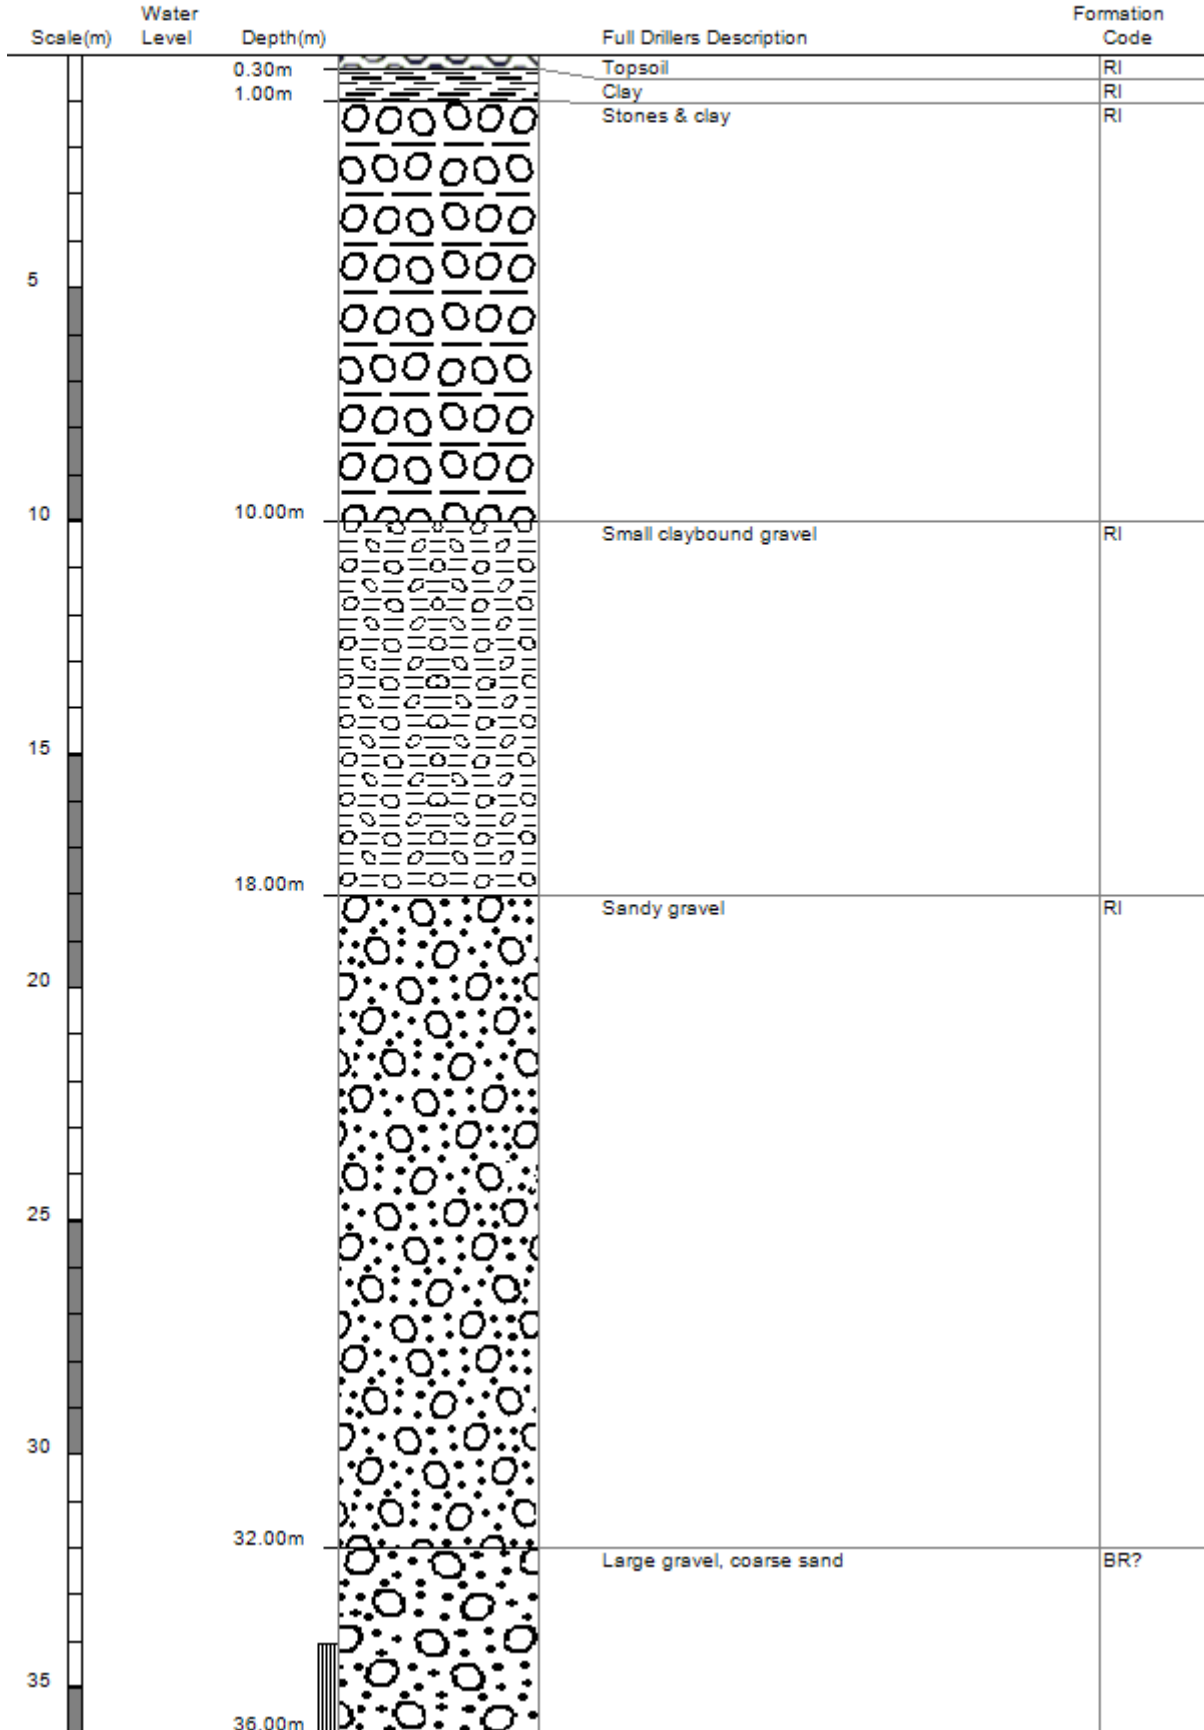
Borelog for well M36/5254

Grid Reference (NZTM): 1550468 mE, 5169031 mN
 Location Accuracy: 50 - 300m
 Ground Level Altitude: 34.4 m +MSD Accuracy: < 2.5 m
 Driller: East Coast Drilling
 Drill Method: Rotary Rig
 Borelog Depth: 36.0 m Drill Date: 01-Dec-1996
