Geotechnical Investigation  
533 East Maddisons Road & 870 Goulds Road  
Rolleston  
Canterbury

Submitted to:  
Hughes Developments Ltd

21.09.2018  
12903.000.000\_37

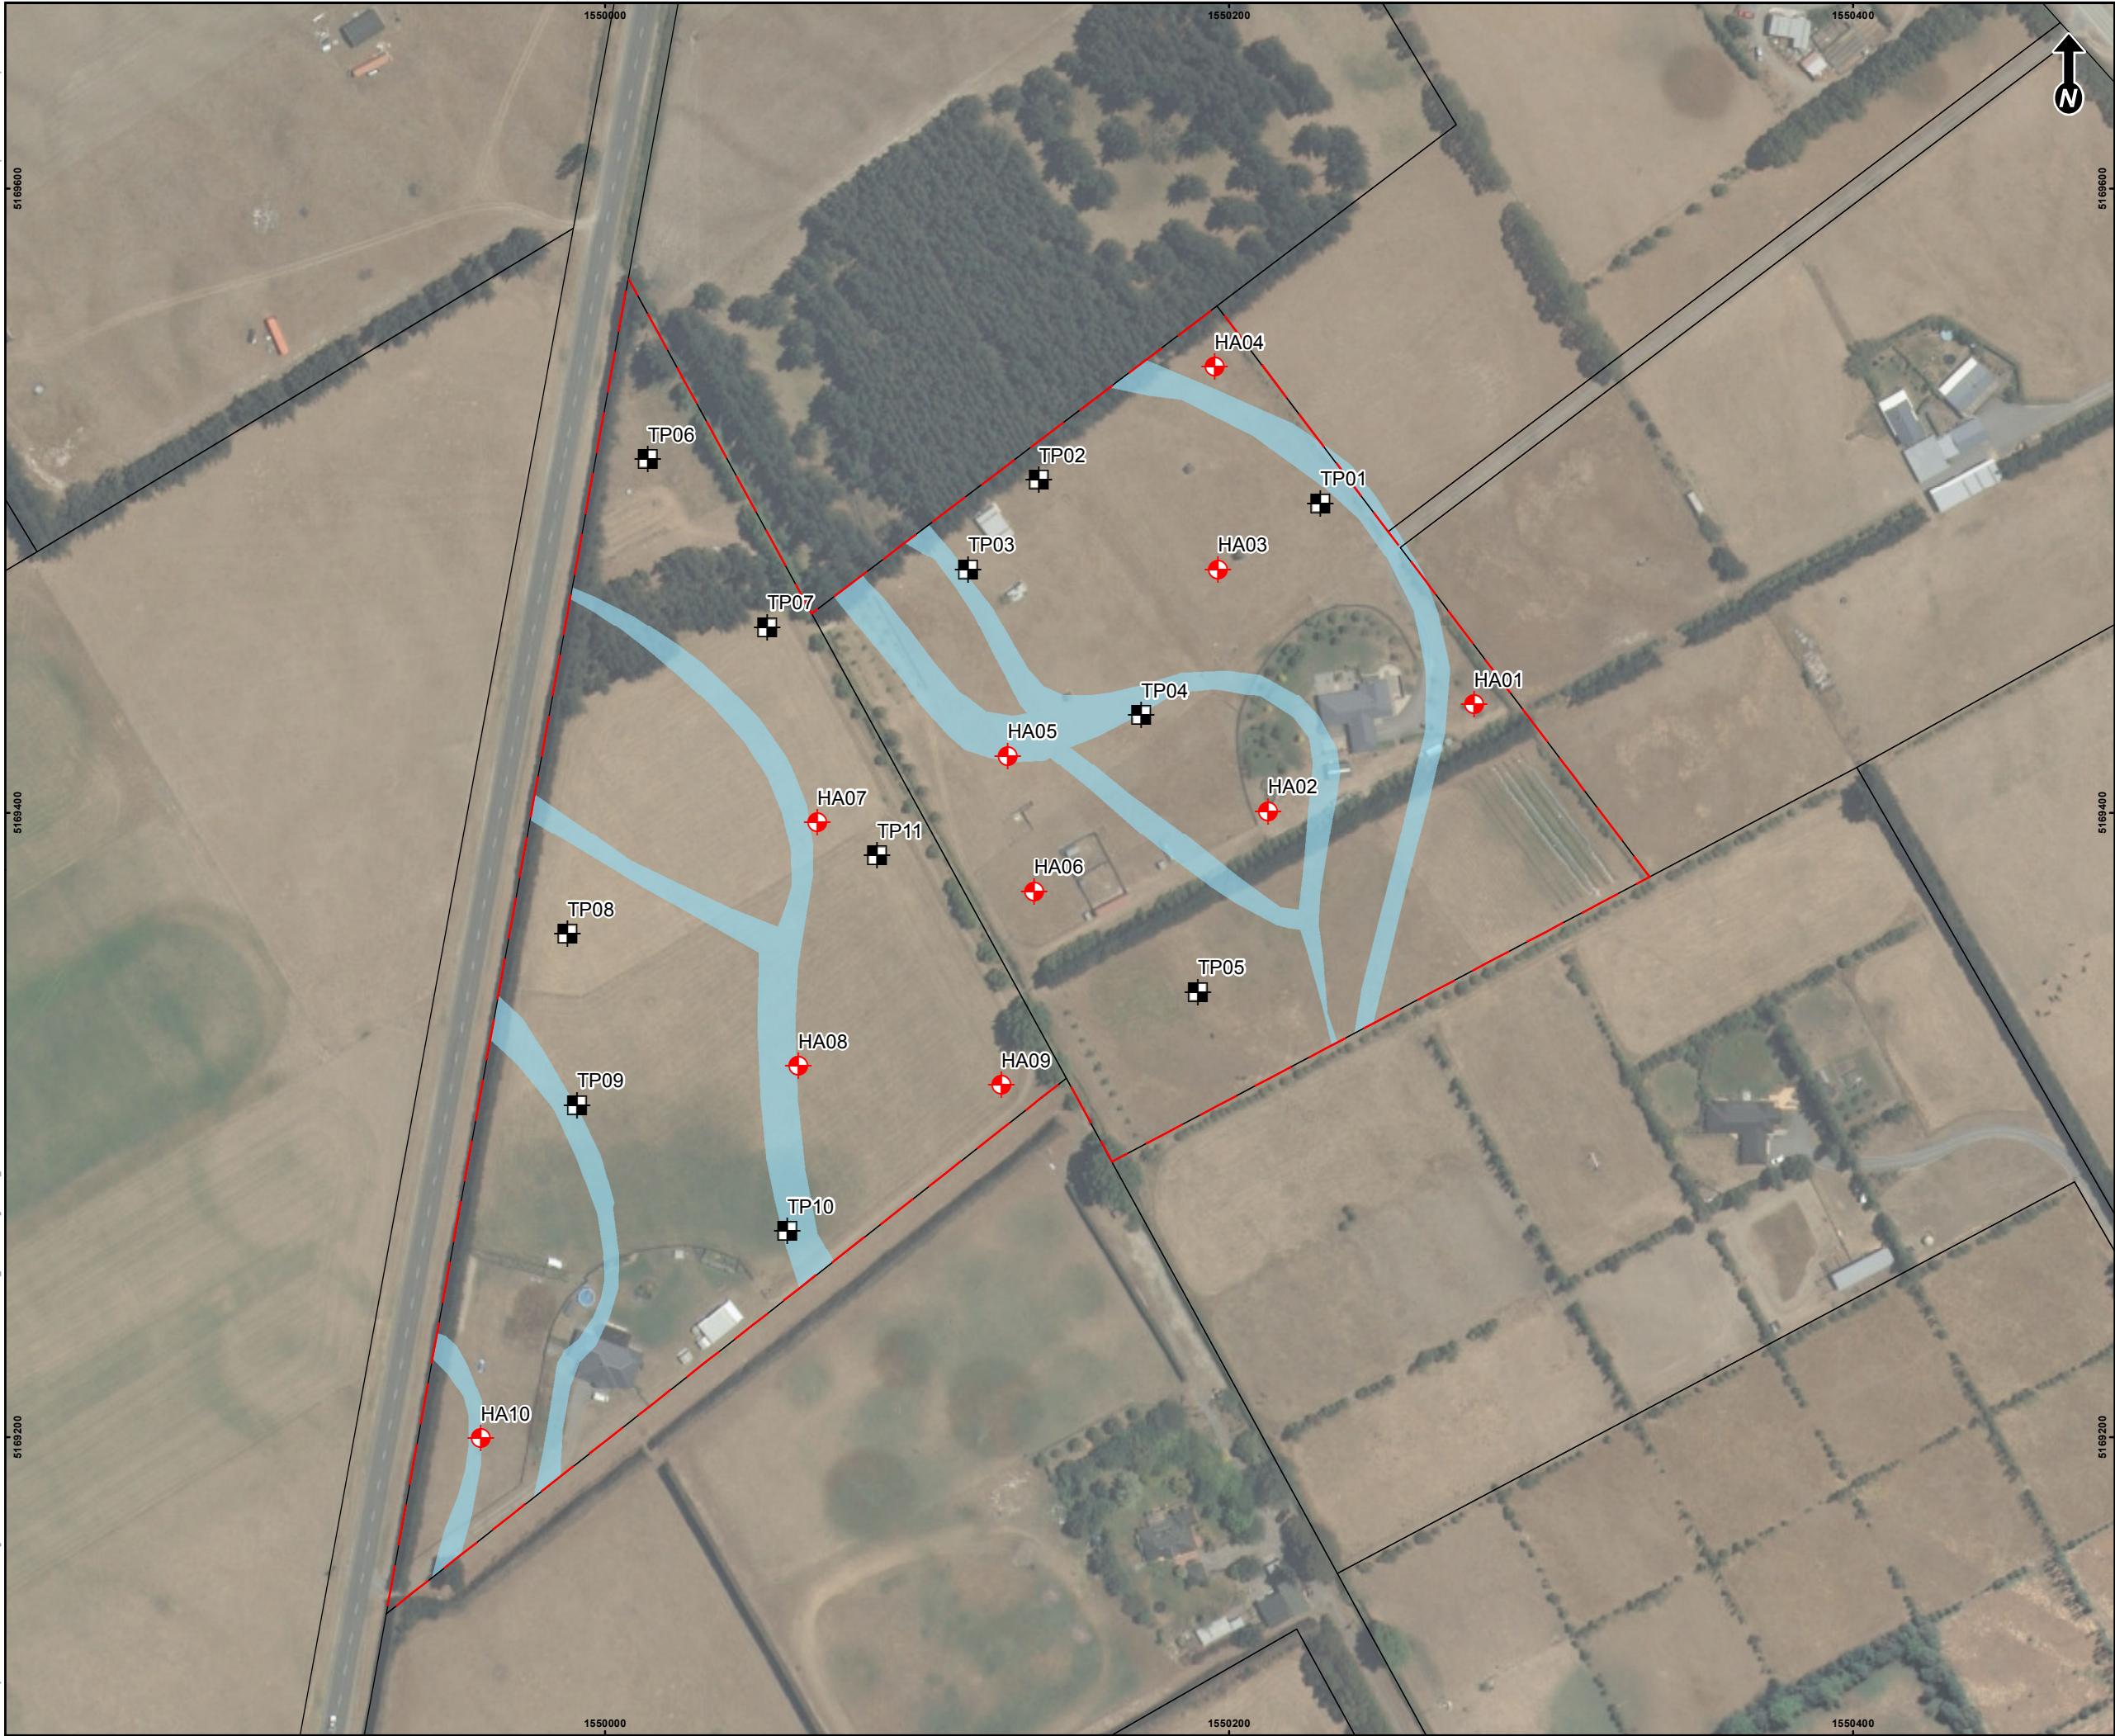
### Test Location and Paleo Channel Plan

The site comprises relatively flat ground, with gentle undulations and depressions in some areas. As evident on aerial imagery (Canterbury Maps, 2016) and observed during our site walkover conducted on 17 and 18 September 2018, undulating and depressed ground can be attributed to paleo-channels, which traverse the site in a general northwest to southeast trend. Based on our testing, silt and sand deposits with variable thickness (up to 0.5 m) are expected to have in-filled the paleo-channels where they have not remained as channel features. Inferred paleo-channels have been mapped to give an indication of areas with potential channel in-fill (Appendix 1).

- Legend**
- Hand auger
  - Test pit
  - site
  - Property title boundary
  - Inferred Paleo-Channel

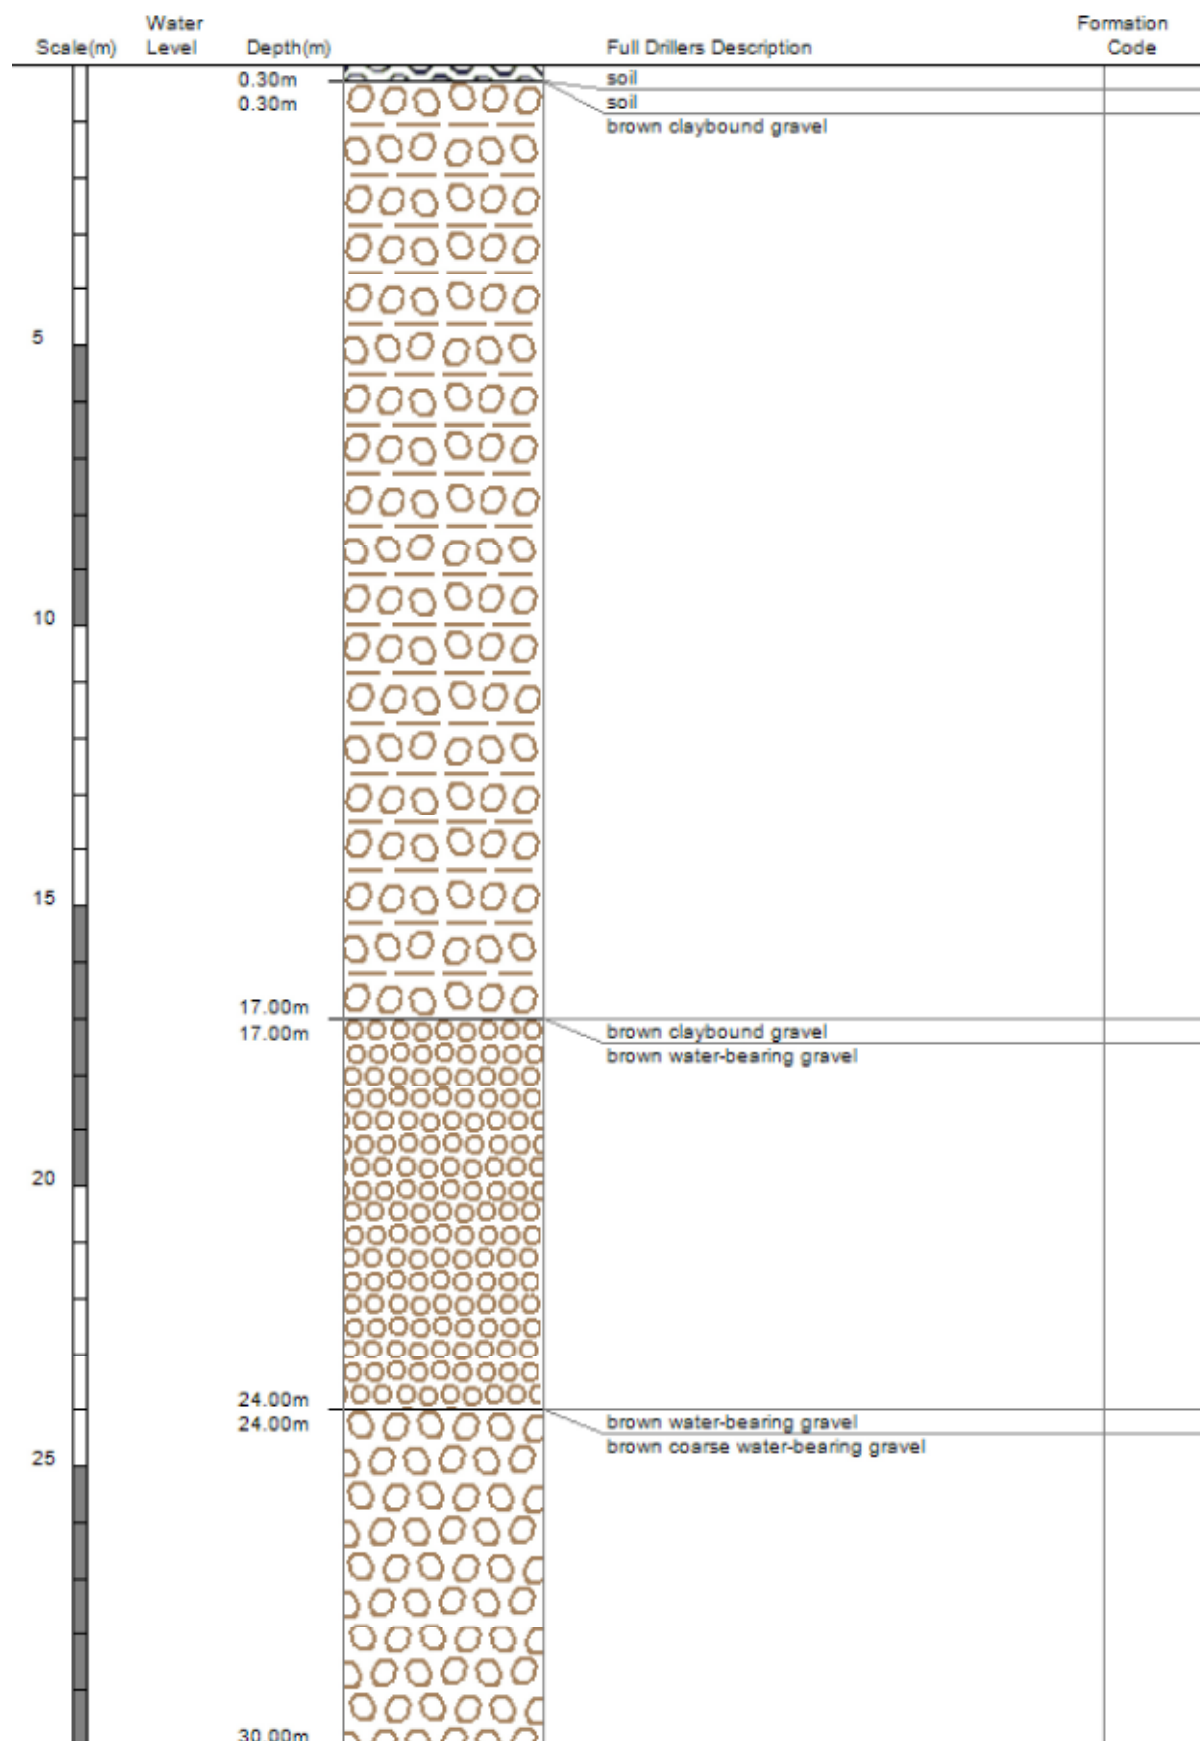
# Borelog for well M36/20535

A review of three deep ECan borehole logs, one located near the southern side of the site (M36/7521), (M36/20535), and the other south of the 870 Goulds Road lot (M36/4221) was conducted (Canterbury Maps). The location of these boreholes is presented in Figure 2. The logs from the three holes of interest are presented in Appendix 3 and indicate the site is broadly underlain by a mixture of sandy and claybound gravels to depths of at least 30 m below ground level. Layers of silt in the upper 0.5 m are recorded in the bore well (M36/20535).

Grid Reference (NZTM): 1550018 mE, 5169231 mN

Drill Method: Rotary Rig

Borelog Depth: 30.0 m Drill Date: 04-Feb-2011
