523 East Maddisons Road Rolleston Canterbury

**Hughes Developments Limited**

Report Title	Geotechnical Investigation - 523 Ea	st Maddisons Road	d, Rolleston	
Project No.	12903.000.000	Doc ID	30	
Client	Hughes Development Ltd	Client Contact	Kelvin Back	
Distribution (PDF)	Hughes Development Ltd			
Date	Revision Details/Status	WP	Author	Reviewer
18/05/2018	Final	ВК	НВ	GM

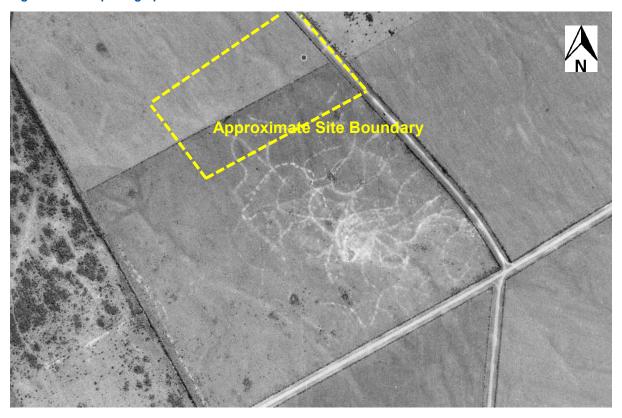
Figure 2: Aerial photograph 1960 - 1964

Aerial photograph sourced from Canterbury Maps. Image not to scale.

Our review of historical aerial photos revealed dashed lines (1960 – 1964) on the southern side of the property, continuing onto the neighbouring property to the south. These appear to be on the photos themselves and could be due to damage to the original photos or damage to the negatives when processing the film, before the scanning process. These markings were also noticed on other properties around the area from this timeframe (1960 -1964). The markings were not observed on the property in other available aerial photos.

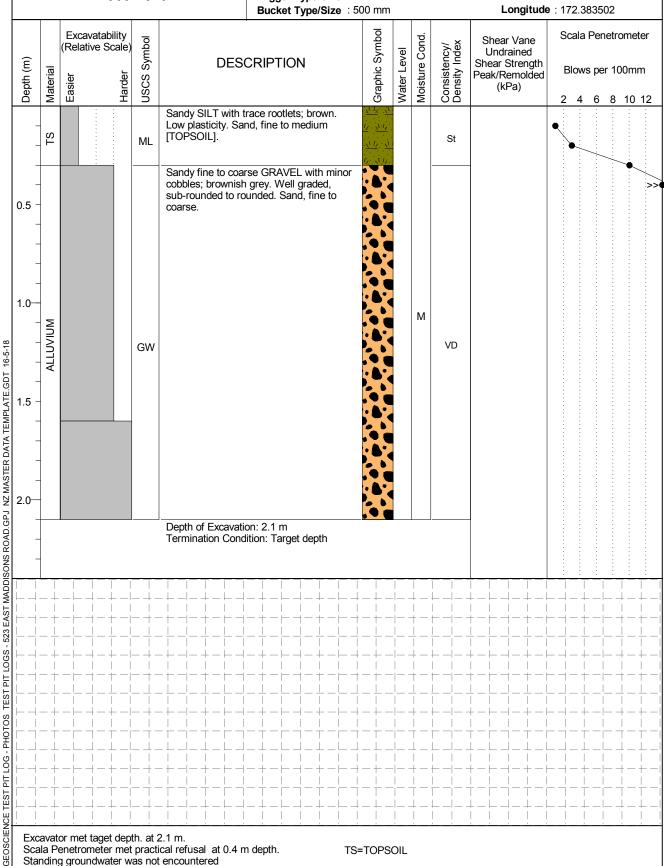
Max Test Pit Depth: 2.1 m Reviewed By: JW

Digger Type/Size : Bucket Excavator Latitude: -43.625995 **Longitude**: 172.383502

The investigations revealed subsurface conditions across the site are consistent with the published geological mapping, as summarised in Table 1. Hand auger and test pit logs are included in Appendix 2 of this report.

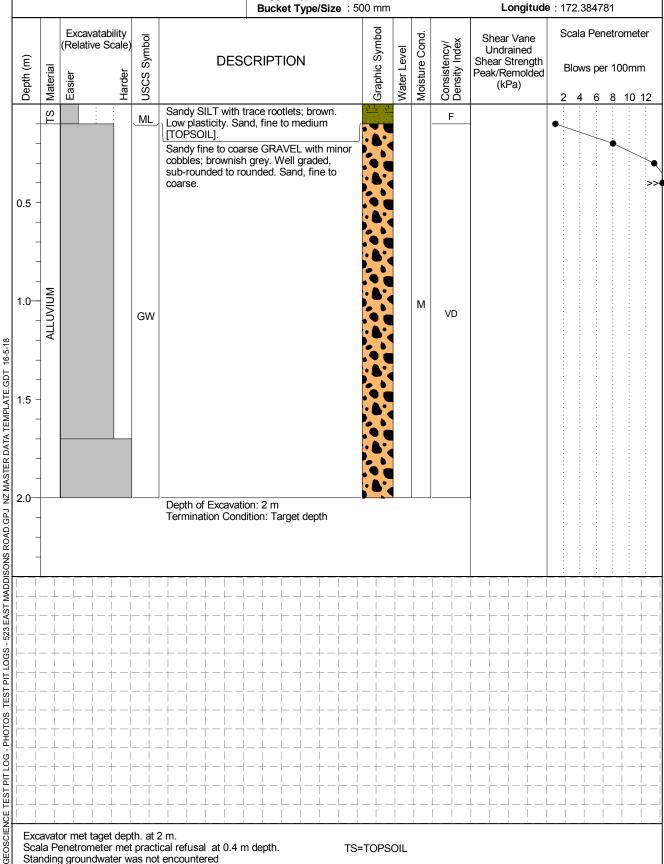
Max Test Pit Depth : 2 m Reviewed By: JW

Digger Type/Size : Bucket Excavator Latitude: -43.625982 Longitude: 172.384781

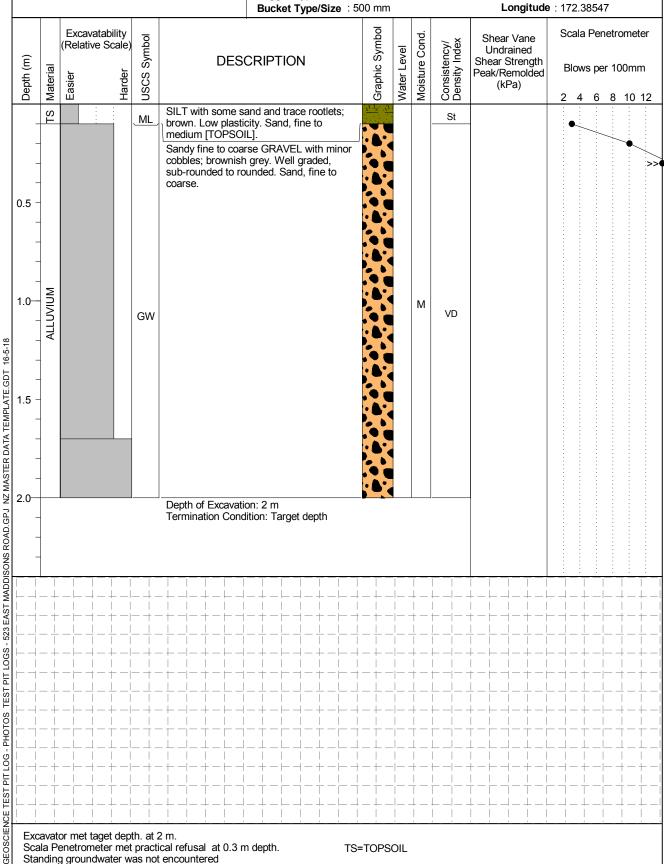
Date: 8/5/2018 Max Test Pit Depth : 2 m Reviewed By: JW

Digger Type/Size : Bucket Excavator Latitude: -43.625257 **Longitude**: 172.38547

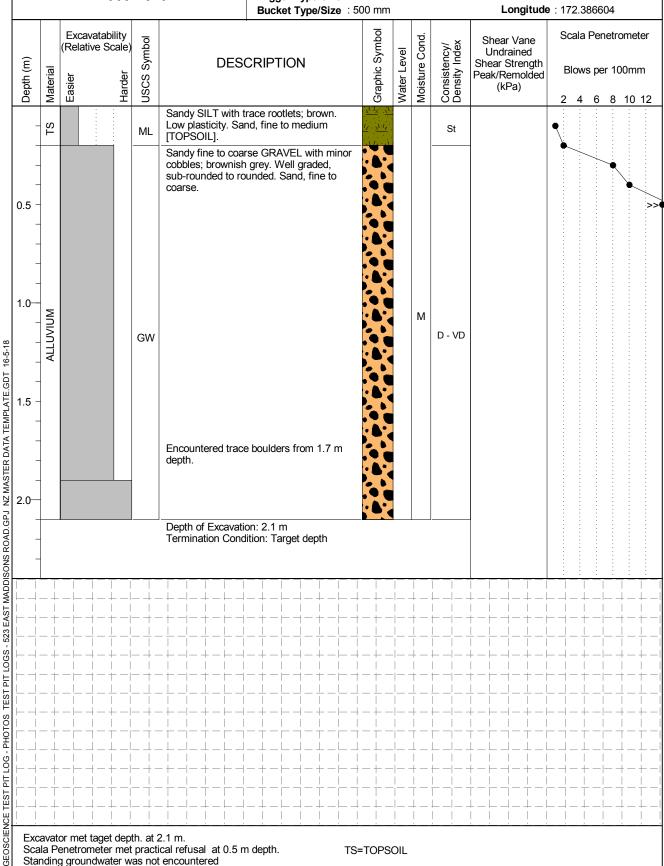
Max Test Pit Depth: 2.1 m Reviewed By: JW

Digger Type/Size : Bucket Excavator Latitude: -43.625254

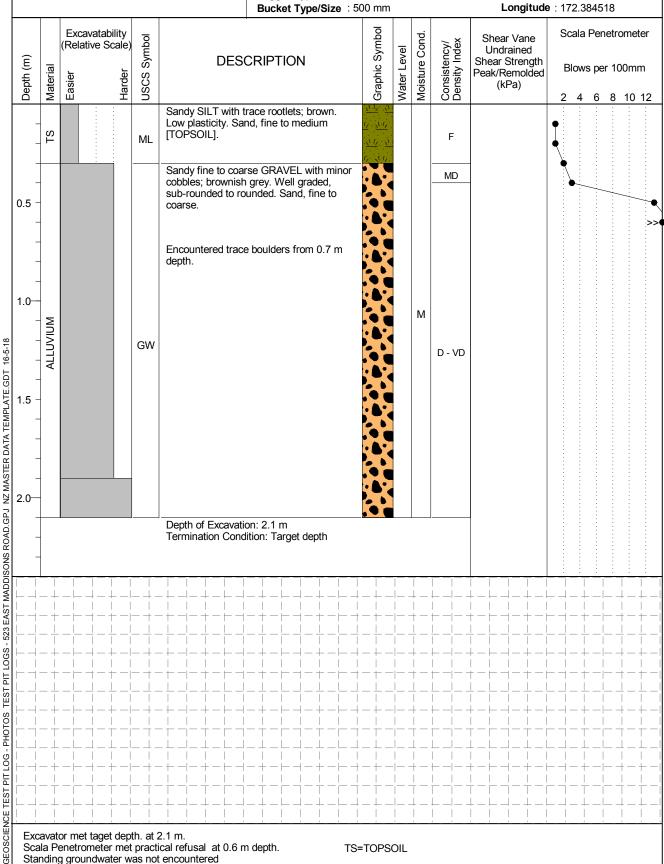
Max Test Pit Depth: 2.1 m Reviewed By: JW

Digger Type/Size : Bucket Excavator Latitude: -43.626559

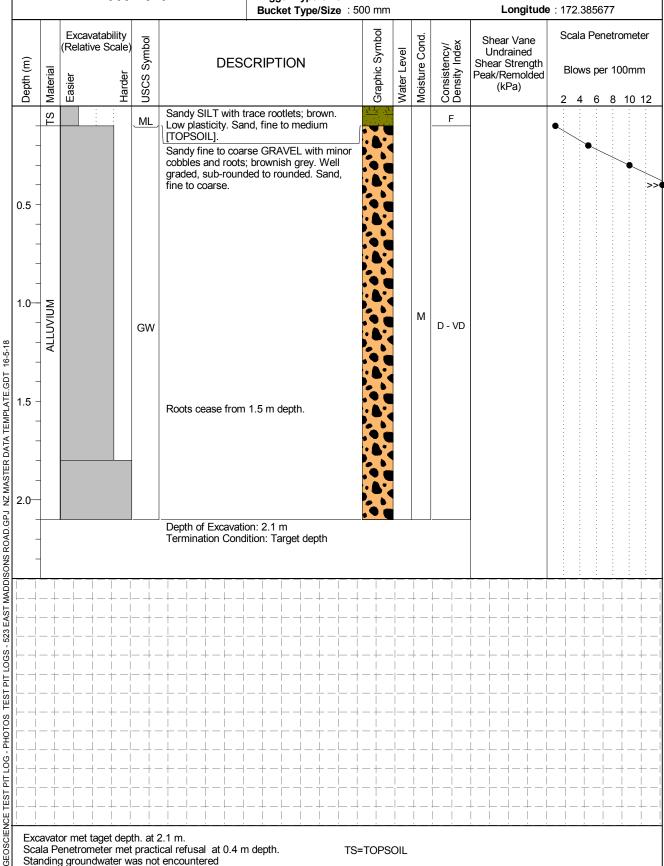
Max Test Pit Depth: 2.1 m Reviewed By: JW

Digger Type/Size : Bucket Excavator Latitude: -43.625892

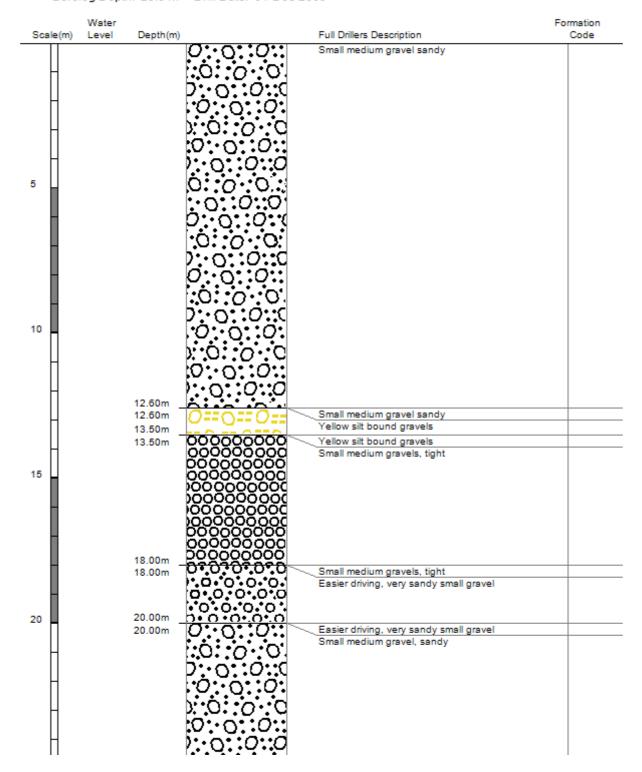
Borelog Depth: 29.0 m Drill Date: 01-Dec-2003

The location of these boreholes is presented in Figure 2 and includes well points on-site and to the northeast that have no log data available. The logs from the two holes of interest are presented in Appendix 3 and indicate the site is broadly underlain by a mixture of sandy gravels to depths of at least 28.5 m below ground level.

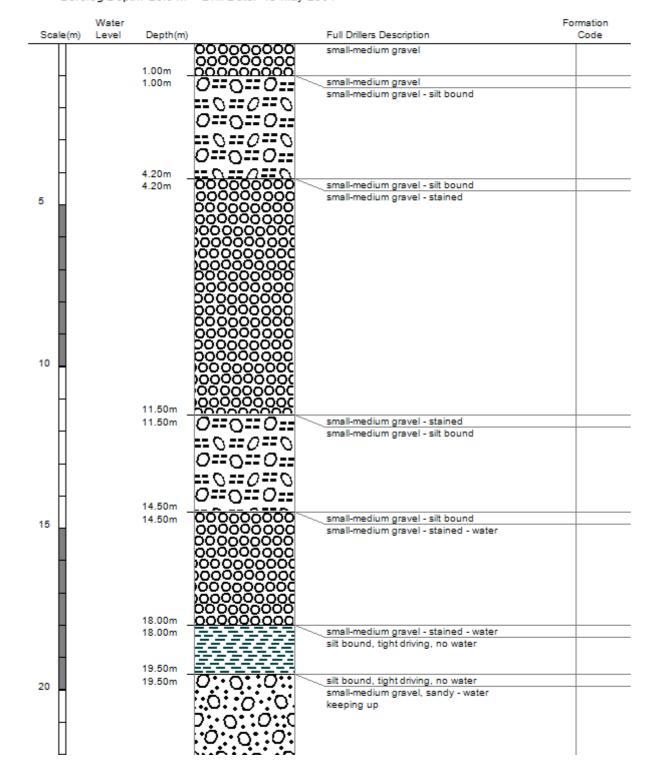
Borelog Depth: 26.0 m Drill Date: 15-May-2004
