Geotechnical Investigation

503 East Maddisons Road

Rolleston

Hughes Development Ltd

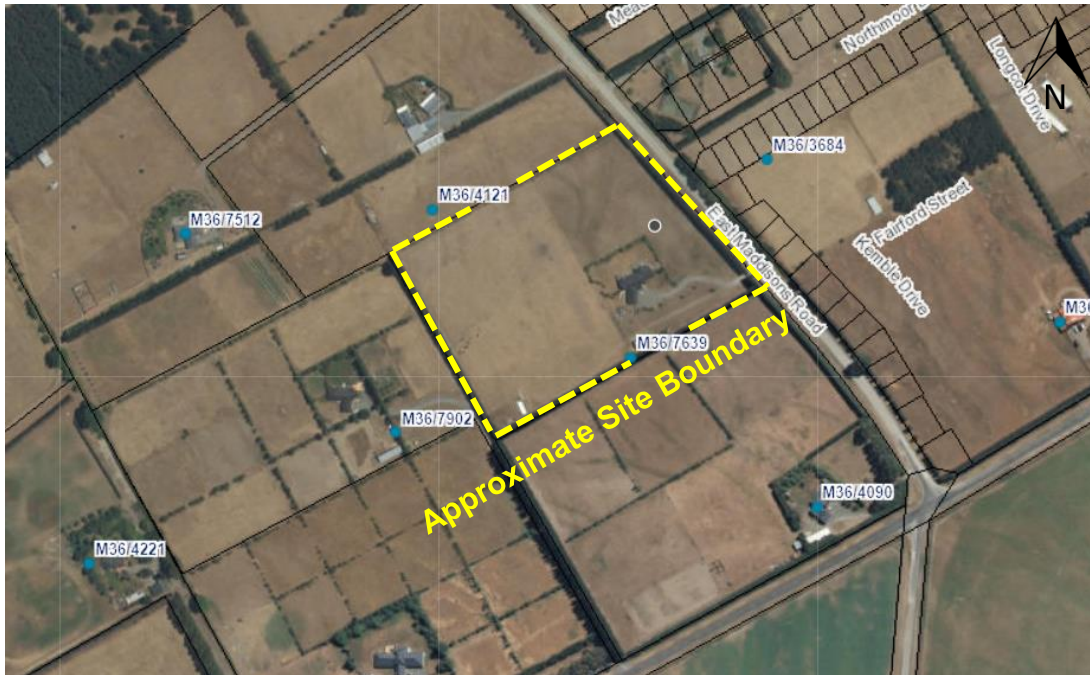
Figure 2: Nearby ECAN Borehole Locations

Aerial photograph sourced from Canterbury Maps (retrieved November 2018). Not to Scale.

The location of these boreholes is presented in Figure 2 and includes the well points on site that have no log data available. The logs from the three holes of interest are presented in Appendix 3 and indicate the site is broadly underlain by a mixture of sandy gravels to depths of at least 36 m below ground level.

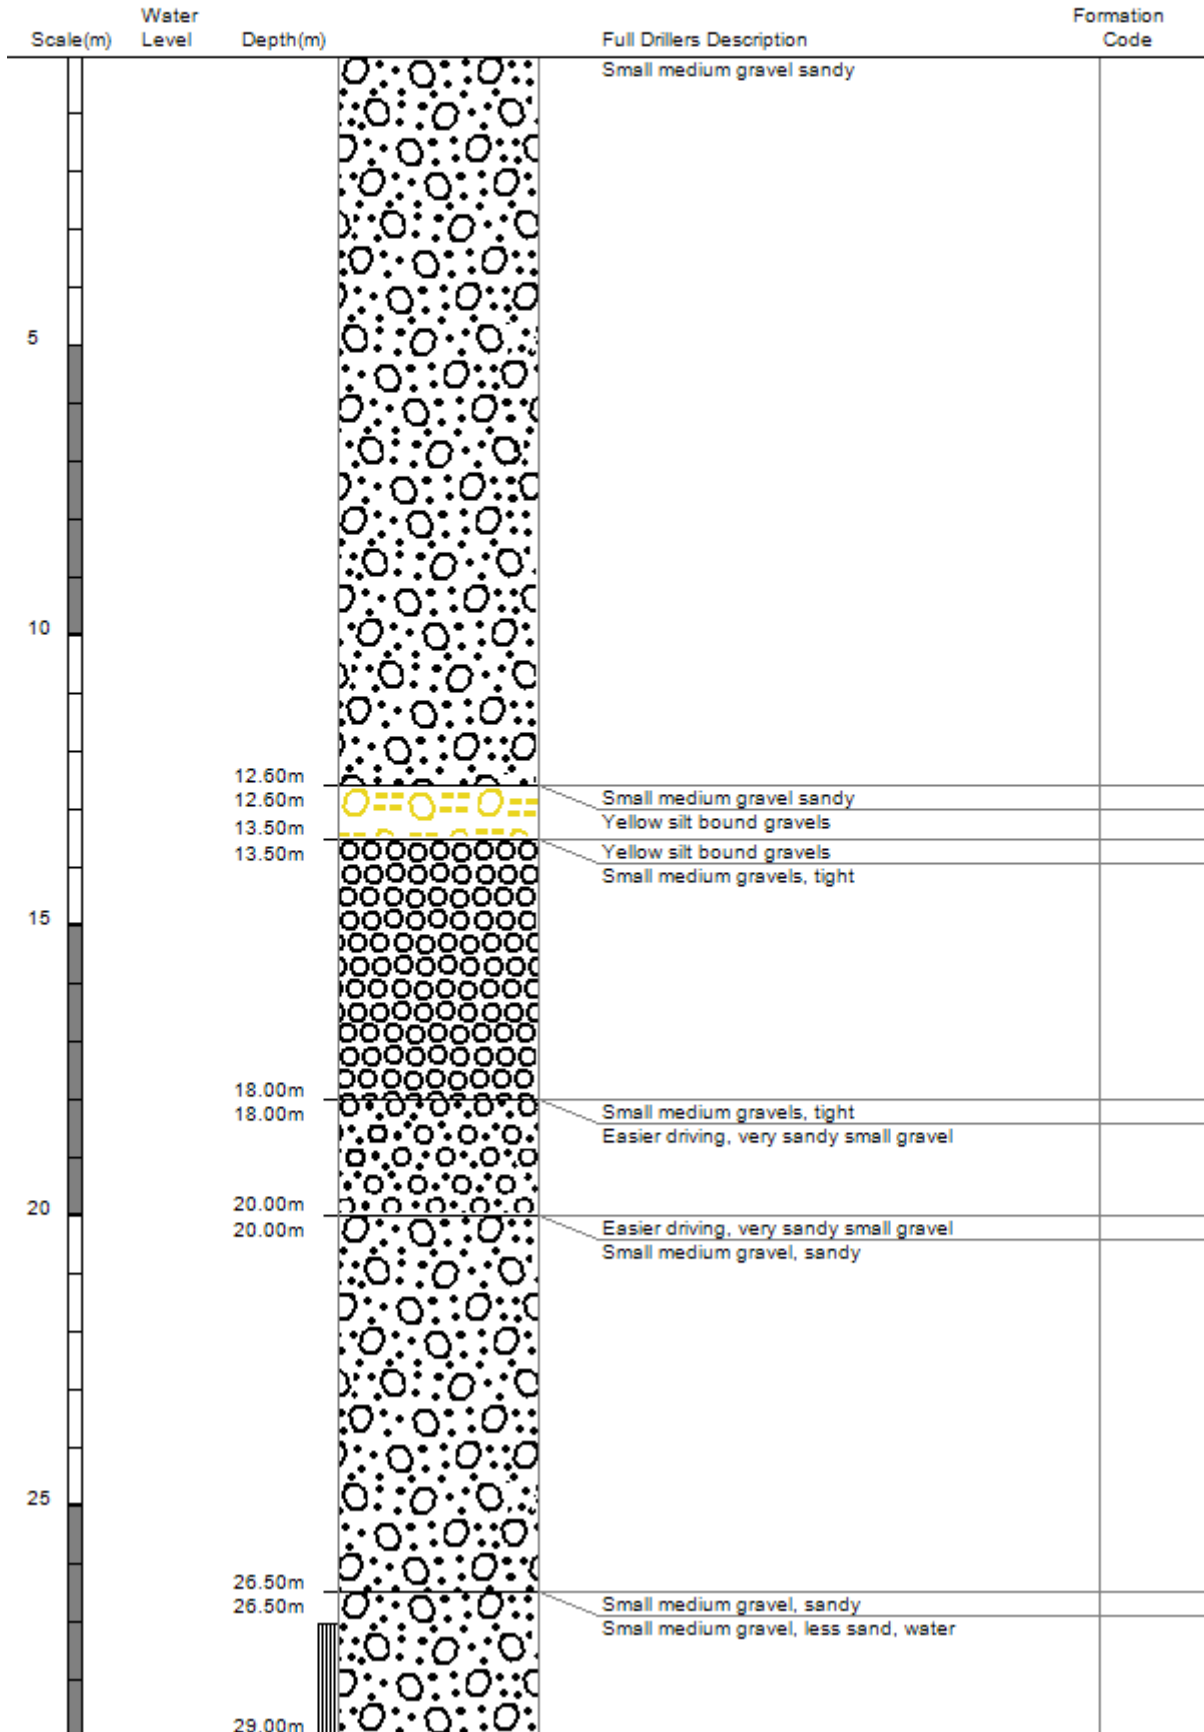
Borelog for well M36/7512

Grid Reference (NZTM): 1550238 mE, 5169431 mN
 Location Accuracy: 50 - 300m
 Ground Level Altitude: 34.9 m +MSD Accuracy: < 0.5 m
 Driller: Dynes Road Drilling
 Drill Method: Cable Tool
 Borelog Depth: 29.0 m Drill Date: 01-Dec-2003
