Geotechnical Investigation

728 Selwyn Road Springston Christchurch

Submitted to: Hughes Developments Ltd Canterbury

23.05.2017 12903.000.000_12

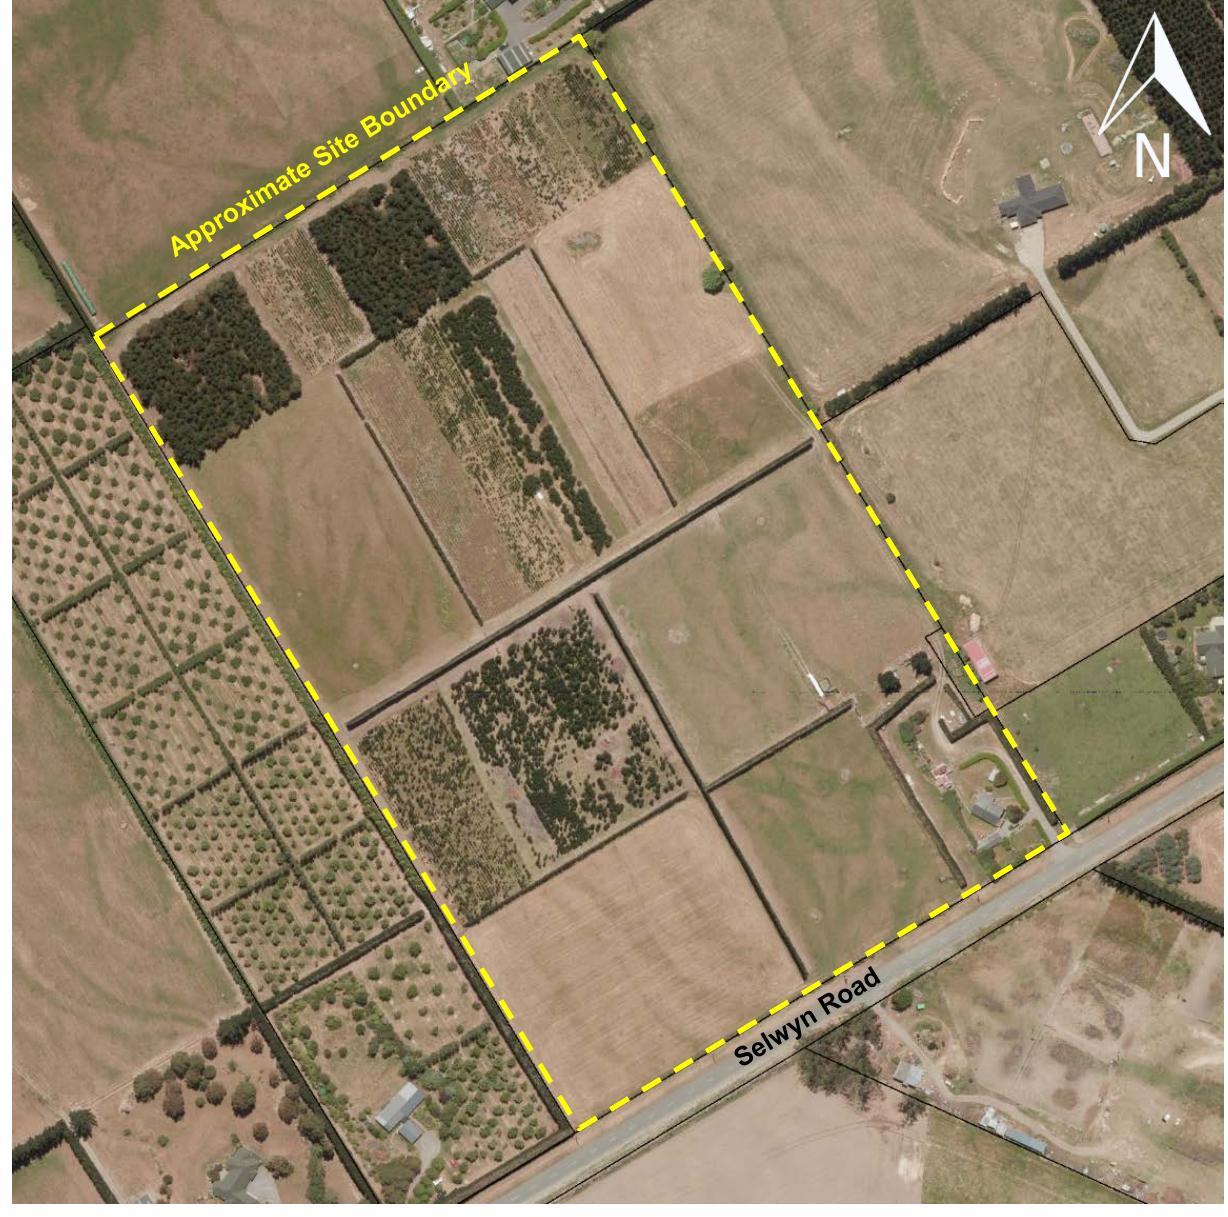
Figure 1: Site Location

Image obtained from Canterbury Maps. Not to scale.

The site covers at total area of 10.3 ha (Figure 1), and has the legal description of Lot 2 DP 63632 and Lot 3 DP 441634 (Selwyn District Council). It is located approximately 3.4 km south of Rolleston town centre and is bound to the south-east by Selwyn Road and farmland on the remaining sides.

The predominantly flat site is currently used as agricultural land with one residential dwelling and associated sheds and buildings (Figure 1).

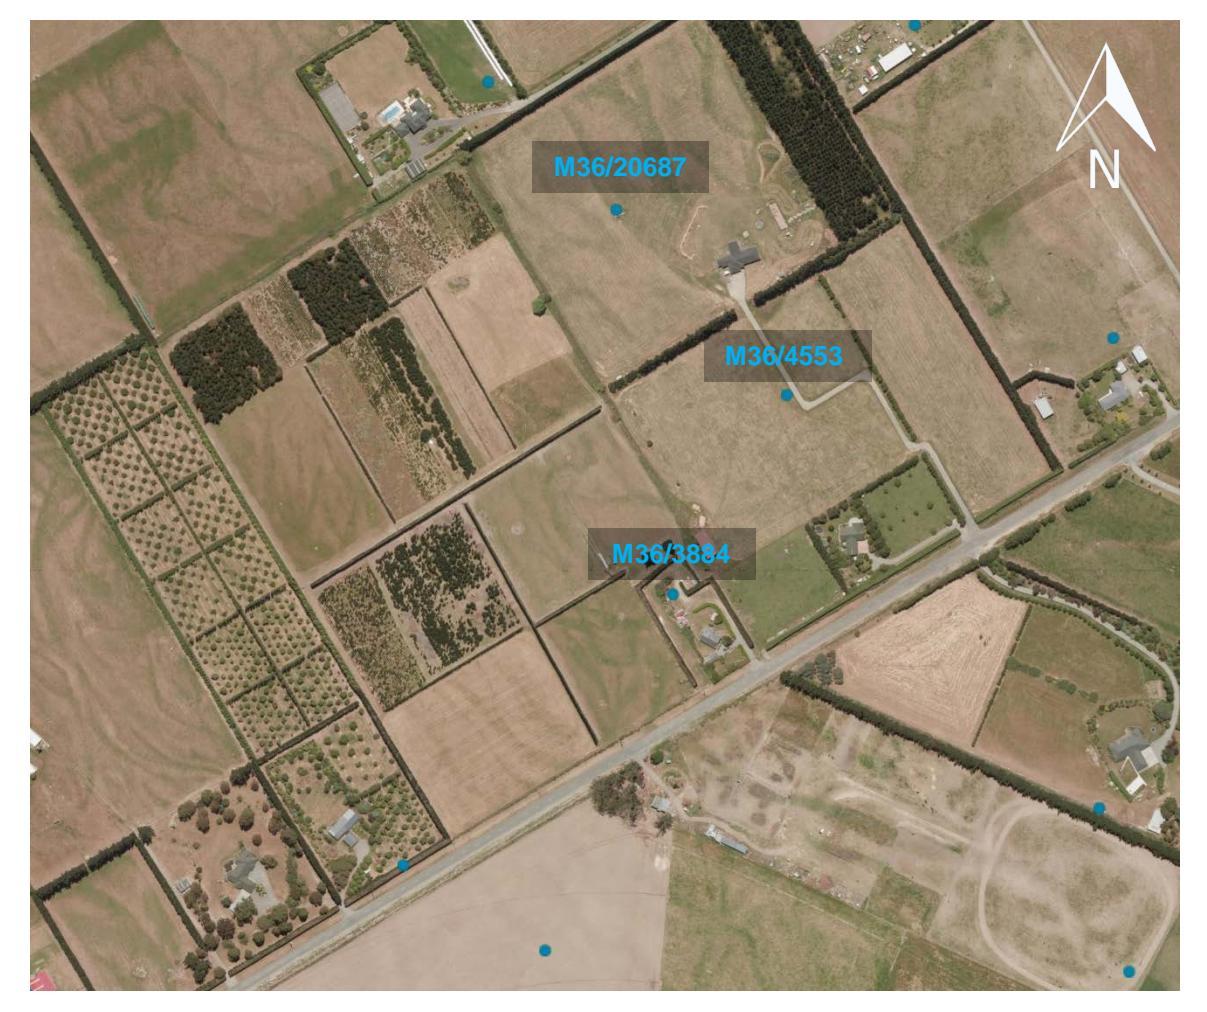
Figure 2: Nearby ECan Borehole Locations

Image sourced from Canterbury Maps. Not to scale.

A review of three deep ECan borehole logs located on site (M36/3884), 80 m east of the site (M36/20687) and 120 m east of site (M36/4553) was conducted (Canterbury Maps). The location of these boreholes is presented in Figure 2 and includes the well points that have no log data available. The logs from the three holes of interest are presented in Appendix 3 and indicate the site is underlain by a mixture of gravel and sand to depths of at least 36 m below ground level. A layer of clay and clay bound gravel up to 6 m thick was encountered between 24 and 27 m below ground level.

Groundwater level is recorded in the surrounding ECan boreholes between approximately 5.8 and 6.7 m depth. We note that the water was likely encountered in the boreholes at approximately 30 m depth within the "water-bearing gravel" layer.

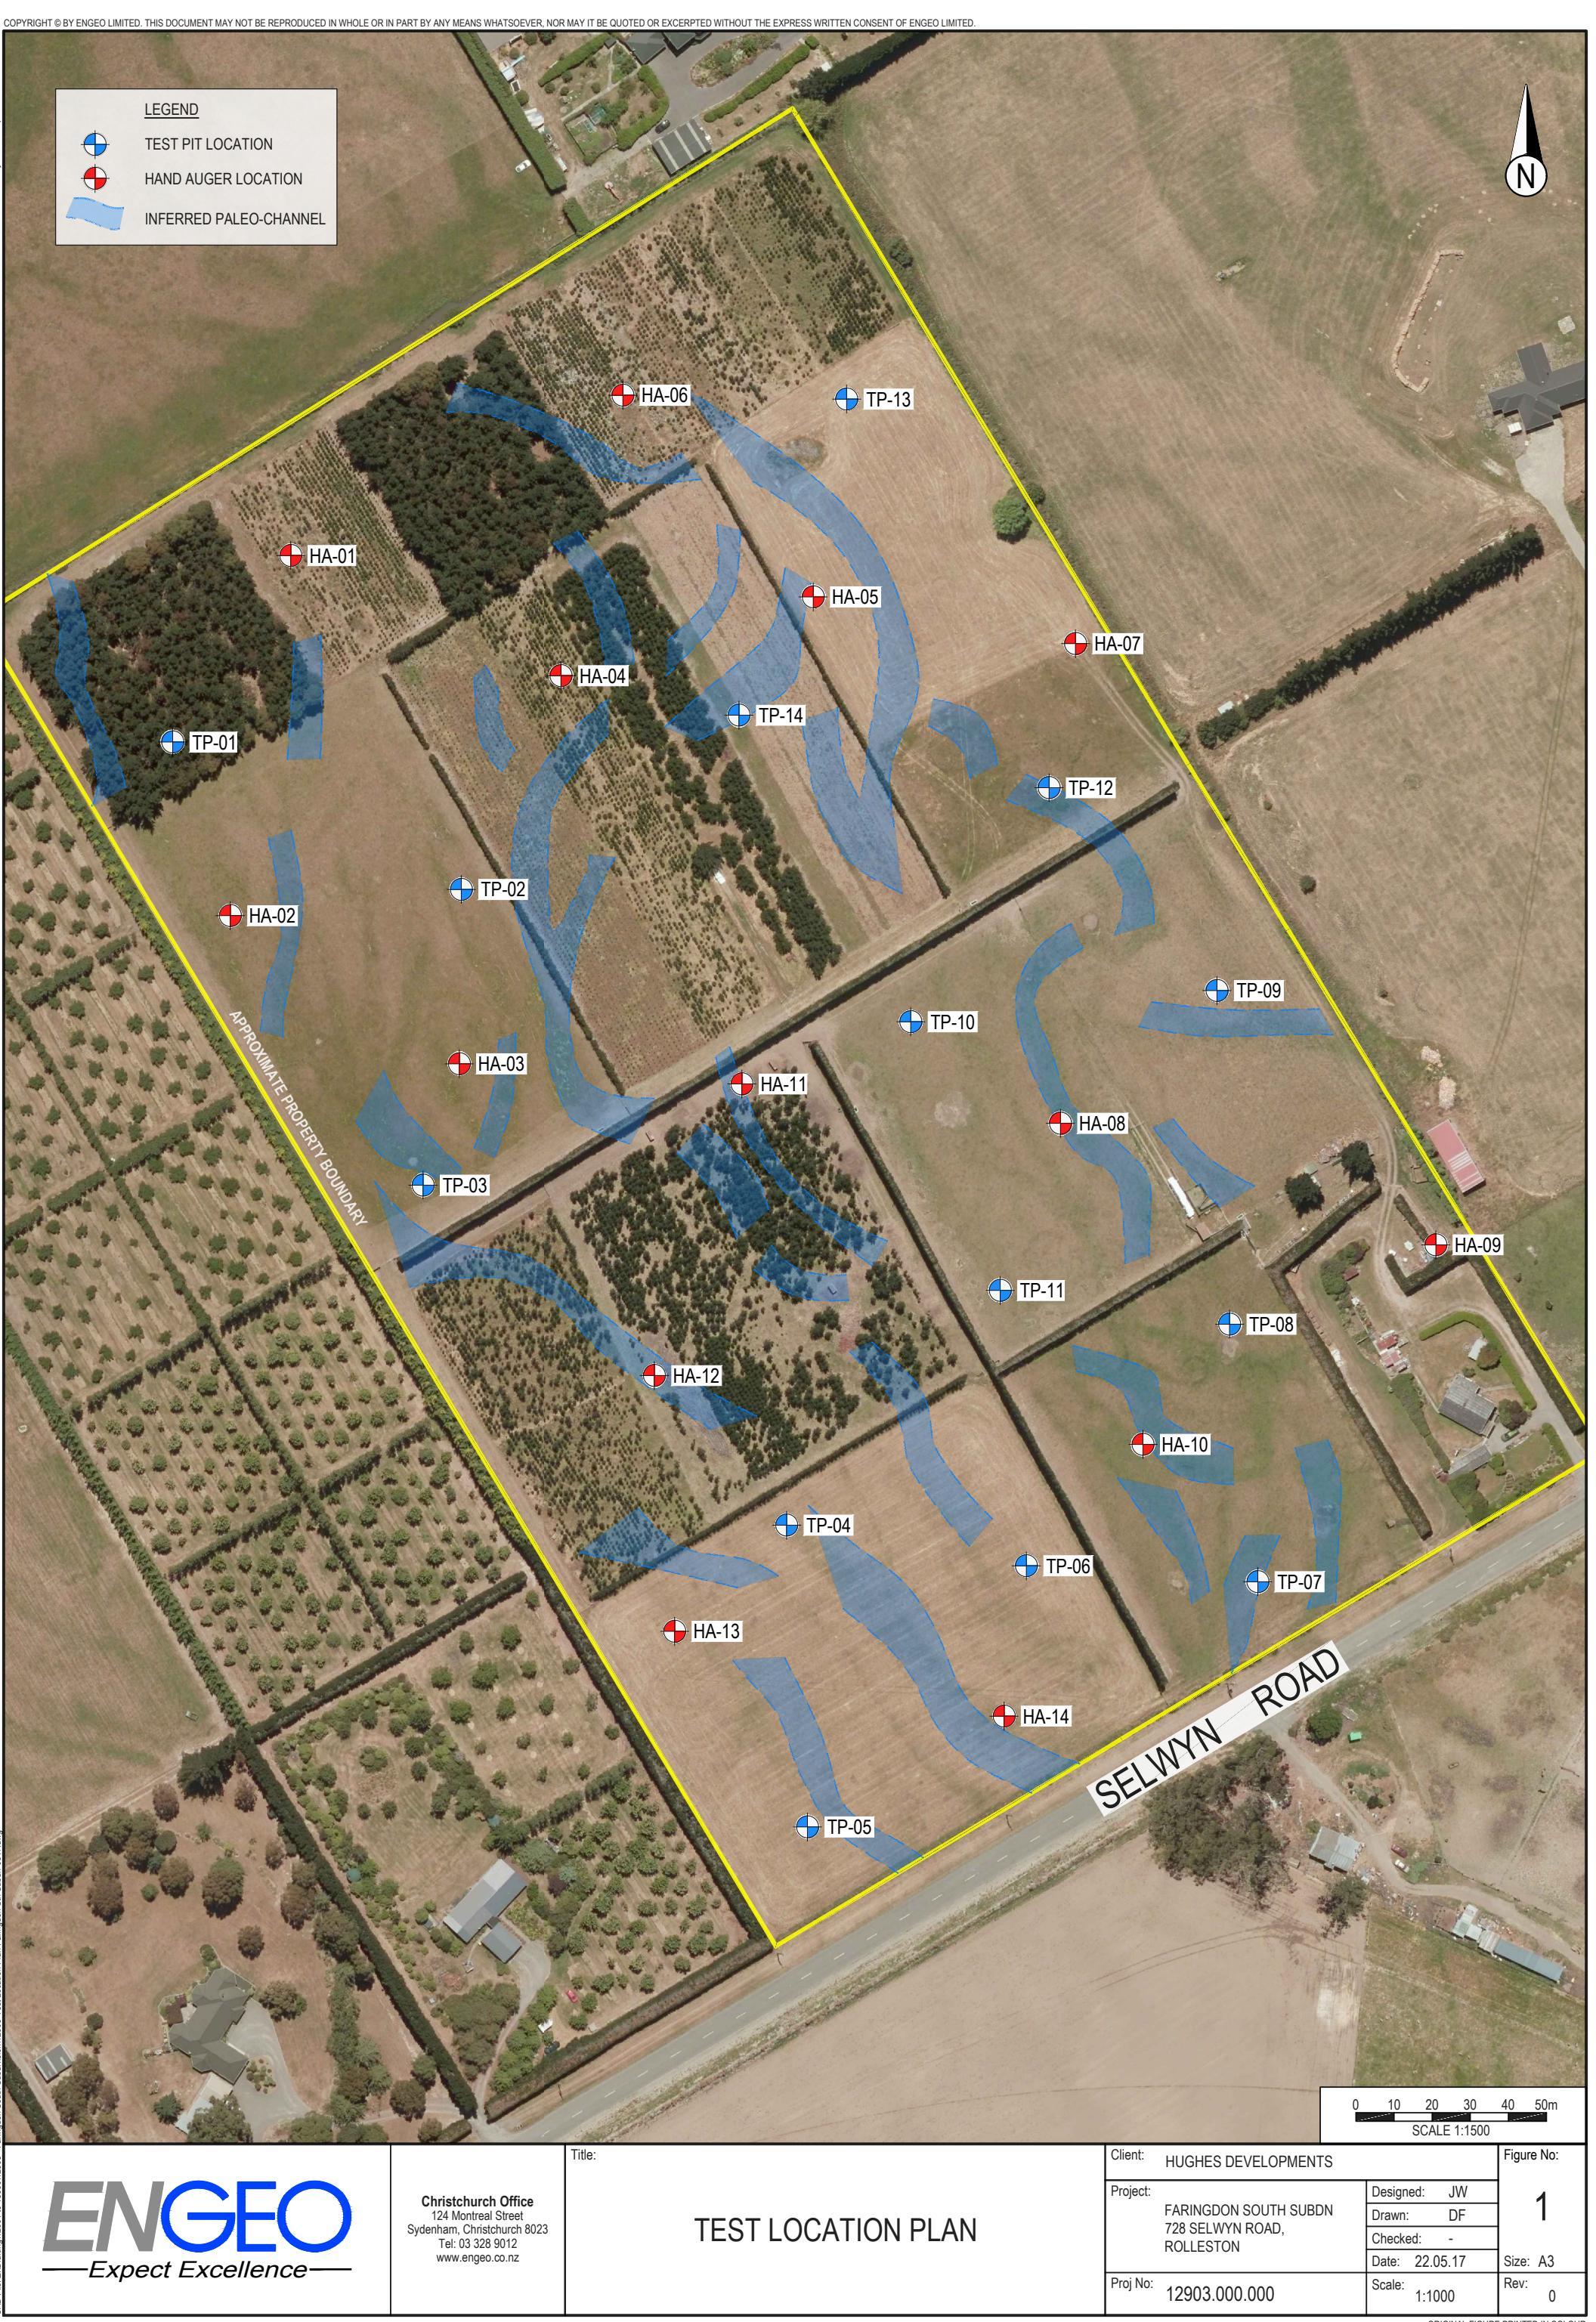
APPENDIX 1: Site Plan and Test Locations

REF's: selwyn-0125m-urban-aerial-photos-2012-13

The site comprises relatively flat ground, with gentle undulations and depressions in some areas. As evident on aerial imagery (Canterbury Maps, 2016) and observed during our site walkover conducted on 16 May 2017, undulating and depressed ground can be attributed to paleo-channels, which traverse the site in a general northwest to southeast trend. Based on observations, silt and sand deposits with variable thickness (up to 0.7 m) are expected to have in-filled the paleo-channels where they have not remained as channel features. Inferred paleo-channels have been mapped to give an indication of areas with potential channel in-fill (Appendix 1).

Test Locations are shown on the site plan presented in Appendix 1. Test pit and hand auger hole logs, showing detailed soil descriptions are presented in Appendix 2.

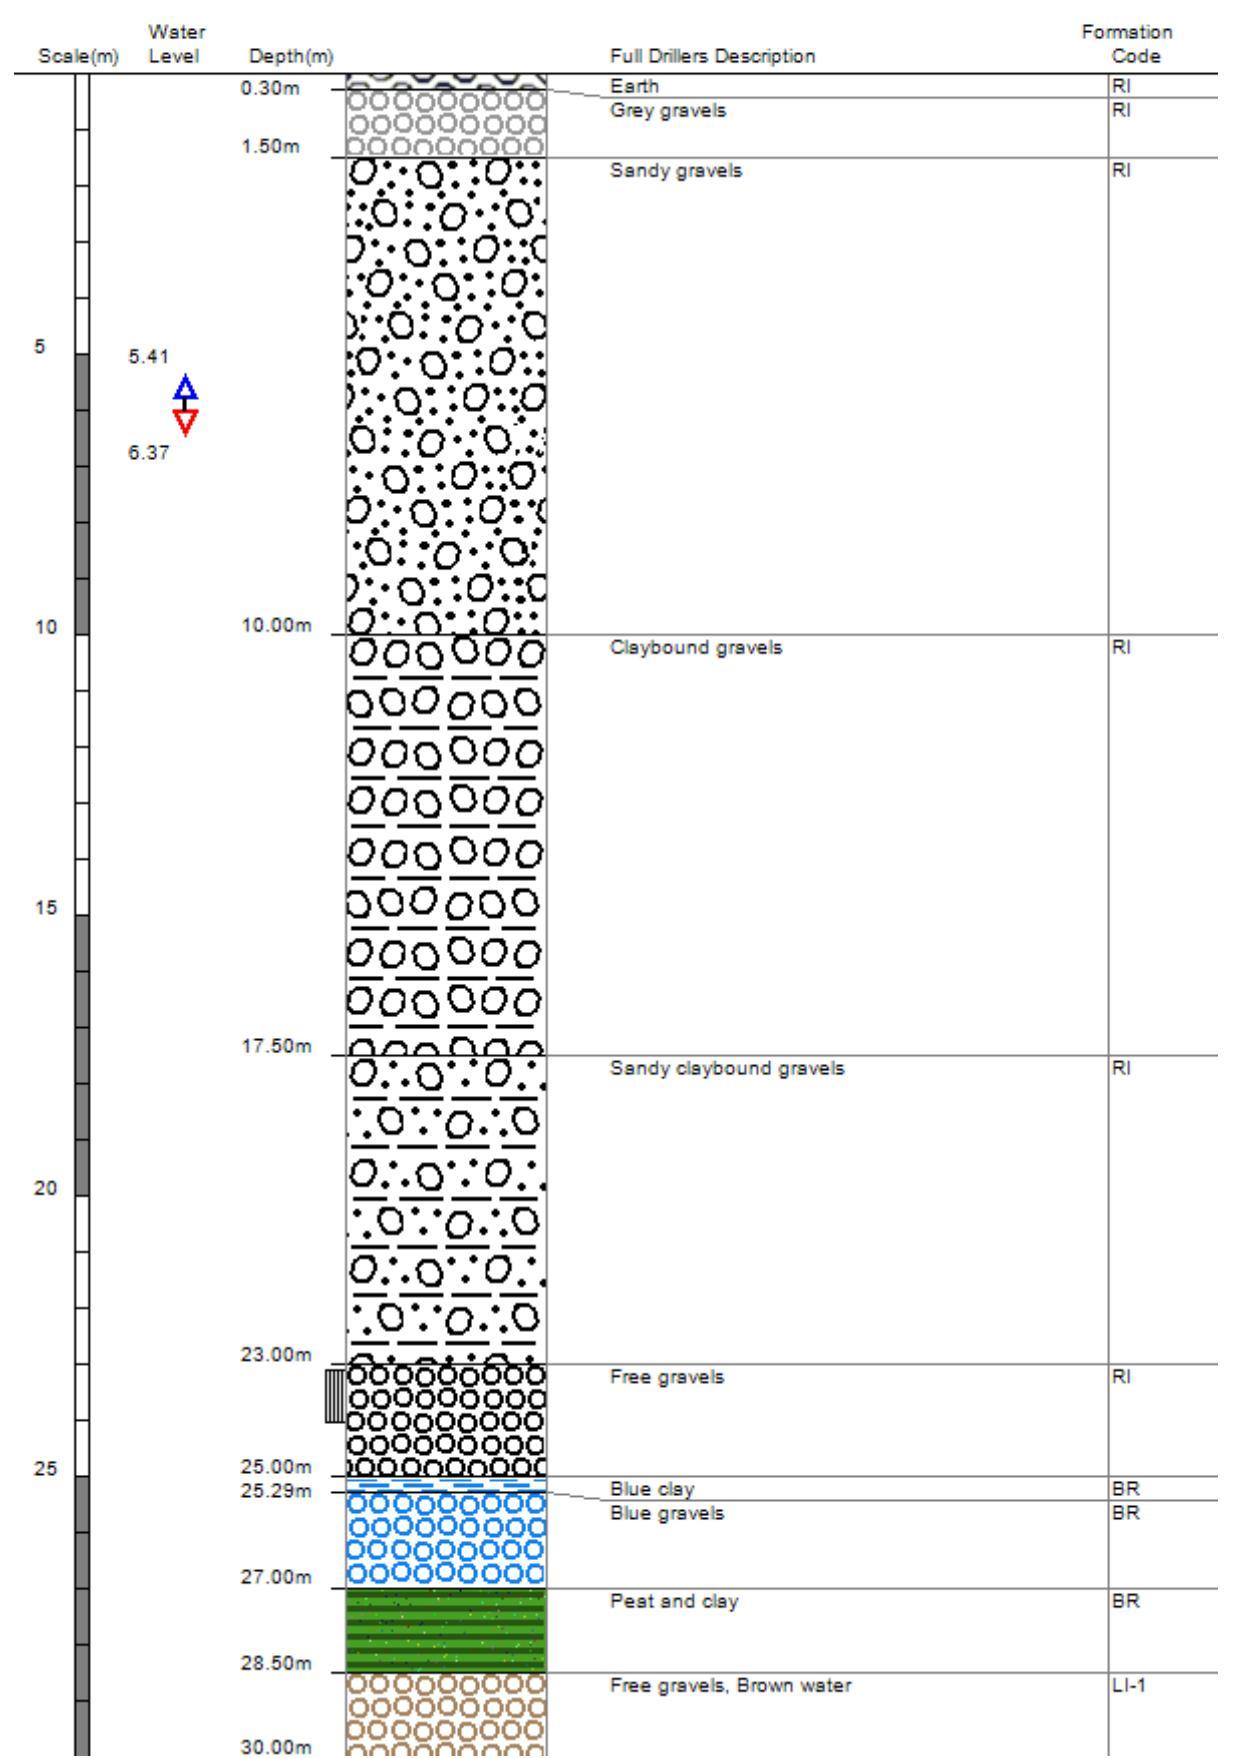
Borelog for well M36/20687

Grid Reference (NZTM): 1551357 mE, 5169911 mN Location Accuracy: 2 - 15m Ground Level Altitude: m +MSD Accuracy: Driller: East Coast Drilling Drill Method: Rotary Rig Borelog Depth: 36.0 m Drill Date: 12-Oct-2011
